# The Mondrian

## Depreciation Report Update

The Owners, Strata Corp. EPS 1502  
1090 Johnson Street, Victoria, BC

June 26, 2018

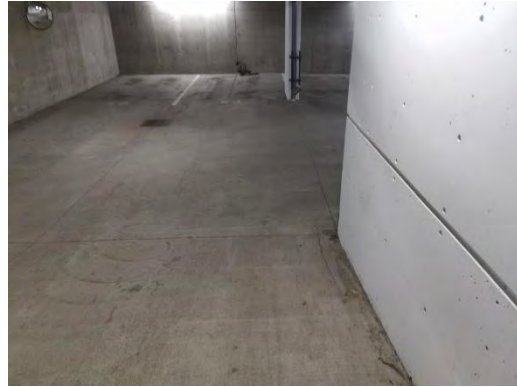
Item 3 - Standard Slab on Grade

3	A103001	Standard Slab on Grade - Contingency	The lowest floor of the parkade is a slab on grade. This is a non-structural item.	Good	2013	Budget for repairs at isolated locations on a periodic basis.	Contingency	4 - Discretionary	5	20	15	5%	100%	Y	\$6,000
4	A103006	Foundation Drainage - Study	Typically perimeter drainage is installed around the perimeter of the building and under the parkade slab. These systems can be prone to clogging with debris and root ingress. No issues reported during site visit.	Not Applicable	2013	Periodic camera inspection to identify issues as they arise.	Study	4 - Discretionary	5	10	5	5%	100%	Y	\$3,000
5	A103006	Foundation Drainage - Repair Contingency	Typically, perimeter drainage is installed around the perimeter of the building and under the parkade slab. These systems can be prone to clogging with debris and root ingress. No issues reported during site visit.	Not Applicable	2013	Contingency to remove and replace damaged or failed perimeter weeping tile as required.	Contingency	3 - Renewal	5	35	30	5%	100%	Y	\$29,000

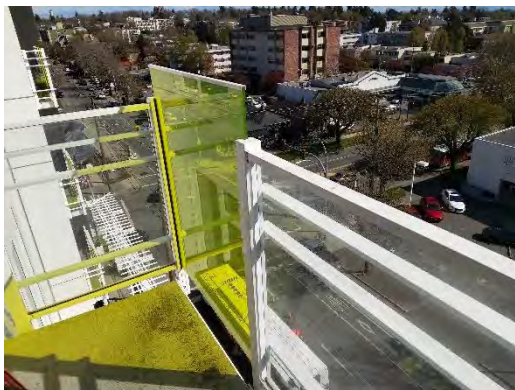
Item 6 - Aluminum Railings w/ Glass Panel

6	B101004	Fencing and Gates - Aluminum Railings w/ Glass Panel - Replacement	Balcony railings are a glazed aluminum rail, with coloured glass. Bolts are showing signs of premature rusting. Nuts at some locations could be removed by hand. Gaskets are drying out and not in proper position at some locations.	Fair	2013	Review of these assemblies is recommended.  Budget for replacement at end of service life. Repainting and repairs assumed to be a maintenance item.	Replacement	3 - Renewal	5	35	30	5%	100%	Y	\$153,000
7	B2	Suspended Slab - Slab & Column Repair Contingency	The below-grade parkade is a suspended concrete slab system. Concrete columns provide the support system for major loads.	Good	2013	Localized slab and column repairs as required.	Contingency	4 - Discretionary	5	20	15	5%	100%	Y	\$8,000
8	B2010	Exterior Walls - Painted Concrete - Repair Contingency	Areas of the lower levels (above grade) exterior cast-in-place concrete walls are painted.	Good	2013	Contingency for concrete repairs at painted walls as necessary. This line item is provided for localized repairs of 25% the wall surface.	Contingency	4 - Discretionary	5	25	20	5%	25%	Y	\$13,000

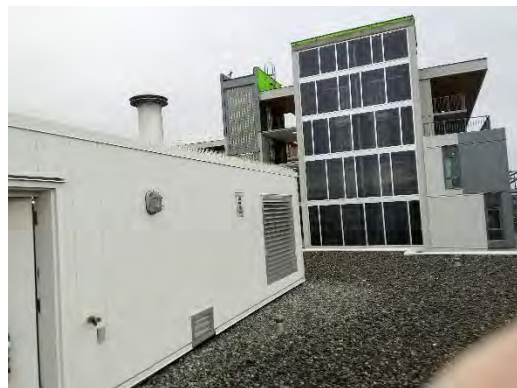
Item 9 - Mechanical Penthouse

9	B201001	Exterior Enclosure - Rain screen Metal Panels - Mechanical Penthouse - Replacement	Corrugated metal panels are installed on the mechanical penthouse walls. Penetrations through these walls are limited to the roof access doors and vents.	Good	2013	Install new corrugated metal panels at end of service life.	Replacement	3 - Renewal	5	35	30	5%	100%	Y	\$92,000
10	B201001	Exterior Enclosure - Rain screen Accent Composite Panel - Replacement	Composite panels are installed at various locations on all elevations of the building.	Good	2013	Install new composite panels as required at end of service life.	Replacement	3 - Renewal	5	35	30	5%	100%	Y	\$930,000
11	B201001	Exterior Enclosure - Rain screen Prefinished Metal Panels - Replacement	Prefinished metal panels are installed on all elevations.	Good	2013	Install new metal panels as required at end of service life.	Replacement	3 - Renewal	5	35	30	5%	100%	Y	\$2,064,000

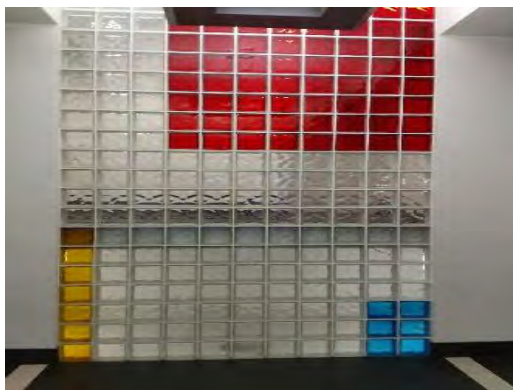
Item 12 - Glass Block Masonry

12	B201001	Glass Block Masonry - Level 1 (main entrance) - Replacement	Glass block masonry has been installed at the main entrance. MH notes that blocks are typically well protected by overhangs above.	Good	2013	Replace glass block at the end of service life.	Replacement	3 - Renewal	5	35	30	5%	100%	Y	\$12,000
13	B201008	Exterior Soffits - Repair Contingency	Exterior soffits include the underside of balconies and the underside of the roof overhangs. These areas are a painted concrete surface.	Good	2013	A budget has been provided for repair of soffits. This has been provided at a 10% budget of the total area of soffits.	Contingency	3 - Renewal	5	15	10	5%	10%	Y	\$27,000
14	B201010	Exterior Coatings - Paint Concrete Soffits - Repaint	Exterior soffits include the underside of balconies and the underside of the roof overhangs. These areas are painted concrete surfaces.	Good	2013	A budget has been provided for repainting all soffits and completing localized repairs to soffits.	Replacement	3 - Renewal	5	20	15	5%	100%	Y	\$64,000

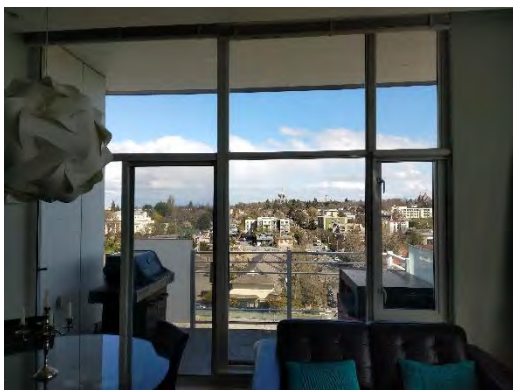
Item 21 - Balcony Swing Doors

21	B203002	Glazed Doors - Balcony Swing - Replacement	Glazed balcony swing doors provide access to individual balconies. Multiple doors reviewed were difficult to close/lock.	Good	2013	Replace exterior balcony swing doors at end of useful service life.	Replacement	3 - Renewal	5	35	30	5%	100%	Y	\$188,000
22	B203002	Glazed Doors - Balcony Sliding - Replacement	Glazed balcony sliding doors provide access to individual balconies. Multiple doors reviewed were difficult to close/lock.	Good	2013	Replace exterior balcony swing doors at end of useful service life.	Replacement	3 - Renewal	5	35	30	5%	100%	Y	\$73,000
23	B203001	Exterior Metal Doors - Replacement	Exterior metal doors are used on the generator room, mechanical room access (main roof) and rear fire escape/access door.	Good	2013	Exterior doors are expected to last the life of the building. This is a 33% contingency provided for the potential repair of these doors for replacement of locking mechanisms and handles.	Replacement	3 - Renewal	5	25	20	5%	33%	Y	\$2,000

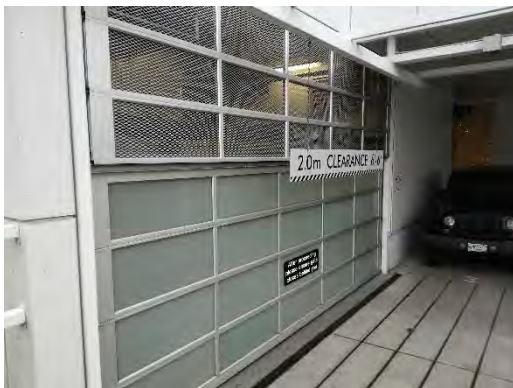
Item 24 - Overhead Garage Door

24	B203004	Overhead Garage Doors - Replacement	One single access gate provides security for the below grade parkade. Motor: LiftMaster, 1/2 HP	Good	2013	Replace overhead garage doors and motor. Depending on usage the door may be able to be retained.	Replacement	3 - Renewal	5	8	3	5%	100%	Y	\$12,000
25	B301002	Suspended Slab Podium Membrane - Replacement	An portion of the below grade parkade extends outside of the building's footprint. The topside (podium) of the parkade is waterproofed with an SBS membrane at landscaped and pavement areas.	Not Applicable	2013	Replace podium membrane at end of service life.	Replacement	3 - Renewal	5	35	30	5%	100%	Y	\$397,000
26	B301002	Intermediate Suspended Slab - Traffic Coating - Replacement	The parkade suspended slab has been waterproofed with a liquid applied traffic membrane. This item will help to prolong the repair cycle to the suspended slabs.	Good	2013	Apply vehicular traffic coating to intermediate suspended slabs. Cost for membrane replacement at end of service life. Cost of localized repairs assumed to be taken from operating budget.	Replacement	3 - Renewal	5	15	10	5%	100%	Y	\$51,000

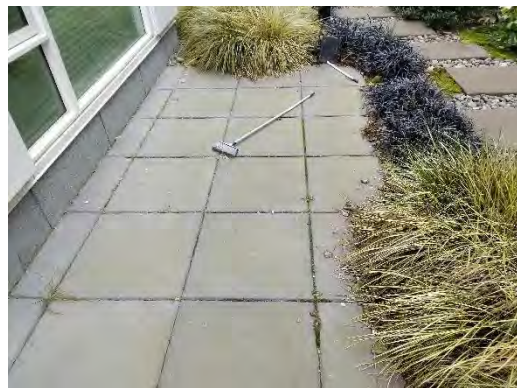
Item 25/27 - Podium Membrane

27	B301002	Roofing - Low Sloped Roof Deck Membrane System - SBS - Replacement	Roof deck areas and patios are waterproofed with an SBS membrane. Patio pavers provide the wear course to these areas.	Not Applicable	2013	Replace roofing system including flashings, sealants, etc. as required. Patio pavers assumed to be reused after roof renewal.	Replacement	3 - Renewal	5	25	20	5%	100%	Y	\$96,000
28	B301002	Roofing - Low Sloped Main Roof Membrane System - SBS - Replacement	The low slope main roof of the building is an inverted system, where the waterproofing membrane is covered by insulation and stone ballast.	Good	2013	Replace roofing system including flashings, sealants, etc. as required. Ballast and insulation assumed to be reused.	Replacement	3 - Renewal	5	25	20	5%	100%	Y	\$258,000

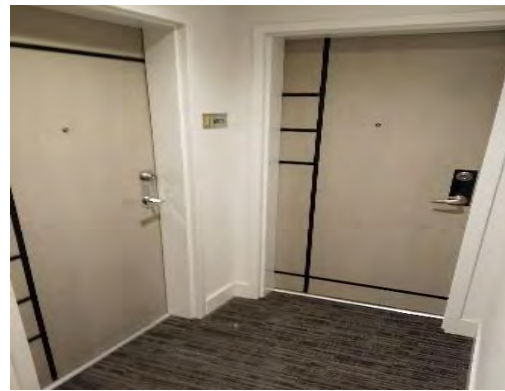
Item 32 - Suite Entry Doors

32	C102001	Suite Entry Doors and Thresholds- Replacement	Suite entry doors to units from common areas.	Good	2013	For replacement of thresholds and suite doors. Doors are expected to last the life of the building. A contingency of 20% replacement has been included for localized replacement as required.	Contingency	3 - Renewal	5	35	30	5%	20%	Y	\$12,000
33	C202001	Stair Finishes - Common Areas- Paint	Interior stairwell walls are finished with paint.	Good	2013	Repaint and update interior finishes.	Replacement	3 - Renewal	5	10	5	5%	100%	Y	\$42,000
34	C301005	Gypsum Board Wall Finishes Common Areas- Paint	All other interior common areas painted areas.	Good	2013	Repaint interior common walls.	Replacement	3 - Renewal	5	15	10	5%	100%	Y	\$93,000
35	C301005	Wood Paneling - Lobby - Replacement	Wood paneling has been installed around the elevators in the main lobby.	Good	2013	Replace wood paneling as required.	Replacement	3 - Renewal	5	25	20	5%	100%	Y	\$7,000

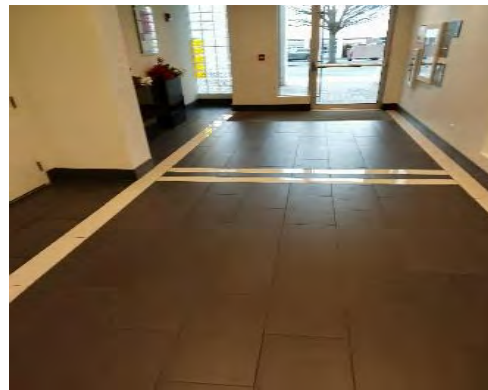
Item 36 - Lobby Tile Finishes

36	C302001	Tile Floor Finishes - Main lobby and parkade elevator lobbies - Replacement	Lobby areas and elevator lobby areas have a ceramic tile floor finish.	Good	2013	Replace lobby and main entrance tile floors.	Replacement	3 - Renewal	5	35	30	5%	100%	Y	\$29,000
37	C302005	Carpeting - Corridors and Meeting Room - Replacement	Carpeting is present in the corridors as well as the common meeting room.	Good	2013	Replace corridor carpeting and meeting room carpet	Replacement	4 - Discretionary	5	15	10	5%	100%	Y	\$47,000
38	C103009	Storage Lockers - Replacement	Metal wire storage lockers are present on level P2.	Good	2013	Replace storage lockers at the end of their service life. Lockers are anticipated to last beyond the scope of this report and do not appear in the capital table calculations.	Replacement	4 - Discretionary	5	50	45	5%	100%	Y	\$177,000
39	C103002	Toilet and Bath Accessories - Upgrade	Common area washroom in meeting room (one toilet and one sink).	Good	2013	Update washroom as required.	Upgrade	4 - Discretionary	5	20	15	5%	100%	Y	\$12,000

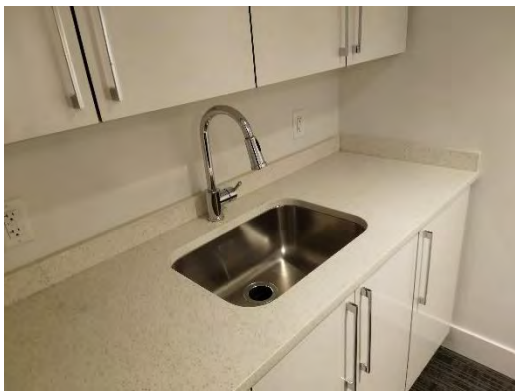
Item 40 - Meeting Room Kitchen

40	C103002	Kitchen - Upgrade	A small kitchen is present in the meeting room (cupboards and sink).	Good	2013	Update kitchen as required.	Upgrade	4 - Discretionary	5	20	15	5%	100%	Y	\$6,000
41	C1030	Fittings - Upgrade	Interior art and movable furnishings.	Good	2013	Replace at end of service life.	Upgrade	4 - Discretionary	5	20	15	5%	100%	Y	\$6,000
42	D202003	Domestic Water Equipment - Replacement	Hot water storage and expansion tanks. Storage Tanks: Rheem ST120 - 115 gal.	Good	2013	Replace DHW storage tanks.	Replacement	3 - Renewal	5	30	25	5%	100%	Y	\$11,000
43	D202003	Domestic Water Equipment - Boiler - Replacement	Raypak Raytherm atmospheric boiler provides hot water for the building.	Good	2013	Replace boiler at end of service life.	Replacement	3 - Renewal	5	25	20	5%	100%	Y	\$6,000
44	D202099	Other Domestic Water Supply - Backflow Preventer - Replacement	Backflow preventers are a CRD requirement to avoid water from various systems back drafting into the city water supply. Watts-709 (4") & Watts-009M2 2"	Good	2013	Replace or install new backflow preventer in existing water entry room.	Replacement	3 - Renewal	5	30	25	5%	100%	Y	\$6,000
