## **Parc Résidences** **Depreciation Report**

160 Wilson Street

September 11, 2013

RJC No.: VIC.106400.0001

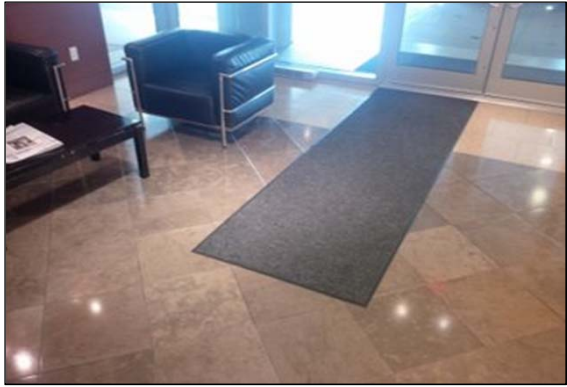
Item	Component	Description / Assessment / Priority
<b>A1.0 Building Interior</b>		
1.01.b.1	Main Lobby - Flooring - Replacement

<p><b>Description</b> Main lobby floor finishes consist of ceramic tiles.</p> <p><b>Assessment</b> The flooring appeared to be generally in good condition.</p> <p><b>Priority</b> 4 Building Functionality; cost effective and/or marketability upgrades.</p>
	<p><b>Expected Service Life</b> 30 Years</p> <p><b>Present Equivalent Age</b> 5 Years</p> <p><b>Estimated Remaining Life</b> 25 Years</p>	<p><b>Note:</b></p> <p style="text-align: right;"><b>Estimated Budget \$ 6,500</b></p>

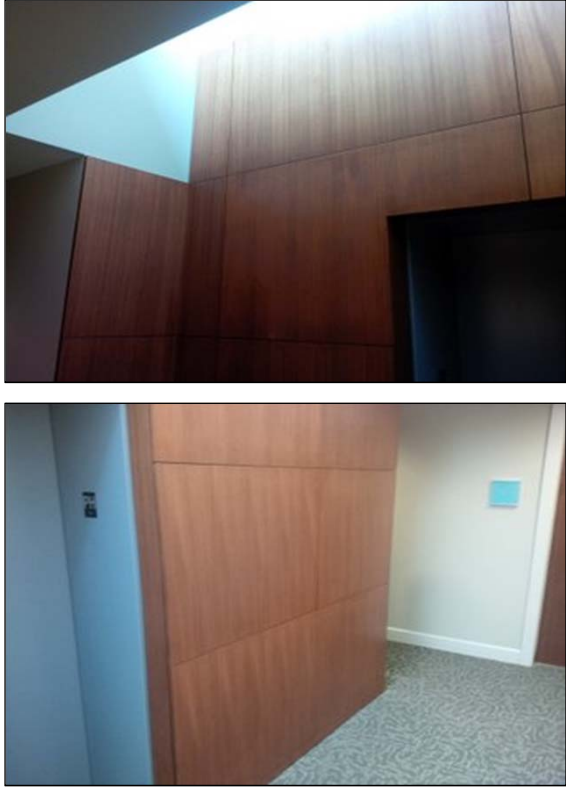
<p><b>Description</b> Hallway wall finishes include wood panelling around elevator doors.</p> <p><b>Assessment</b> The wood panelling appeared to be generally in good condition.  Renewals are not expected to be required within the time frame of this report.</p> <p><b>Priority</b> 4 Building Functionality; cost effective and/or marketability upgrades.</p>
	<p><b>Expected Service Life</b> 40 Years  <b>Present Equivalent Age</b> 7 Years  <b>Estimated Remaining Life</b> 33 Years</p>	<p><b>Note:</b></p> <p style="text-align: right;"><b>Estimated Budget</b> NA</p>

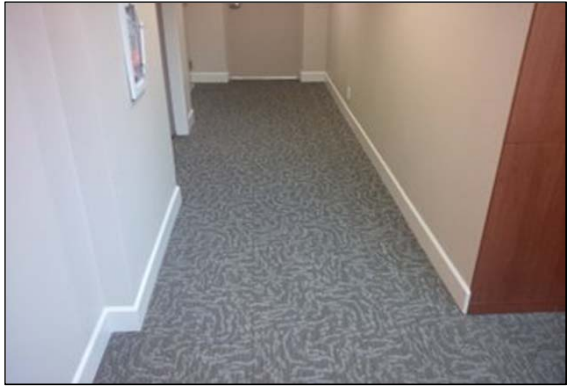
<p><b>Description</b> Hallway floor finishes consist of a patterned carpet.</p> <p><b>Assessment</b> The carpet appeared to be generally in good condition.  Strata records indicate that the carpet was replaced in 2012.</p> <p><b>Priority</b> 4 Building Functionality; cost effective and/or marketability upgrades.</p>
	<p><b>Expected Service Life</b> 25 Years  <b>Present Equivalent Age</b> 1 Years  <b>Estimated Remaining Life</b> 24 Years</p>	<p><b>Note:</b></p> <p style="text-align: right;"><b>Estimated Budget \$ 50,000</b></p>

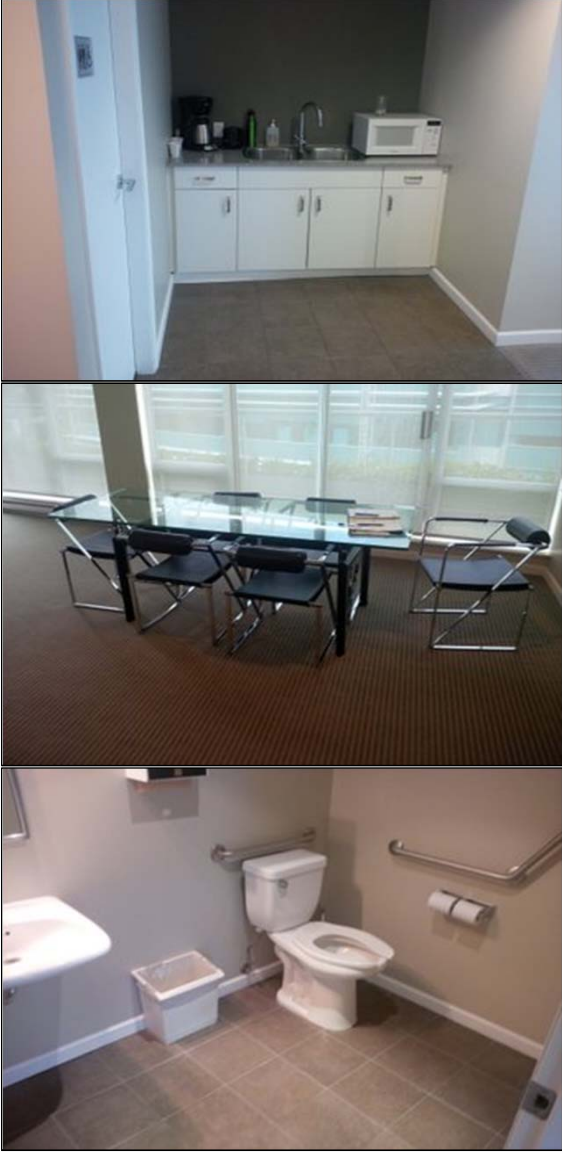
<p><b>Description</b> Miscellaneous chattels within the meeting room include, but are not limited to, the kitchenette, the boardroom table, and various plumbing fixtures within the bathroom.</p> <p><b>Assessment</b> The various chattels appeared to be generally in good condition.  Because of the varying expected service lives, the following budgeting is suggested:  Cabinets: \$750; Year 23 Furniture &amp; Miscellaneous: \$1,500; every 10 years Plumbing: Fixtures \$\$1,500; Year 23</p> <p><b>Priority</b> 4 Building Functionality; cost effective and/or marketability upgrades.</p>
	<p><b>Expected Service Life</b> Varies</p> <p><b>Present Equivalent Age</b> 7 Years</p> <p><b>Estimated Remaining Life</b> Varies</p>	<p><b>Note:</b> Cabinets: \$750; Year 23 (30 yr. life) Furniture: \$1,500; every 10 years Plumbing: Fixtures \$\$1,500; Year 23 (30 yr. life)</p> <p style="text-align: right;"><b>Estimated Budget</b>    <b>See Above</b></p>

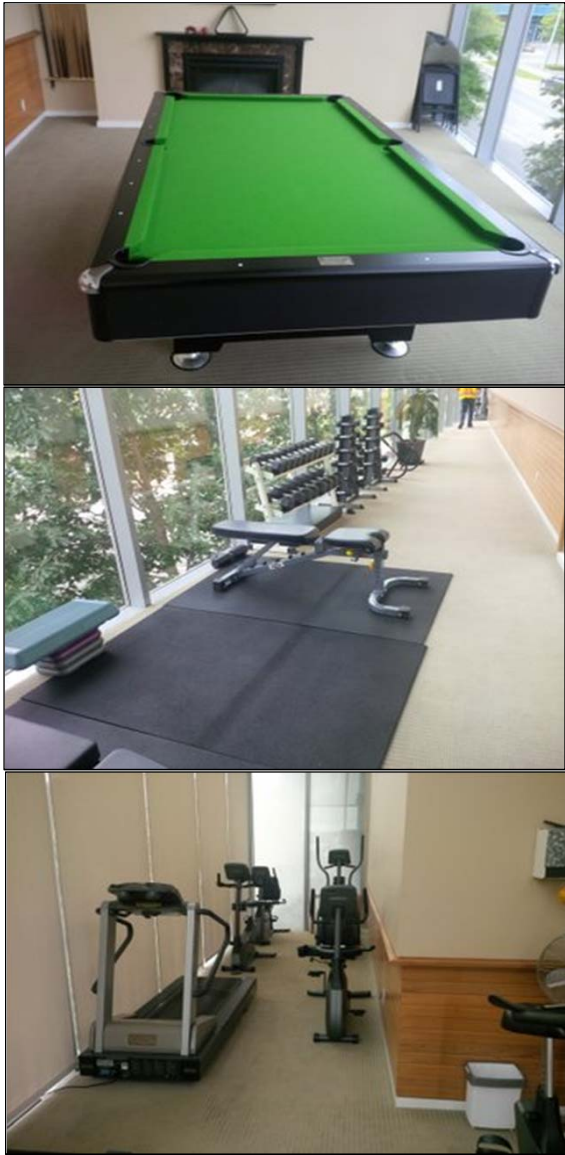
<p><b>Description</b> Gym room chattels include, but are not limited to, a pool table, free weights, bench, various cardiovascular equipment, and a flat screen television.</p> <p><b>Assessment</b> The equipment appeared to be generally in good condition and we understand the Strata has upgraded over the last several years.</p> <p><b>Priority</b> 4 Building Functionality; cost effective and/or marketability upgrades.</p>
	<p><b>Expected Service Life</b> Varies</p> <p><b>Present Equivalent Age</b> Varies</p> <p><b>Estimated Remaining Life</b> Varies</p>	<p><b>Note:</b> An Estimated Budget to replace approximately \$2,500 every 3 years is suggested.</p> <p style="text-align: right;"><b>Estimated Budget \$ 2,500</b></p>

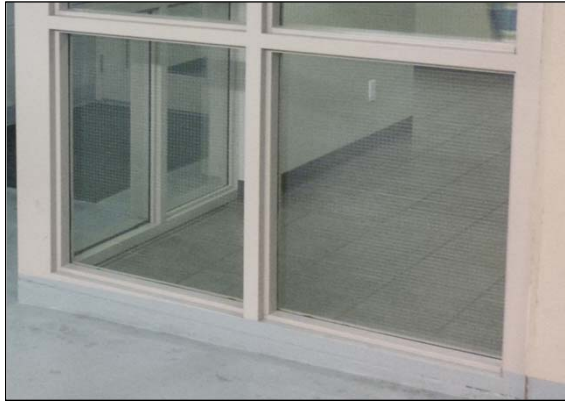
<p><b>Description</b></p> <p>Parkade corridor floor finishes consists of a painted concrete floor.</p> <p>Elevator lobby areas within the parkade consist of a ceramic tile.</p> <p><b>Assessment</b></p> <p>The floor finishes appeared to be generally in good condition.</p> <p>Expected service life of paint on a concrete floor is approximately 7 years compared to 30 years for the ceramic tile.</p> <p><b>Priority</b></p> <p>4 Building Functionality; cost effective and/or marketability upgrades.</p>
	<p><b>Expected Service Life</b> 7 to 30 Years</p> <p><b>Present Equivalent Age</b> 3 to 7 Years</p> <p><b>Estimated Remaining Life</b> 4 to 23 Years</p>	<p><b>Note:</b></p> <p>Painted finish: \$2,000</p> <p>Ceramic tile: \$1,500</p> <p style="text-align: right;"><b>Estimated Budget</b>    <b>See Above</b></p>

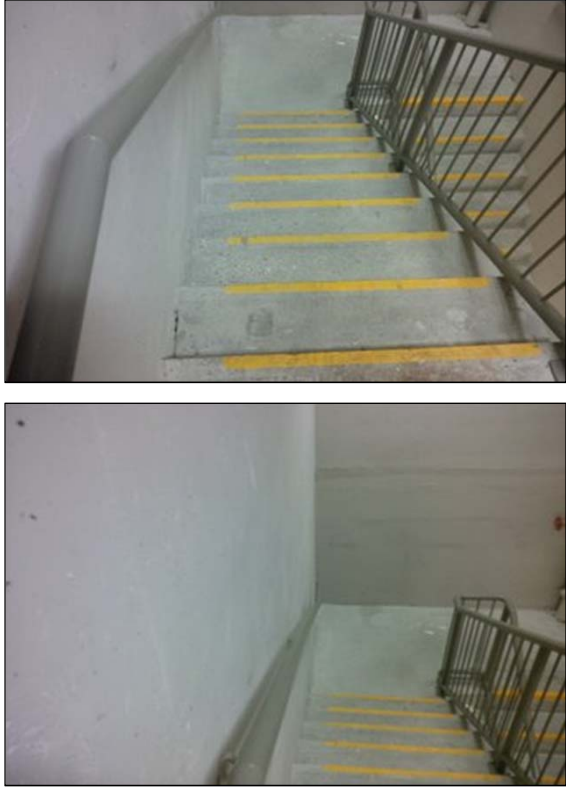
<p><b>Description</b>                      Stairwell finishes consist of exposed concrete stairs and landings with painted vision strip. Walls are painted concrete. Painted steel handrails are also provided.</p> <p><b>Assessment</b>                      The various components appeared to be generally in good condition except for some minor scuffing in the handrails.</p> <p><b>Priority</b>                      4 Building Functionality; cost effective and/or marketability upgrades.</p>
	<p><b>Expected Service Life</b> 15 Years  <b>Present Equivalent Age</b> 7 Years  <b>Estimated Remaining Life</b> 8 Years</p>	<p><b>Note:</b></p> <p style="text-align: right;"><b>Estimated Budget \$ 15,000</b></p>

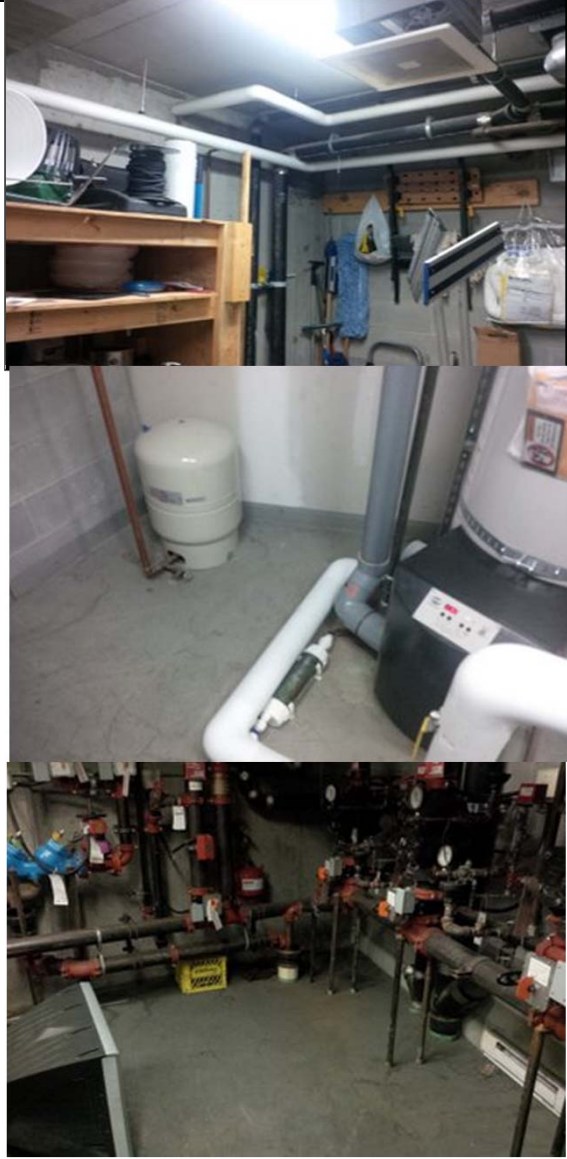
<p><b>Description</b></p> <p>Various utility room finishes consist of:</p> <ul style="list-style-type: none"> <li>-exposed or painted concrete floors;</li> <li>-unfinished/painted concrete block, concrete, drywall, and plywood walls;</li> <li>-exposed concrete soffits.</li> </ul> <p><b>Assessment</b></p> <p>The finishes varied from good to fair condition.</p> <p>Although most of these areas are rarely accessed by the residents, an Estimated Budget of \$2,500 is suggested to be allocated every 7 years for painting of different areas as required.</p> <p><b>Priority</b></p> <p>4 Building Functionality; cost effective and/or marketability upgrades.</p>
	<p><b>Expected Service Life</b> 7 Years</p> <p><b>Present Equivalent Age</b> 3 Years</p> <p><b>Estimated Remaining Life</b> 4 Years</p>	<p><b>Note:</b></p> <p style="text-align: right;"><b>Estimated Budget \$ 2,500</b></p>

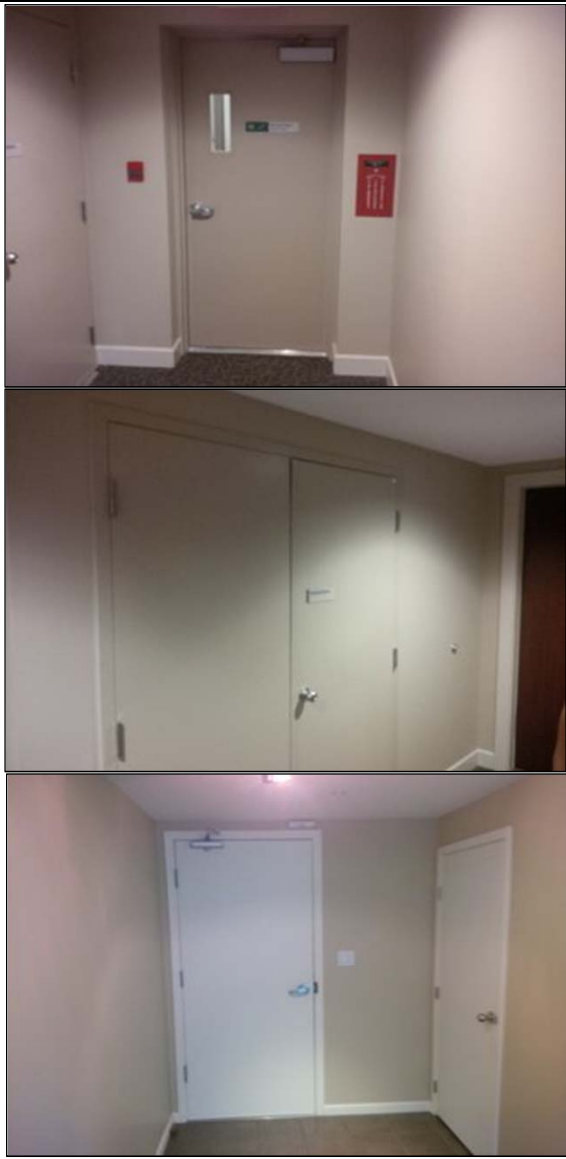
<p><b>Description</b> Utility doors consist of fire-rated solid core metal doors.</p> <p><b>Assessment</b> The doors appeared to be generally in good condition.</p> <p><b>Priority</b> 4 Building Functionality; cost effective and/or marketability upgrades.</p>
	<p><b>Expected Service Life</b> 55 Years</p> <p><b>Present Equivalent Age</b> 7 Years</p> <p><b>Estimated Remaining Life</b> 48 Years</p>	<p><b>Note:</b> Painting of doors would be included with painting of the hallways.</p> <p style="text-align: right;"><b>Estimated Budget</b> NA</p>

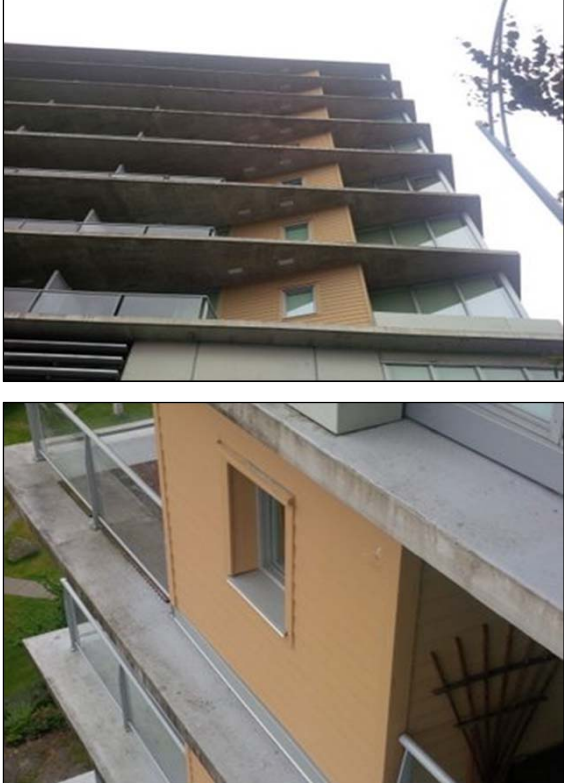
<p><b>Description</b>                      Painted fibre reinforced cementitious panel board is installed on various elevations.</p> <p><b>Assessment</b>                      The fibre cement board siding appeared to be generally in good condition.</p> <p><b>Priority</b>                      4 Building Functionality; cost effective and/or marketability upgrades.</p>
	<p><b>Expected Service Life</b> 50 Years  <b>Present Equivalent Age</b> 7 Years  <b>Estimated Remaining Life</b> 43 Years</p>	<p><b>Note:</b></p> <p style="text-align: right;"><b>Estimated Budget</b> NA</p>

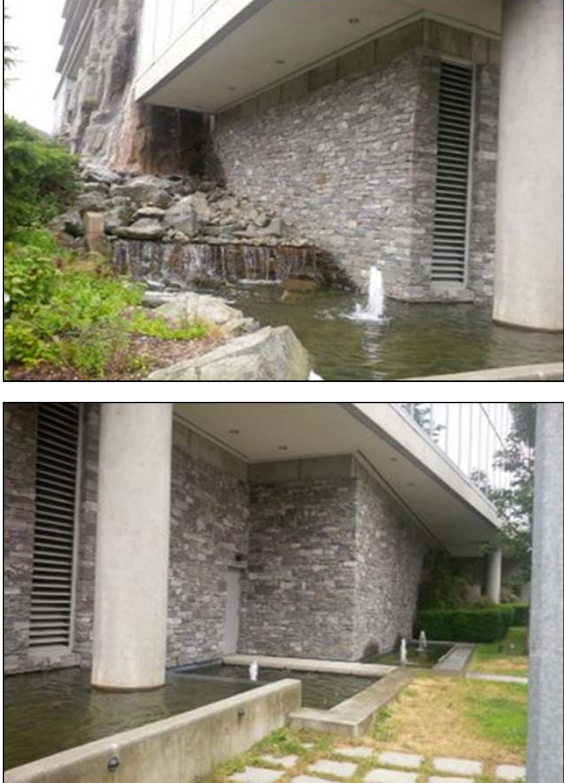
<p><b>Description</b>                      Stone cladding is located along the water feature at the south-east corner of the building.</p> <p><b>Assessment</b>                      The stone cladding appeared to be generally in good condition.                       Renewals of the slate, other than surface cleaning as necessary, should not be required.</p> <p><b>Priority</b>                      4 Building Functionality; cost effective and/or marketability upgrades.</p>
	<p>Expected Service Life                      NA                      Present Equivalent Age                      NA                      Estimated Remaining Life                      NA</p>	<p><b>Note:</b></p> <p style="text-align: right;"><b>Estimated Budget                      NA</b></p>

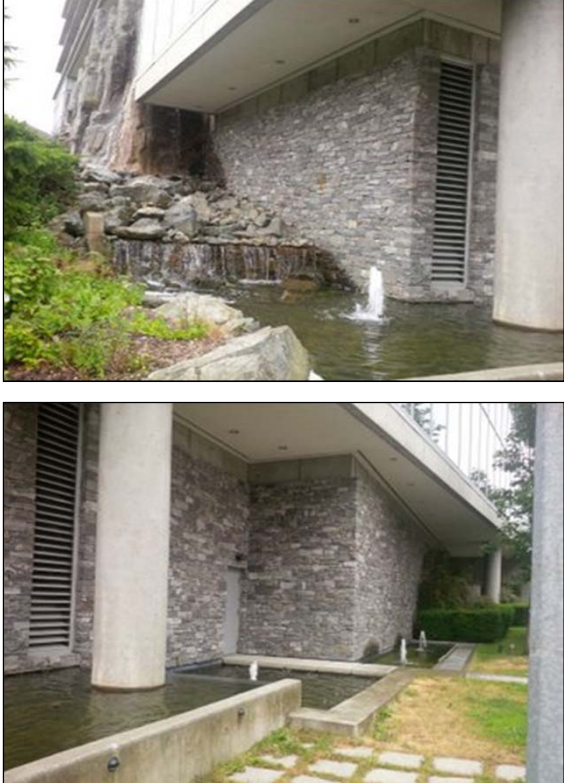
<p><b>Description</b>            Stone cladding is located along the water feature at the south-east corner of the building.</p> <p><b>Assessment</b>            The stone cladding appeared to be generally in good condition.             The stone is a durable cladding material with a long expected service life.</p> <p><b>Priority</b>            4 Building Functionality; cost effective and/or marketability upgrades.</p>

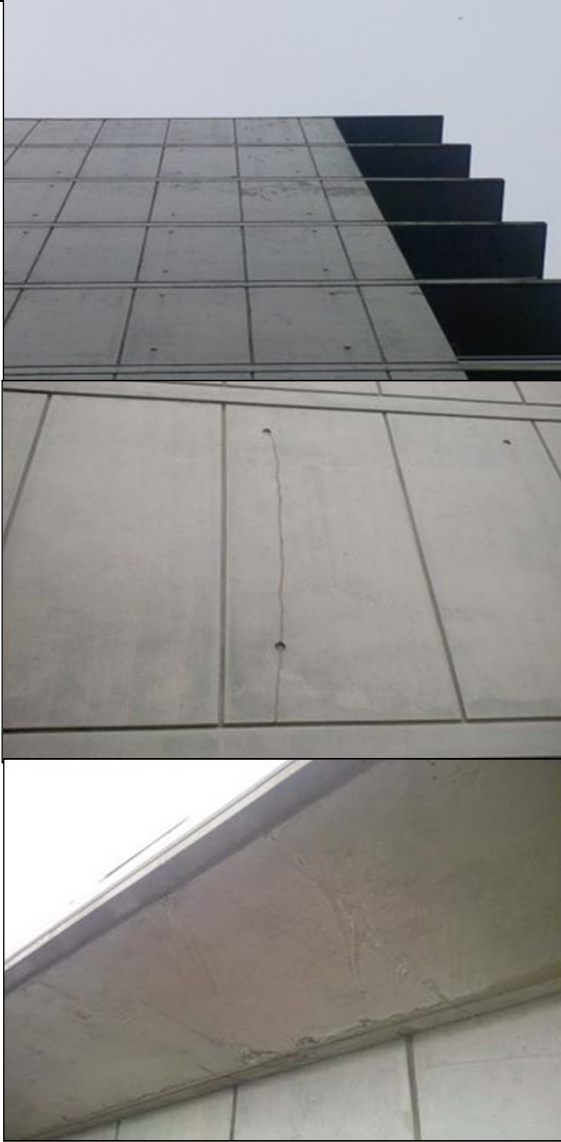
<p><b>Description</b></p> <p>Exterior walls consist primarily of exposed concrete walls with a concrete sealer applied to the surface.</p> <p>Exposed concrete soffits are located on the underside of the balconies and eyebrows.</p> <p><b>Assessment</b></p> <p>The exposed wall surface appeared to be generally in good condition with some cracking evident. There was some staining on the concrete soffits that could be indicative of water ingress through the waterproofing membrane above. Cracking was also evident in the soffits.</p> <p>Renewals required on bare concrete walls is typically limited to the application of a clear water repellent sealer unless delamination or spalling of the concrete surface is present.</p> <p>The sealer reduces the amount of water absorption and the associated mottled appearance of the surface when wet. Over the long term, the sealer may reduce the incidence of delamination or spalling.</p> <p>Sealers are typically reapplied on a 5 to 7 year cycle.</p> <p><b>Priority</b></p> <p>4 Building Functionality; cost effective and/or marketability upgrades.</p>

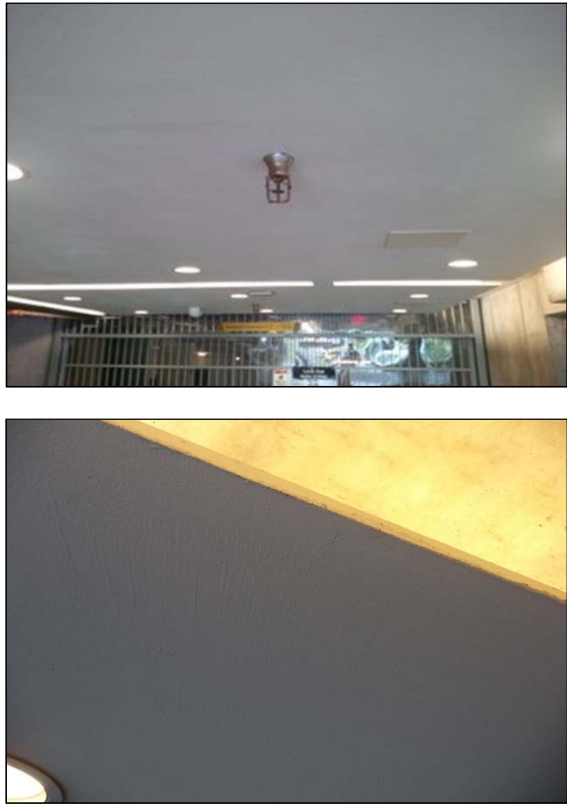
<p><b>Description</b>                      Wood drop soffit panels are located at the main entrance.</p> <p><b>Assessment</b>                      The soffits appeared to be generally in good condition.</p> <p><b>Priority</b>                      4 Building Functionality; cost effective and/or marketability upgrades.</p>
	<p>Expected Service Life 10 Years                      Present Equivalent Age 5 Years                      Estimated Remaining Life 5 Years</p>	<p><b>Note:</b></p> <p style="text-align: right;"><b>Estimated Budget \$ 1,500</b></p>

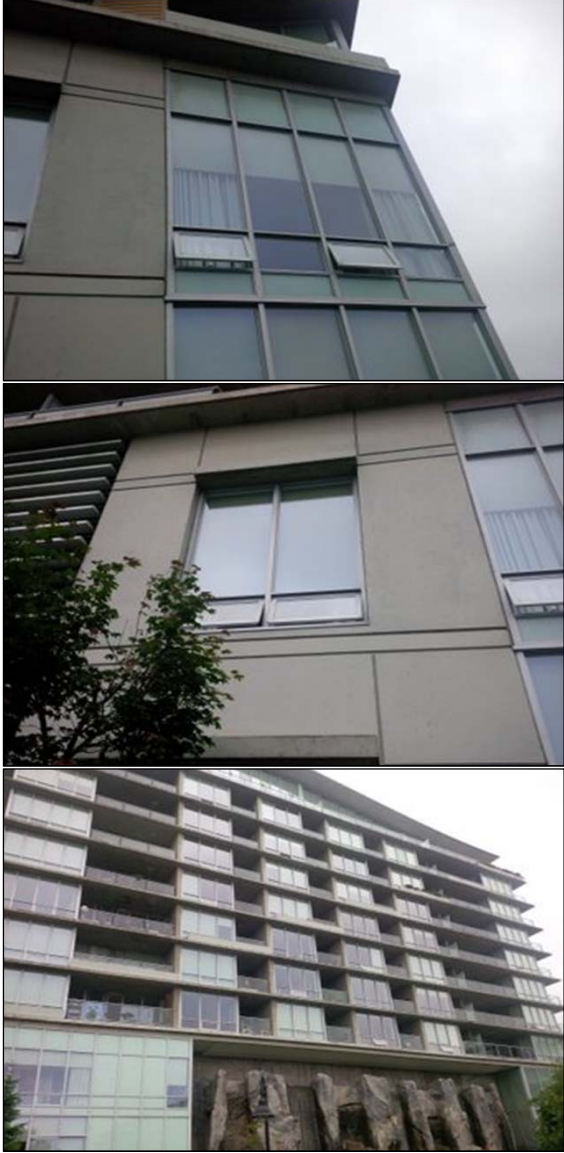
<p><b>Description</b>                      Windows consist of a thermally-broken, aluminum frame window wall system with double-glazed Insulated Glazing Units (IGUs). Punched windows are also present. Windows have awning operable vents.</p> <p><b>Assessment</b>                      The window assemblies appeared to be generally in good condition.                       The IGU seals can be expected to fail at random after 10 to 15 years and should be replaced on an as-required basis.                       It is recommended that an allowance of \$7,000 be set aside every 3 years for the replacement of failed sealed units.                       Hardware may also have to be replaced and is included in the proposed budget.</p> <p><b>Priority</b>                      4 Building Functionality; cost effective and/or marketability upgrades.</p>

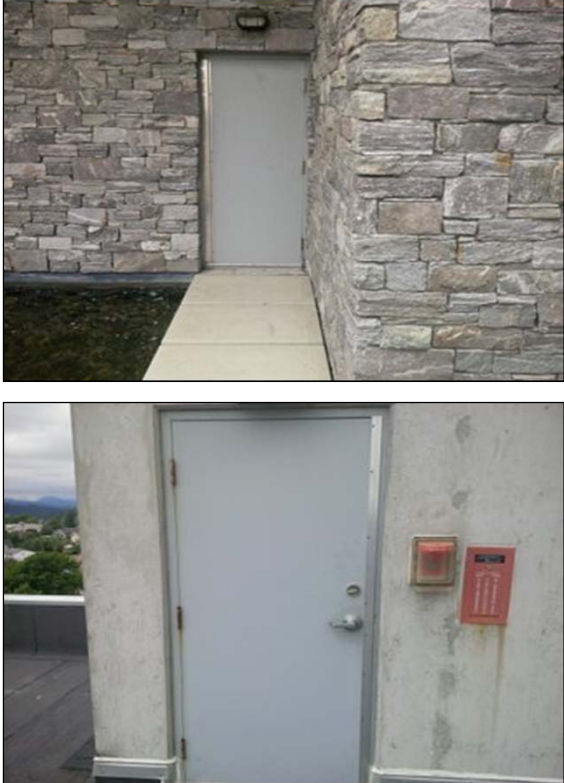
<p><b>Description</b>                      Metal exterior doors are located at parkade exits and at roof access points. Doors consist of solid core metal skin doors.</p> <p><b>Assessment</b>                      The door assemblies appeared to be generally in good condition except for some corrosion on the rooftop door hinges.</p> <p>Renewals would include repainting and replacement of hardware such as hinges as required.</p> <p><b>Priority</b>                      4 Building Functionality; cost effective and/or marketability upgrades.</p>

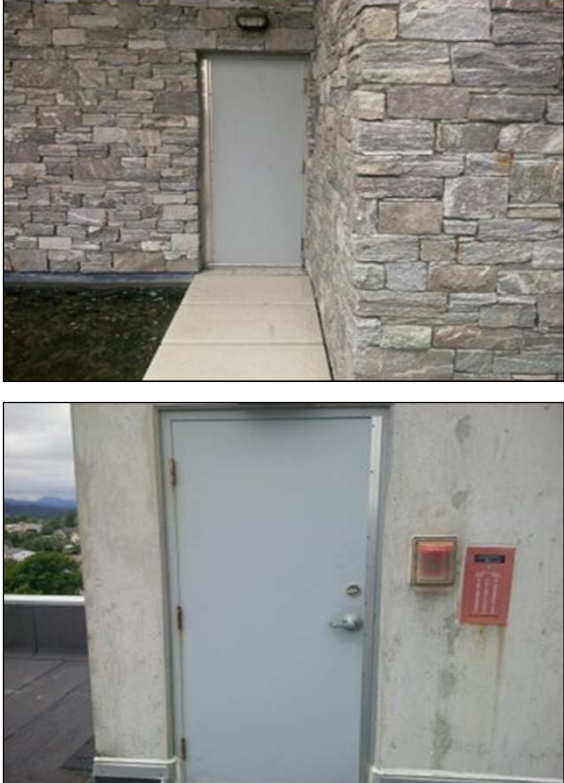
<p><b>Description</b>                      Metal exterior doors are located at parkade exits and at roof access points. Doors consist of solid core metal skin doors.</p> <p><b>Assessment</b>                      The door assemblies appeared to be generally in good condition.                       This type of door assembly would be expected to last up to 40 years before requiring replacement.</p> <p><b>Priority</b>                      4 Building Functionality; cost effective and/or marketability upgrades.</p>
	<p><b>Expected Service Life</b> 40 Years  <b>Present Equivalent Age</b> 7 Years  <b>Estimated Remaining Life</b> 33 Years</p>	<p><b>Note:</b></p> <p style="text-align: right;"><b>Estimated Budget</b> NA</p>

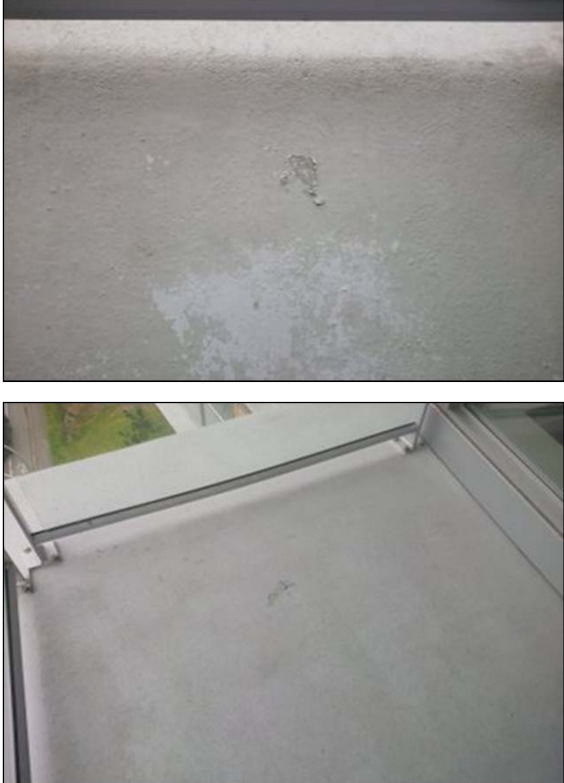
<p><b>Description</b>                      Liquid applied deck membrane on structural concrete slab.</p> <p><b>Assessment</b>                      The liquid applied membranes appeared to be generally in good to poor condition. Ongoing leaks were reported by the Strata.</p> <p>This type of membrane would normally be expected to last approximately 15 years before requiring renewal however it is suggested that the balcony waterproofing be done sooner to mitigate potential damage to the underlying concrete. As noted in Item 2.01.c.1, there was some staining on the soffits that could be indicative of water ingress through the waterproofing membrane above.</p> <p>The balcony membranes could be renewed in a phased approach with 1/3 being done each year over the first 3 years.</p> <p><b>Priority</b>                      4 Building Functionality; cost effective and/or marketability upgrades.</p>

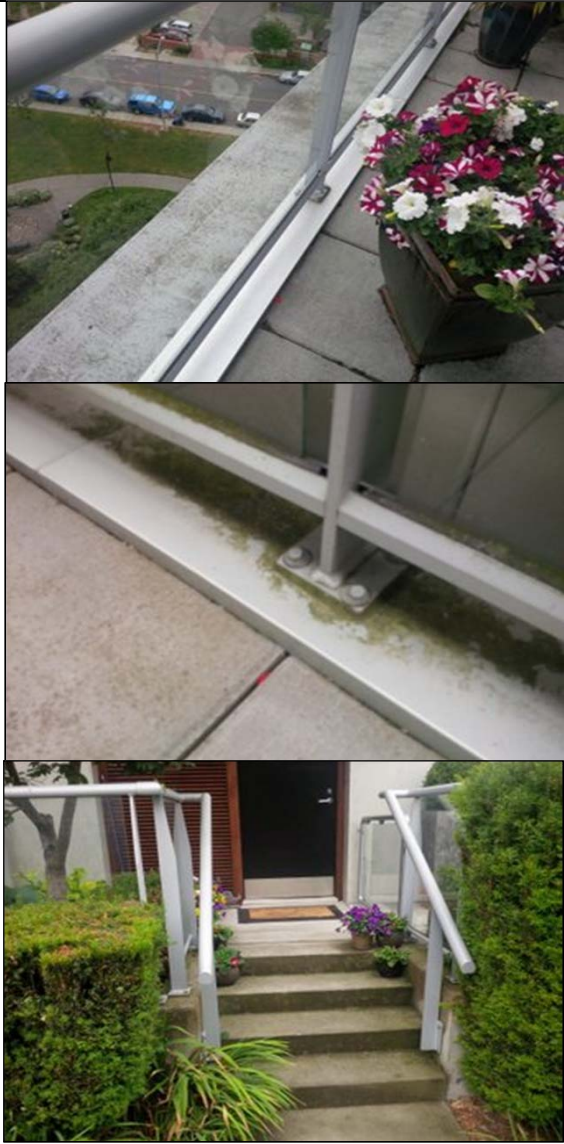
<p><b>Description</b>                      Aluminum framed guardrails with glazing infill panels.</p> <p><b>Assessment</b>                      The guardrails appeared to be generally in good condition.                       This type of assembly would be expected to last approximately 35 to 45 years before requiring replacement.                       The finish on the guardrails should be monitored and scratches repaired as required.</p> <p><b>Priority</b>                      2 Structural Integrity</p>

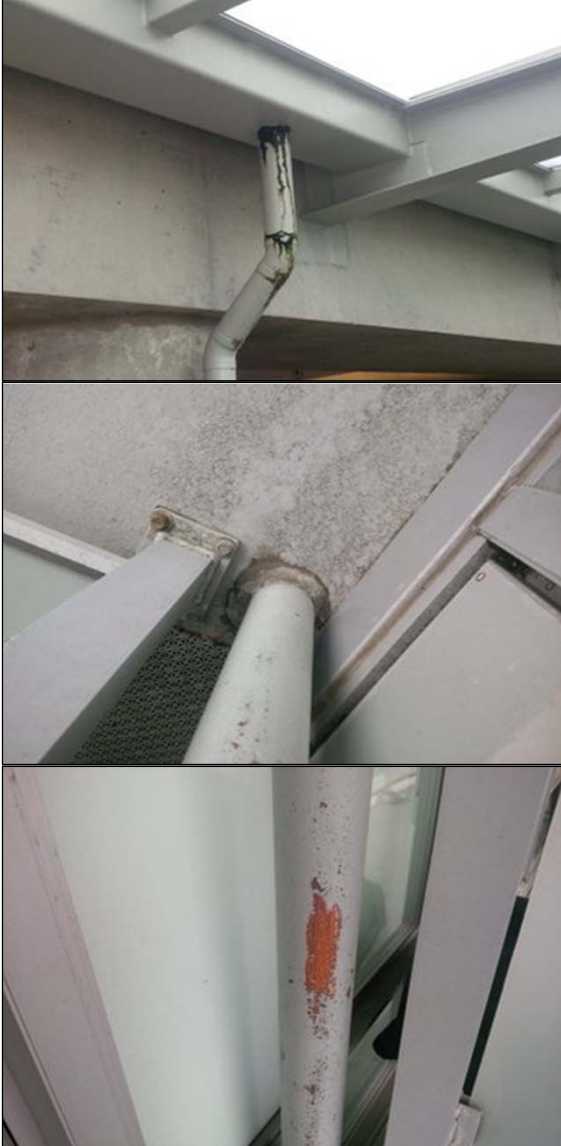
<p><b>Description</b> Painted metal downspouts.</p> <p><b>Assessment</b> The paint finish on the pipe was in poor condition with flaking and corrosion of the pipe visible.  The Strata noted that the piping is currently being repainted.</p> <p><b>Priority</b> 4 Building Functionality; cost effective and/or marketability upgrades.</p>
	<p><b>Expected Service Life</b> 7 Years  <b>Present Equivalent Age</b> 0 Years  <b>Estimated Remaining Life</b> 7 Years</p>	<p><b>Note:</b> For the purpose of this report it is assumed that the pipe will be completely repainted in 2013.</p> <p style="text-align: right;"><b>Estimated Budget \$ 10,000</b></p>

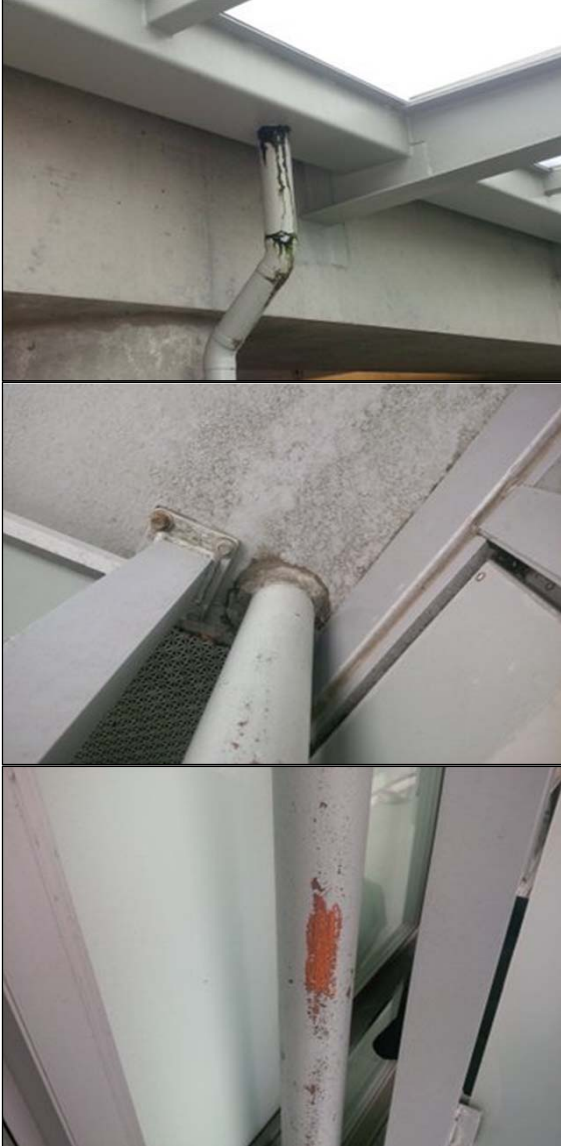
<p><b>Description</b> Painted metal downspouts.</p> <p><b>Assessment</b> The paint finish on the pipe was in poor condition with flaking and corrosion of the pipe visible.  The Strata noted that the piping is currently being repainted.  Assuming continued maintenance, replacement of the pipe should not be required within the next 30 years.</p> <p><b>Priority</b> 4 Building Functionality; cost effective and/or marketability upgrades.</p>
	<p><b>Expected Service Life</b> 40 Years</p> <p><b>Present Equivalent Age</b> 7 Years</p> <p><b>Estimated Remaining Life</b> 33 Years</p>	<p><b>Note:</b></p> <p style="text-align: right;"><b>Estimated Budget</b> NA</p>

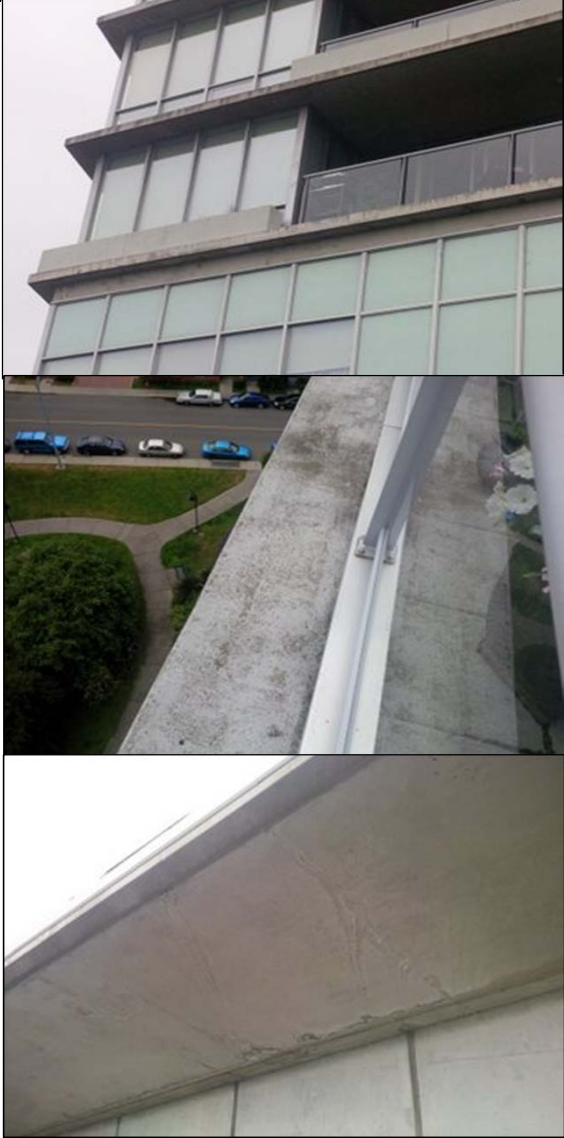
<p><b>Description</b>                      Concrete eyebrows are coated with a liquid applied membrane.</p> <p><b>Assessment</b>                      Similar to the balconies, the condition of the membrane varied and should be renewed when renewing the balconies.</p> <p>As noted in Item 2.01.c.1, there was some staining on the soffits that could be indicative of water ingress through the waterproofing membrane above. Cracking was also noted - this could provide a path for water ingress if not properly sealed.</p> <p><b>Priority</b>                      4 Building Functionality; cost effective and/or marketability upgrades.</p>
	<p><b>Expected Service Life</b> 15 Years  <b>Present Equivalent Age</b> 12 to 15 Years  <b>Estimated Remaining Life</b> 0 to 3 Years</p>	<p><b>Note:</b>                      The Estimated Budget for the eyebrows is included in Item 2.05.b.1.</p> <p style="text-align: right;"><b>Estimated Budget</b>      <b>NA</b></p>

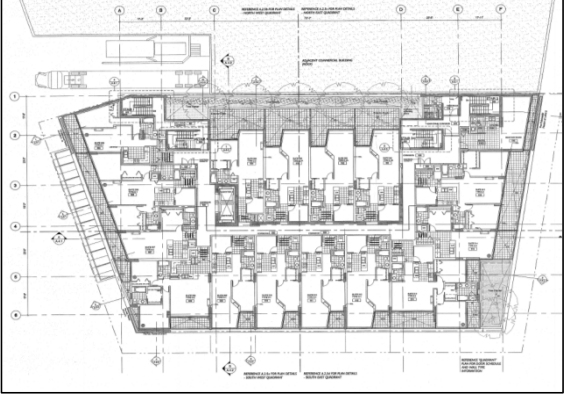
<p><b>Description</b> The base building structure consists of cast-in-place concrete foundations walls and suspended slabs.</p> <p><b>Assessment</b> No visual evidence of structural distress was observed during the review.</p> <p><b>Priority</b> 2 Structural Integrity</p>
	<p><b>Expected Service Life</b> 75+ Years</p> <p><b>Present Equivalent Age</b> 7 Years</p> <p><b>Estimated Remaining Life</b> 68 Years</p>	<p><b>Note:</b></p> <p style="text-align: right;"><b>Estimated Budget</b> NA</p>

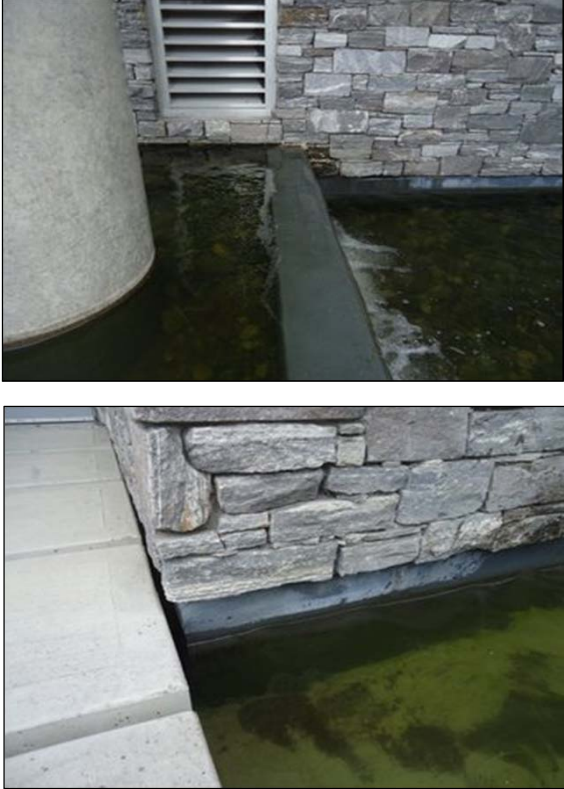
<p><b>Description</b> The pond liner consists of liquid applied membrane on the concrete walls.</p> <p><b>Assessment</b> The pond liner was not visible for review.  The Strata noted that there are no current leaks.</p> <p><b>Priority</b> 4 Building Functionality; cost effective and/or marketability upgrades.</p>
	<p><b>Expected Service Life</b> 15 Years  <b>Present Equivalent Age</b> 7 Years  <b>Estimated Remaining Life</b> 8 Years</p>	<p><b>Note:</b></p> <p style="text-align: right;"><b>Estimated Budget \$ 30,000</b></p>

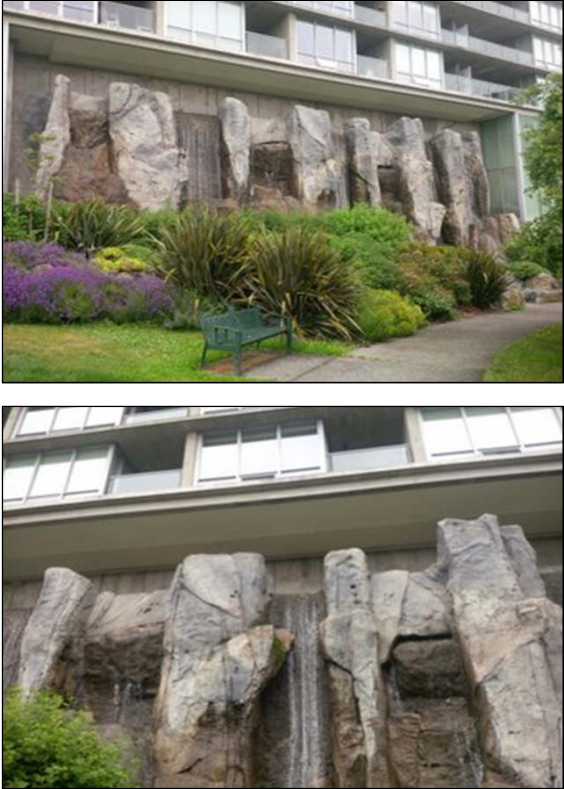
<p><b>Description</b> A concrete waterfall feature is located on the south side of the building.</p> <p><b>Assessment</b> The assembly appeared to be generally in good condition.  The mechanical components are described in the mechanical section of the report.  No renewals of the architectural components would be expected to be required within the next 30 years.</p> <p><b>Priority</b> 4 Building Functionality; cost effective and/or marketability upgrades.</p>
	<p><b>Expected Service Life</b> 40 Years  <b>Present Equivalent Age</b> 7 Years  <b>Estimated Remaining Life</b> 33 Years</p>	<p><b>Note:</b></p> <p style="text-align: right;"><b>Estimated Budget</b> NA</p>

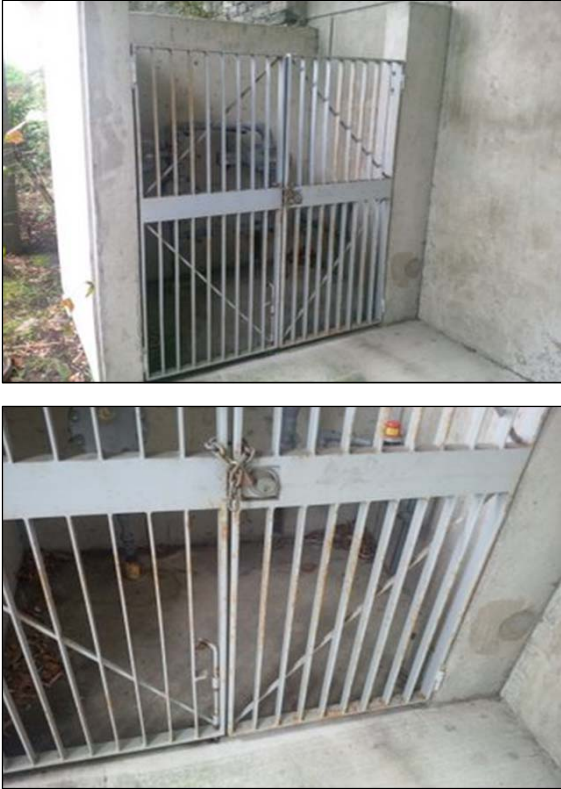
<p><b>Description</b> A painted metal gate is located at the east side of the building to enclose the gas meter system.</p> <p><b>Assessment</b> The gate was lightly corroded and the paint finish should be renewed.</p> <p><b>Priority</b> 4 Building Functionality; cost effective and/or marketability upgrades.</p>
	<p><b>Expected Service Life</b> 7 Years  <b>Present Equivalent Age</b> 7 Years  <b>Estimated Remaining Life</b> 0 Years</p>	<p><b>Note:</b></p> <p style="text-align: right;"><b>Estimated Budget \$ 800</b></p>

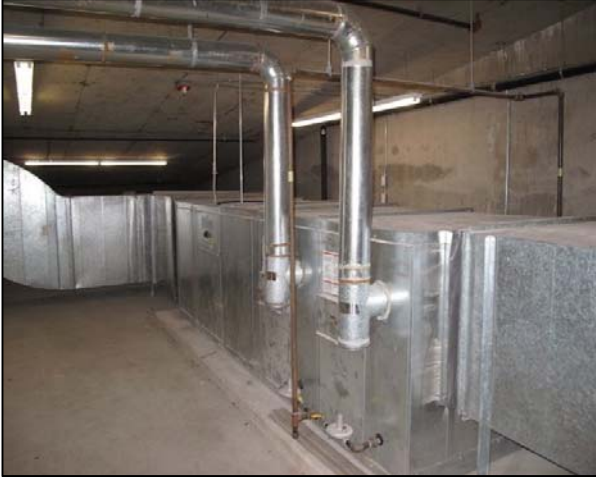
<p><b>Description</b> A natural gas make up air unit (MAU) located in the penthouse mechanical room supplies tempered air for corridors and elevator lobbies on each floor.</p> <p><b>Assessment</b> Good condition. Recommend annual gas burner and fan 'check up' and regular filter changes and vacuum cleaning of unit.</p> <p><b>Priority</b> 4 Building Functionality; cost effective and/or marketability upgrades.</p>
<p><b>Expected Service Life</b> 30 Years  <b>Present Equivalent Age</b> 7 Years  <b>Estimated Remaining Life</b> 23 Years</p>		<p><b>Note:</b> Other rooftop equipment serves condominium units - maintenance and replacement is responsibility of individual owners.</p> <p style="text-align: right;"><b>Estimated Budget \$ 15,000</b></p>

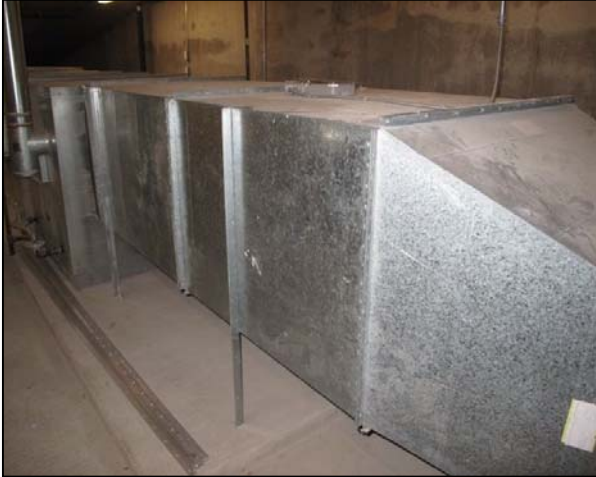
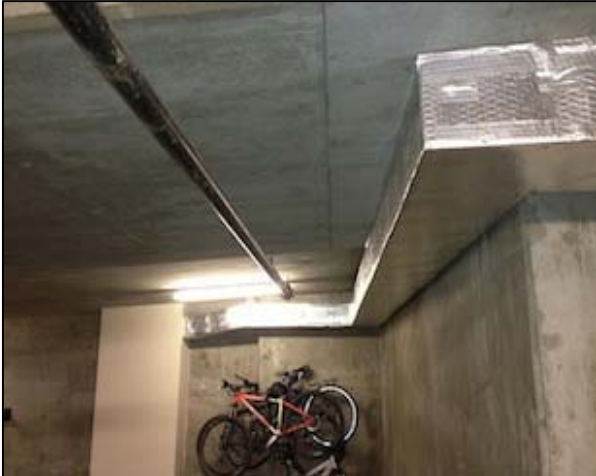
<p><b>Description</b> Ductwork with grilles and fire dampers on each floor delivers the tempered air from the MAU to corridors and elevator lobbies.</p> <p><b>Assessment</b> Good condition. Regular duct cleaning and fire damper maintenance is recommended.</p> <p>Fire dampers should be inspected and tested at least once every 4 years as per NFPA 90A. Refer to attached document FIRE DAMPER MAINTENANCE.pdf.</p> <p><b>Priority</b> 4 Building Functionality; cost effective and/or marketability upgrades.</p>
	<p><b>Expected Service Life</b> 50 Years</p> <p><b>Present Equivalent Age</b> 7 Years</p> <p><b>Estimated Remaining Life</b> 43 Years</p>	<p><b>Note:</b> Estimated budget is based on \$2,000 per floor and includes cutting &amp; patching.</p> <p style="text-align: right;"><b>Estimated Budget \$ 24,000</b></p>

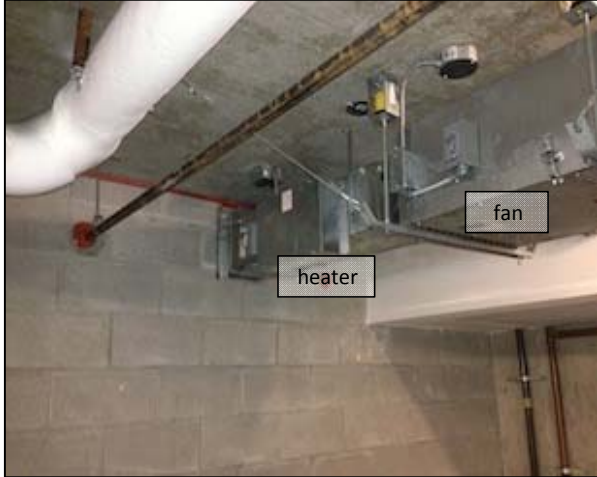
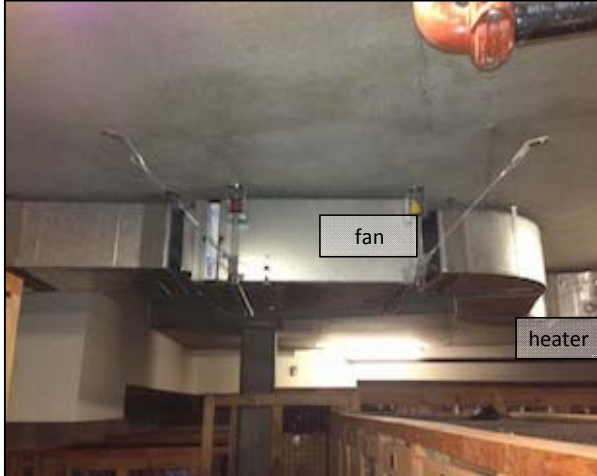
<p><b>Description</b> Supply fans and electric duct heaters deliver tempered fresh air to parkade vestibules, storage rooms and service rooms in order to provide positive pressurization. There are 2 systems, one near the NE corner of level P1 and one in the storage area a the west end of P1.</p> <p><b>Assessment</b> Good condition. Regular filter changes, vacuum cleaning and internal inspection are recommended.</p> <p><b>Priority</b> 4 Building Functionality; cost effective and/or marketability upgrades.</p>
	<p><b>Expected Service Life</b> 25 Years  <b>Present Equivalent Age</b> 6 Years  <b>Estimated Remaining Life</b> 19 Years</p>	<p><b>Note:</b> Estimated budget is \$2,500 per system.</p> <p style="text-align: right;"><b>Estimated Budget \$ 5,000</b></p>

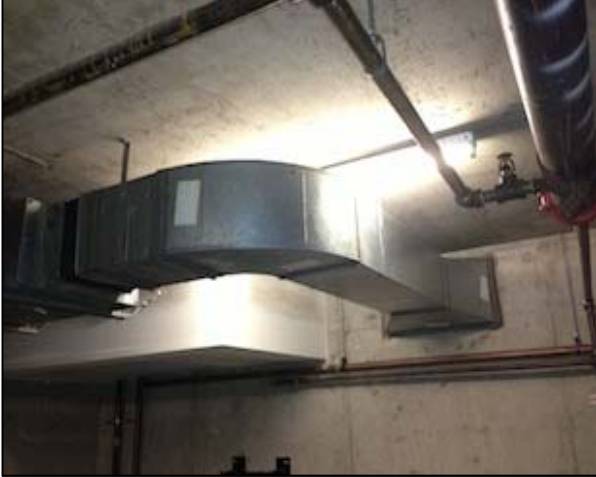
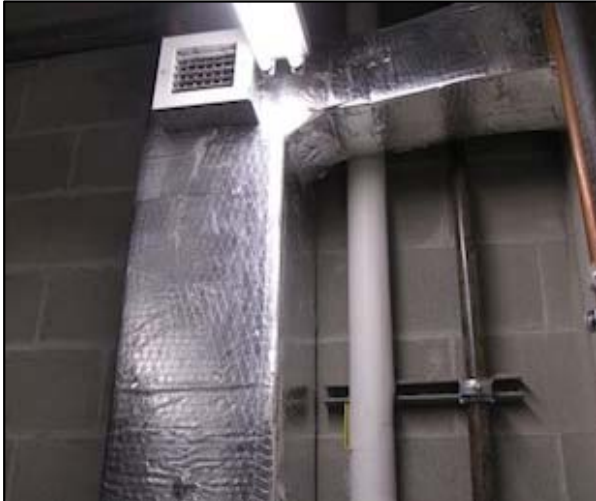
<p><b>Description</b> Ductwork systems with grilles and fire dampers are connected to supply fans and deliver fresh air to parkade vestibules, storage rooms and service rooms.</p> <p><b>Assessment</b> Good condition. Regular duct cleaning and fire damper maintenance is recommended.</p> <p>Fire dampers should be inspected and tested at least once every 4 years as per NFPA 90A. Refer to attached document FIRE DAMPER MAINTENANCE.pdf.</p> <p><b>Priority</b> 4 Building Functionality; cost effective and/or marketability upgrades.</p>
	<p><b>Expected Service Life</b> 50 Years</p> <p><b>Present Equivalent Age</b> 6 Years</p> <p><b>Estimated Remaining Life</b> 44 Years</p>	<p><b>Note:</b> Estimated Budget is \$2,500 per system.</p> <p style="text-align: right;"><b>Estimated Budget \$ 5,000</b></p>

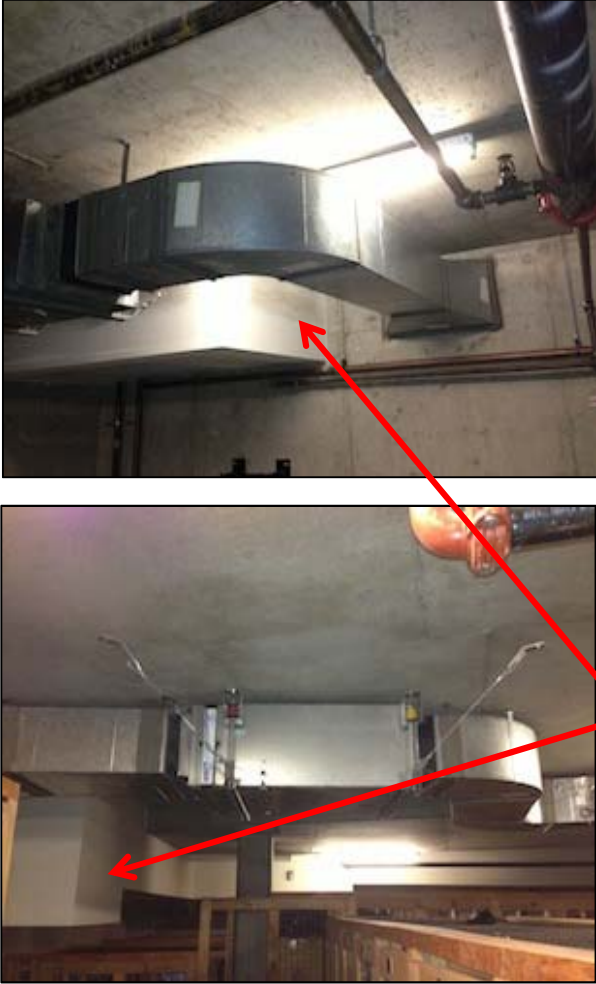
<p><b>Description</b> Supply fans deliver fresh air to each of the three parkade stairwells in order to provide positive pressurization. The fans operate when the fire alarm is activated. There are 3 systems.</p> <p><b>Assessment</b> Good condition. Use is infrequent (emergency only). Regular vacuum cleaning and internal inspection are recommended.</p> <p>Much of the system is installed within fire rated enclosures and may therefore be forgotten with regular maintenance.</p> <p><b>Priority</b> 4 Building Functionality; cost effective and/or marketability upgrades.</p>
	<p><b>Expected Service Life</b> 25 Years  <b>Present Equivalent Age</b> 2 Years  <b>Estimated Remaining Life</b> 23 Years</p>	<p><b>Note:</b> Estimated budget is \$2,500 per system.</p> <p style="text-align: right;"><b>Estimated Budget \$ 7,500</b></p>

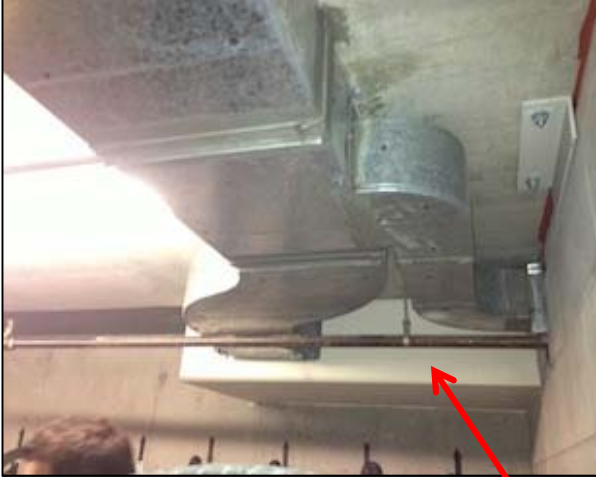
<p><b>Description</b> Ductwork systems with grilles are connected to the supply fans and deliver fresh air to parkade stairwells.</p> <p><b>Assessment</b> Good condition. Use is infrequent (emergency only). Much of the system is installed within fire rated enclosures and may therefore be forgotten with regular maintenance.</p> <p><b>Priority</b> 4 Building Functionality; cost effective and/or marketability upgrades.</p>
	<p><b>Expected Service Life</b> 50 Years <b>Present Equivalent Age</b> 2 Years <b>Estimated Remaining Life</b> 48 Years</p>	<p><b>Note:</b> Estimated budget is \$5,000 per system since rated enclosures would need to be rebuilt.</p> <p style="text-align: right;"><b>Estimated Budget \$ 15,000</b></p>
