## **Parc Résidences** **Depreciation Report**

160 Wilson Street

September 11, 2013

RJC No.: VIC.106400.0001

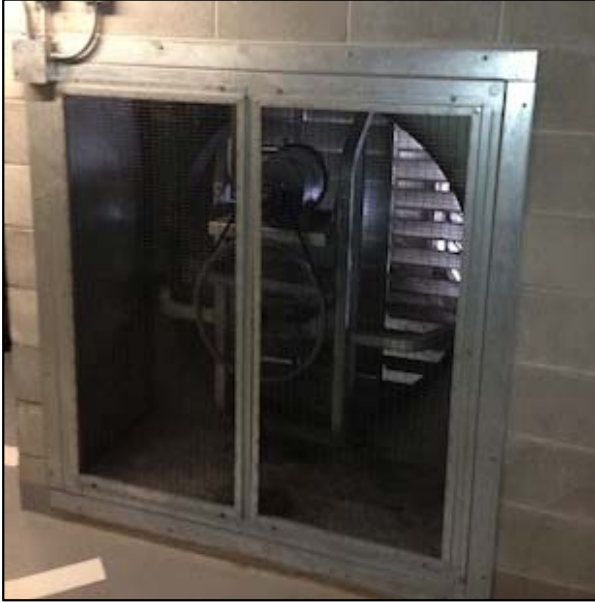
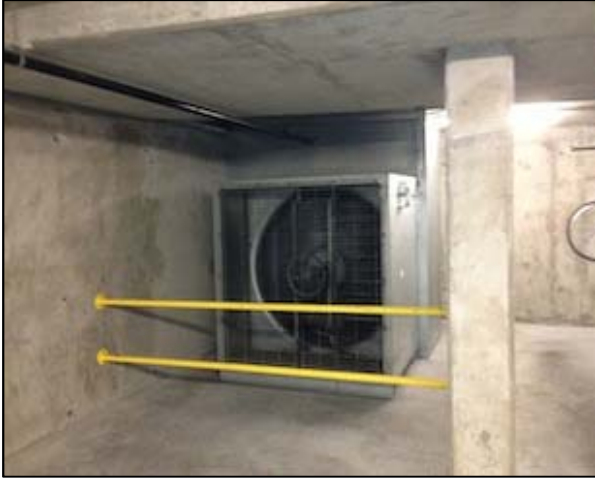
<p><b>Description</b> Three exhaust fans extract air from parkade areas and discharge through louvers to outside. Fresh air is drawn in through the parkade doors.</p> <p><b>Assessment</b> Good condition. Regular vacuum cleaning and internal inspection are recommended.</p> <p><b>Priority</b> 4 Building Functionality; cost effective and/or marketability upgrades.</p>
<p><b>Expected Service Life</b></p>		<p>25 Years</p>
<p><b>Present Equivalent Age</b></p>		<p>8 Years</p>
<p><b>Estimated Remaining Life</b></p>		<p>17 Years</p>
		<p><b>Note:</b> Estimated budget is \$5,000 per system. Parkades do not have carbon monoxide system so fans run continuously.</p> <p style="text-align: right;"><b>Estimated Budget \$ 15,000</b></p>

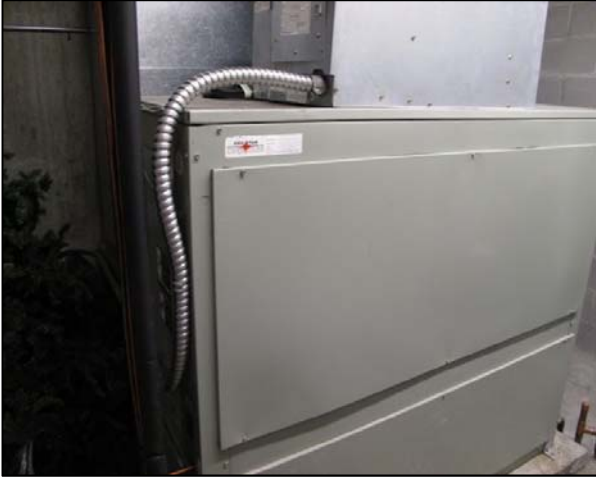
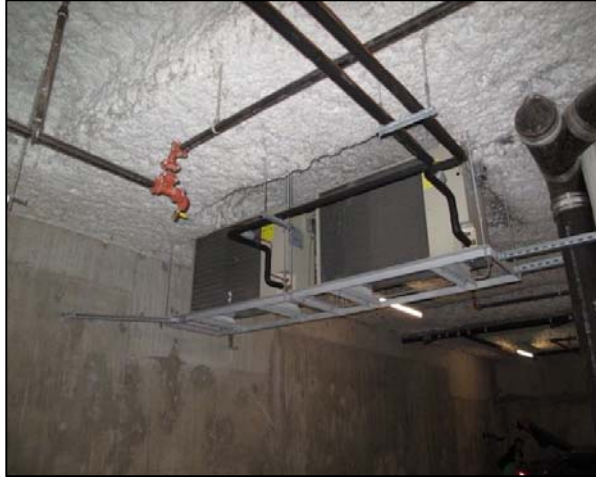
<p><b>Description</b> A split air handling system is installed. It consists of a vertical air handler in a mechanical room on P4 and two DX condensing units installed in the adjacent parkade.</p> <p><b>Assessment</b> Good condition. Regular filter changes, vacuum cleaning and internal inspection are recommended. The DX refrigeration equipment should receive an annual 'check up'.  The condensing unit coils should be vacuumed or power washed to maintain efficiency.</p> <p><b>Priority</b> 4 Building Functionality; cost effective and/or marketability upgrades.</p>
<p><b>Expected Service Life</b> 25 Years  <b>Present Equivalent Age</b> 5 Years  <b>Estimated Remaining Life</b> 20 Years</p>		<p><b>Note:</b></p> <p style="text-align: right;"><b>Estimated Budget \$ 10,000</b></p>

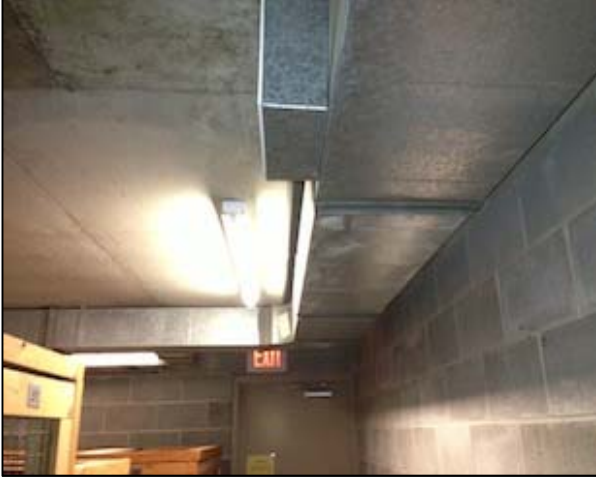
<p><b>Description</b> Ductwork systems with grilles and fire dampers are connected to exhaust fans and remove air from service &amp; storage rooms throughout the building including the garbage room, tel/com room, ozone closet, fitness washroom, meeting room washroom, janitor closets.</p> <p><b>Assessment</b> Good condition. Regular duct cleaning and fire damper maintenance is recommended.</p> <p>Fire dampers should be inspected and tested at least once every 4 years as per NFPA 90A. Refer to attached document FIRE DAMPER MAINTENANCE.pdf.</p> <p><b>Priority</b> 4 Building Functionality; cost effective and/or marketability upgrades.</p>
	<p><b>Expected Service Life</b> 50 Years  <b>Present Equivalent Age</b> 7 Years  <b>Estimated Remaining Life</b> 43 Years</p>	<p><b>Note:</b> Estimated Budget is \$1,000 per system.</p> <p style="text-align: right;"><b>Estimated Budget \$ 5,000</b></p>

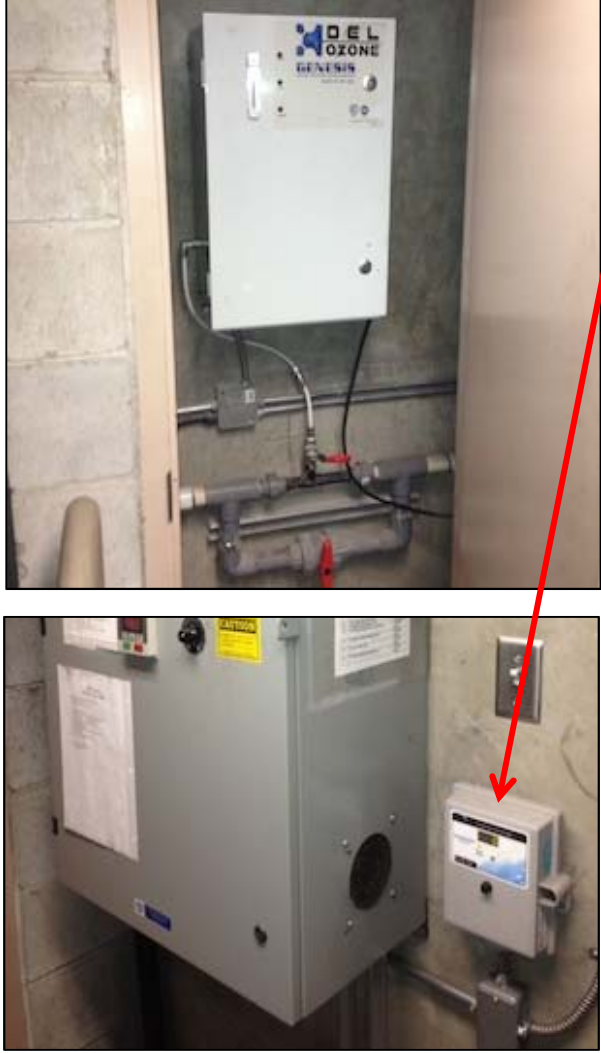
<p><b>Description</b> A sensor in the waterfall pump room is used to turn exhaust fans on and off automatically and will operate an ozone alarm.</p> <p><b>Assessment</b> Good condition. The sensor must be regularly calibrated in order to ensure safe operation of the ozone system.</p> <p><b>Priority</b> 4 Building Functionality; cost effective and/or marketability upgrades.</p>
<p><b>Expected Service Life</b> 15 Years  <b>Present Equivalent Age</b> 8 Years  <b>Estimated Remaining Life</b> 7 Years</p>		<p><b>Note:</b></p>
		<p style="text-align: right;"><b>Estimated Budget \$ 2,500</b></p>

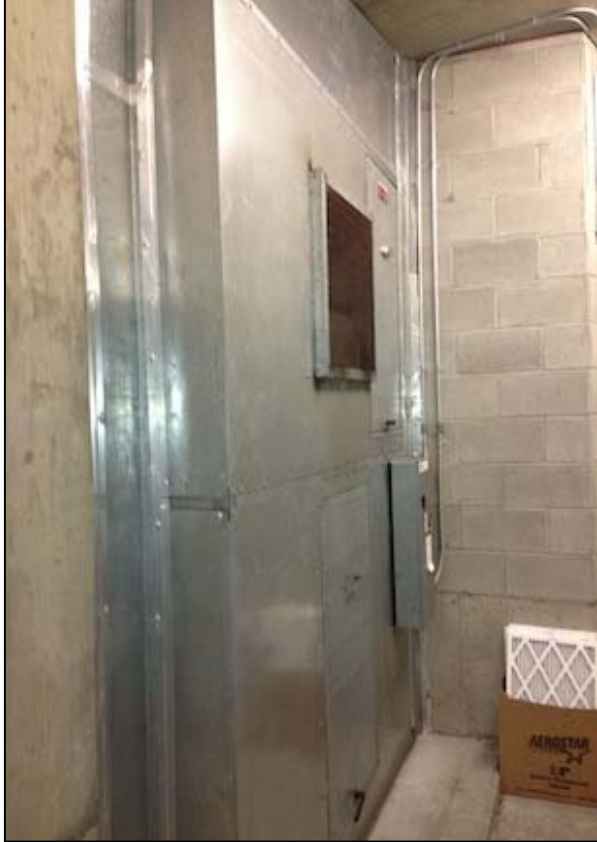
<p><b>Description</b> A supply fan delivers fresh air to the main electrical room for cooling. The air is drawn down through a concrete shaft / well through a grate in the front landscaping.</p> <p><b>Assessment</b> Good condition. Regular filter changes, vacuum cleaning and internal inspection are recommended.</p> <p><b>Priority</b> 4 Building Functionality; cost effective and/or marketability upgrades.</p>
<p><b>Expected Service Life</b> 25 Years</p>		<p><b>Note:</b></p>
<p><b>Present Equivalent Age</b> 9 Years</p>		
<p><b>Estimated Remaining Life</b> 16 Years</p>		
		<p style="text-align: right;"><b>Estimated Budget \$ 5,000</b></p>

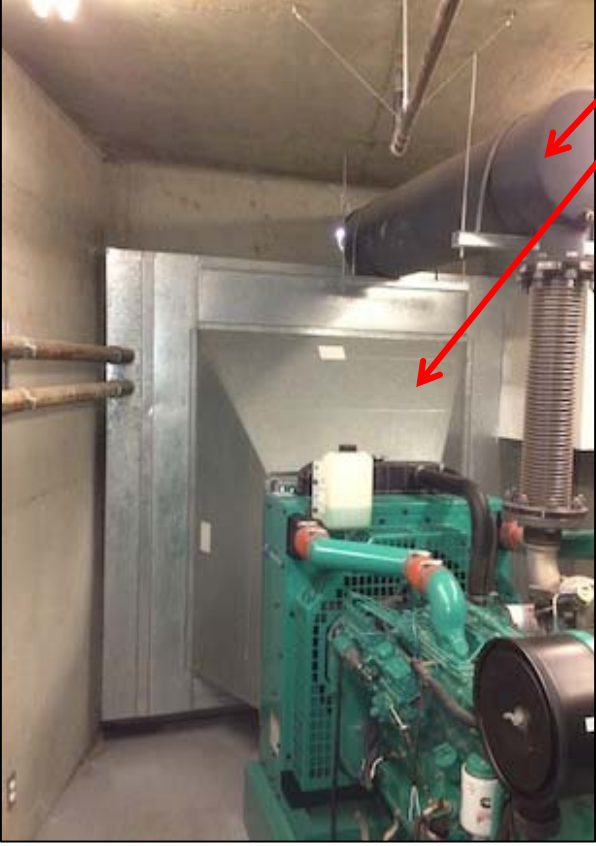
<p><b>Description</b> The generator ventilation system consists of three parts:</p> <ul style="list-style-type: none"> <li>(i) engine exhaust pipe with muffler,</li> <li>(ii) radiator cooling air with plenum &amp; louver, and</li> <li>(iii) replacement air provided from outside through a an underground concrete tunnel (not shown)</li> </ul> <p><b>Assessment</b> Good condition. Use is infrequent (emergency only).</p> <p><b>Priority</b> 4 Building Functionality; cost effective and/or marketability upgrades.</p>
<p><b>Expected Service Life</b> 50 Years</p>		<p><b>Note:</b></p>
<p><b>Present Equivalent Age</b> 3 Years</p>		
<p><b>Estimated Remaining Life</b> 47 Years</p>		
		<p><b>Estimated Budget \$ 5,000</b></p>

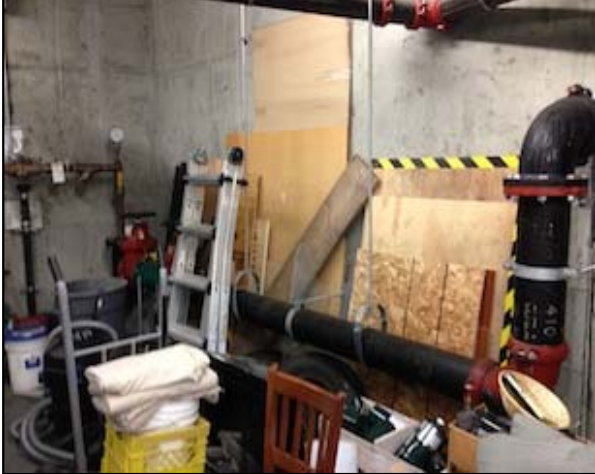
<p><b>Description</b> Water enters the mechanical room from an underground water main off Wilson St.</p> <p><b>Assessment</b> Good condition.</p> <p><b>Priority</b> 4 Building Functionality; cost effective and/or marketability upgrades.</p>
	<p><b>Expected Service Life</b> 60 Years  <b>Present Equivalent Age</b> 8 Years  <b>Estimated Remaining Life</b> 52 Years</p>	<p><b>Note:</b> Estimate includes replacement of the underground main, cutting and patching, plus piping in the mechanical room.</p> <p style="text-align: right;"><b>Estimated Budget \$ 7,500</b></p>

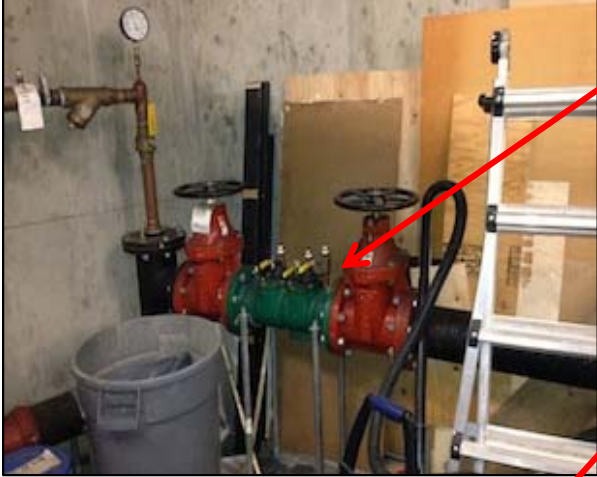
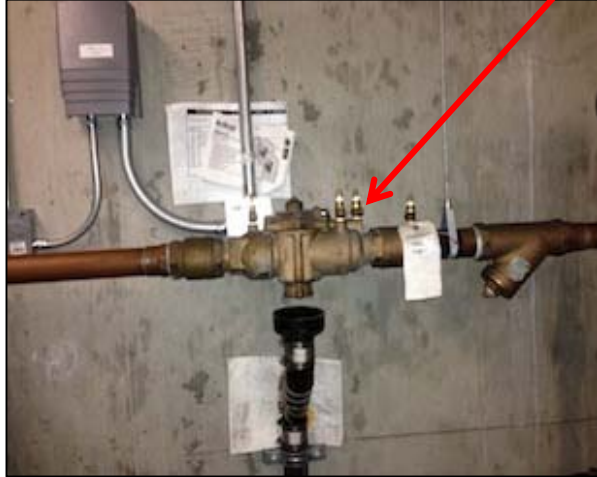
<p><b>Description</b> Backflow devices protect the municipal water supply from possible contamination by the building. There is a device on the primary potable water supply, the irrigation line, and the waterfall fill line.</p> <p><b>Assessment</b> Devices are in good condition. They are tagged and receive regular testing.</p> <p><b>Priority</b> 4 Building Functionality; cost effective and/or marketability upgrades.</p>
<p><b>Expected Service Life</b> <b>Present Equivalent Age</b> <b>Estimated Remaining Life</b></p>	<p>30 Years 8 Years 22 Years</p>	<p><b>Note:</b> Estimated budget: \$5,000 primary potable water supply, \$1,000 irrigation line, \$1,000 waterfall fill line</p> <p style="text-align: right;"><b>Estimated Budget \$ 7,000</b></p>

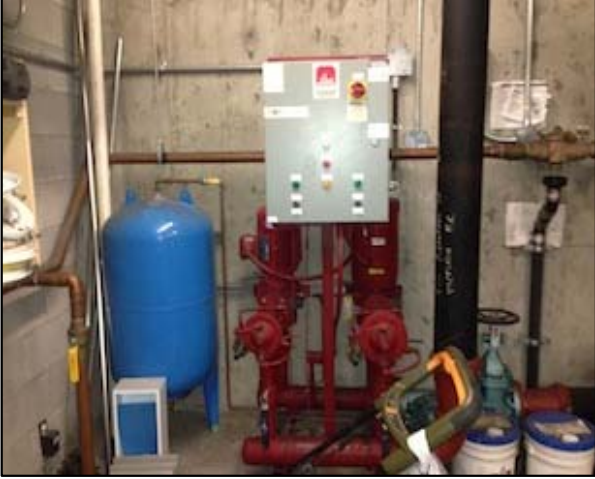
<p><b>Description</b> A duplex booster pump with regulating valves and pressure tank supplies water to the building.</p> <p><b>Assessment</b> Good condition.</p> <p><b>Priority</b> 4 Building Functionality; cost effective and/or marketability upgrades.</p>
<p><b>Expected Service Life</b> 25 Years</p>		<p><b>Note:</b> Recommend eventual replacement with a duplex, variable speed pumping system in order to reduce operating costs.</p>
<p><b>Present Equivalent Age</b> 8 Years</p>		
<p><b>Estimated Remaining Life</b> 17 Years</p>		
		<p style="text-align: right;"><b>Estimated Budget \$ 30,000</b></p>

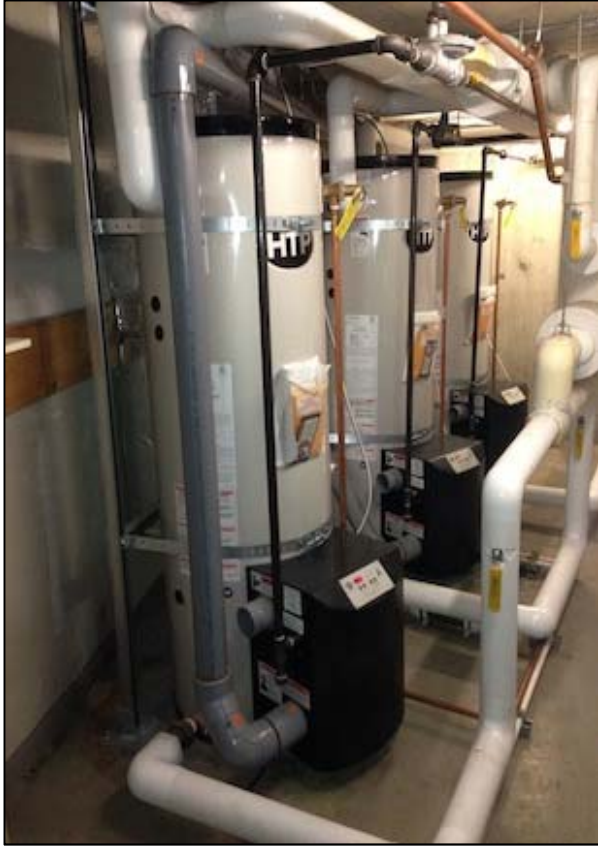
<p><b>Description</b> Natural gas water heaters are installed in the level P4 mechanical room and produce domestic hot water for the entire building.</p> <p><b>Assessment</b> The tanks were installed in 2011 and are in good condition.</p> <p><b>Priority</b> 4 Building Functionality; cost effective and/or marketability upgrades.</p>
<p><b>Expected Service Life</b> 15 Years</p>		<p><b>Note:</b> Estimated Budget is \$10,000 per tank.</p>
<p><b>Present Equivalent Age</b> 3 Years</p>		
<p><b>Estimated Remaining Life</b> 12 Years</p>		
		<p><b>Estimated Budget \$ 30,000</b></p>

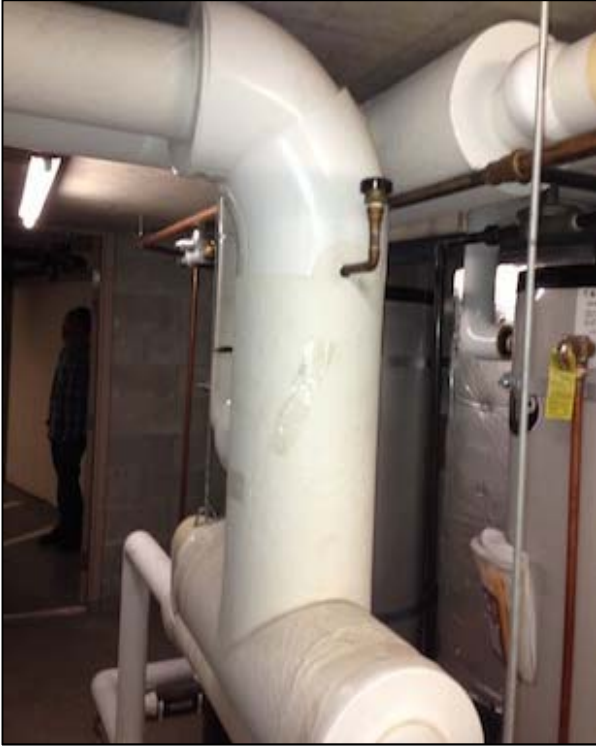
<p><b>Description</b> Cold, hot and recirculation mains distribute water to/from suites. Piping in common areas and risers are ductile iron and copper. Within suites, in-slab PEX piping delivers hot and cold water to plumbing fixtures.</p> <p><b>Assessment</b> Good condition.</p> <p>A water leak that occurred previously on level 5 is believed to be the result of stress on the copper pipe due to thermal expansion / contraction. Should this continue to be an issue, the recommendation is to install an expansion loop about half-way along the length of the pipe that runs down the hallway.</p> <p>In order to reduce the risk caused by water leaks, the Strata and owners are encourage to review the measures for washer hoses, washer valves and dishwashers included in the attached PLUMBING RISK MANAGEMENT document.</p> <p><b>Priority</b> 4 Building Functionality; cost effective and/or marketability upgrades.</p>

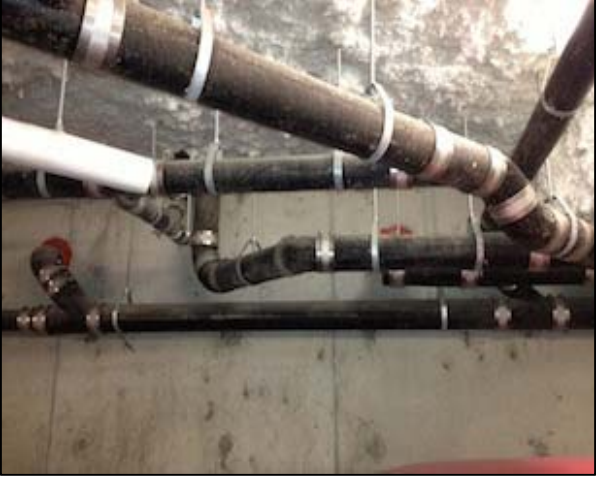
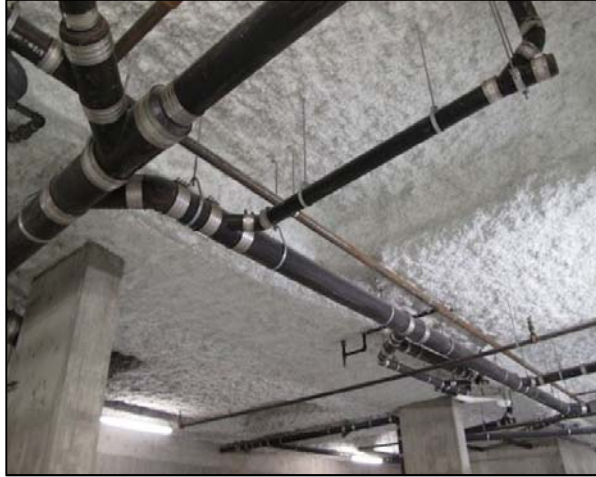
<p><b>Description</b>                      Plumbing fixtures drain to sanitary stacks and are vented through the roof.                      Roof areas and balconies drain to interior rain water leaders and exterior downspouts.                      Parking areas drain to trench drains and catch basins.                      Perforated drains are installed around the building perimeter.                      Above ground piping is cast iron. Underground piping is plastic.</p> <p><b>Assessment</b>                      Good condition.</p> <p>Drain scoping / flushing may be warranted as building ages.                      Consider adding to maintenance activates.</p> <p><b>Priority</b>                      4 Building Functionality; cost effective and/or marketability upgrades.</p>

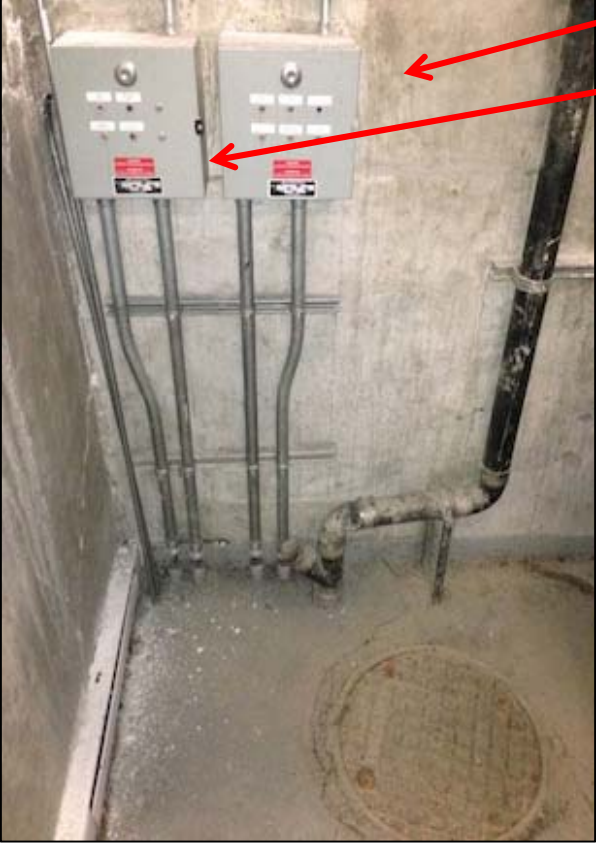
<p><b>Description</b></p> <p>Sanitary sump system (duplex) collects sewage from fixtures below street main.</p> <p>Storm sump system (simples) collects water from foundation perforated drainage, parkade catch basins, elevator pit and service room floor drains.</p> <p>Pumps in each sump chamber 'lift' the effluent to an elevation where it can exit the building through the gravity drain. Electronic controls (floats) are used to control pumps.</p> <p><b>Assessment</b></p> <p>Good condition.</p> <p><b>Priority</b></p> <p>4 Building Functionality; cost effective and/or marketability upgrades.</p>
<p><b>Expected Service Life</b> 20 Years</p>		<p><b>Note:</b> Estimated budget is \$5,000 per system.</p>
<p><b>Present Equivalent Age</b> 6 Years</p>		
<p><b>Estimated Remaining Life</b> 14 Years</p>

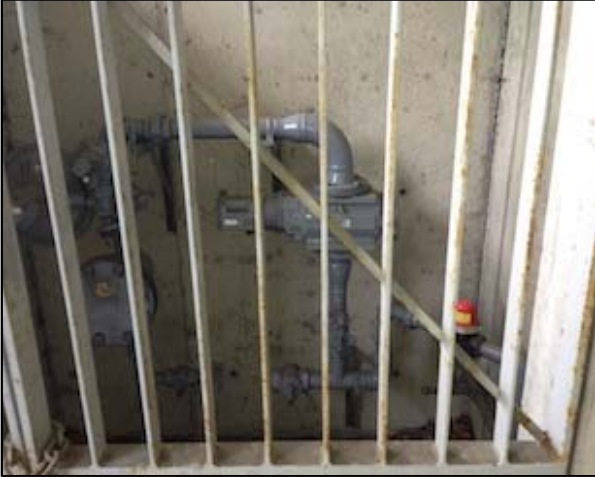
<p><b>Description</b> The gas meter is installed at the east end of the building along Tyee Rd. Steel piping delivers gas to the hot water tanks, the make-up air unit, and to gas ranges in residential units.</p> <p><b>Assessment</b> Good condition.</p> <p><b>Priority</b> 4 Building Functionality; cost effective and/or marketability upgrades.</p>
	<p><b>Expected Service Life</b> 50 Years <b>Present Equivalent Age</b> 7 Years <b>Estimated Remaining Life</b> 43 Years</p>	<p><b>Note:</b> Estimated budget is based on a unit cost of \$1,000 per suite for overall system replacement including common areas.</p> <p style="text-align: right;"><b>Estimated Budget \$ 123,000</b></p>

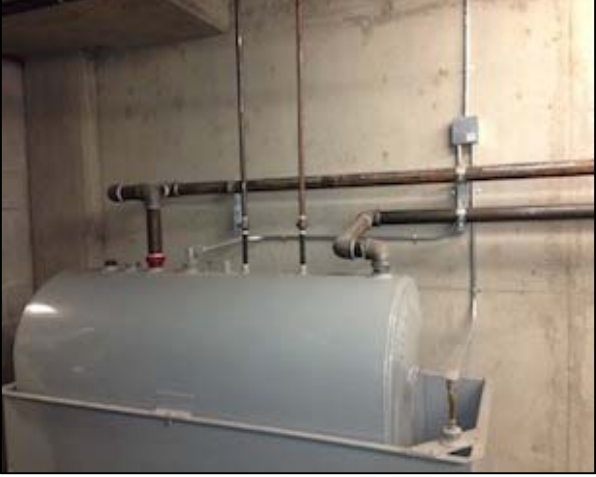
<p><b>Description</b> A fuel storage tank is located in the generator room. Fuel lines are steel.</p> <p><b>Assessment</b> Good condition. Use is infrequent (emergency only).</p> <p><b>Priority</b> 4 Building Functionality; cost effective and/or marketability upgrades.</p>
	<p><b>Expected Service Life</b> 25 Years  <b>Present Equivalent Age</b> 3 Years  <b>Estimated Remaining Life</b> 22 Years</p>	<p><b>Note:</b></p> <p style="text-align: right;"><b>Estimated Budget \$ 5,000</b></p>
