## **DEPRECIATION REPORT – SEAVIEW MANOR**

May 21, 2015

### Re: Depreciation Report Seaview Manor Apartments EPS401 218 Bayview Avenue, Ladysmith, BC

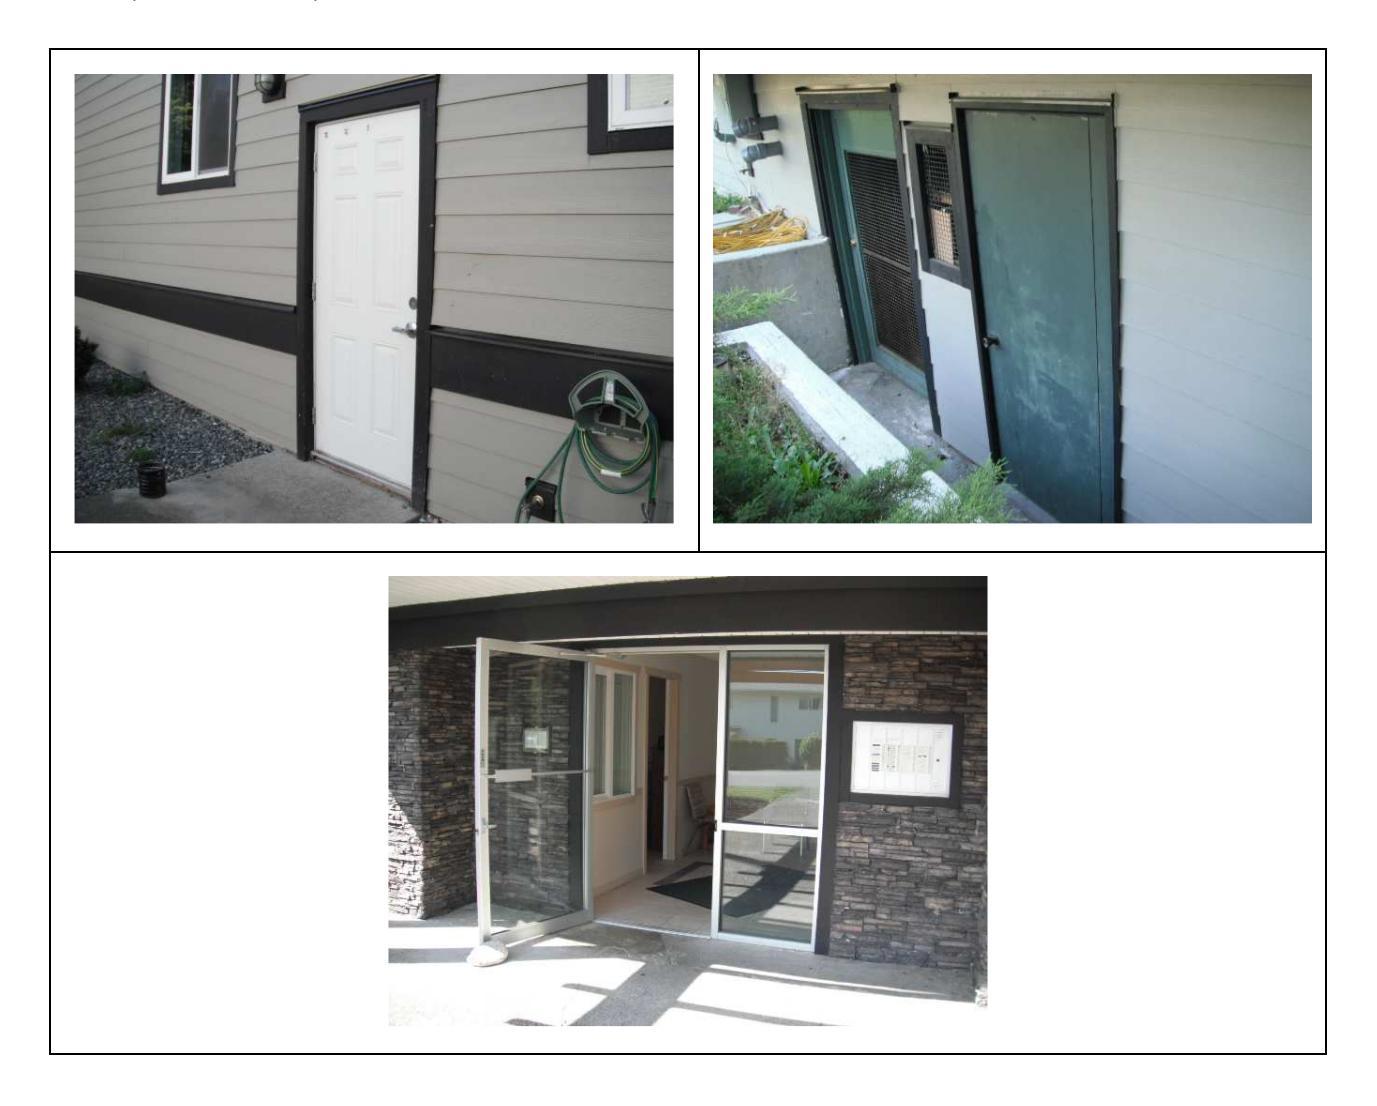
Reserve Component:	Reserve Component: (7) Painting/Staining and Sealant/Water Proofing		
Physical Description:	This component also includes the reserve for the repainting of the exterior siding components. This is inclusive of the exterior walls, trim, and exterior doors.		
Financial Analysis	The windows of the building have concrete fibre board and wood trim, which has caulking and weather stripping applied to the intersection between the window unit and the surrounding trim and at the joints of the trim.		
	This component also includes the reserve for the repainting and staining on a periodic basis. This is inclusive of all wood components and concrete fibreboard components.		
Potential Deterioration	Potential deterioration of the painted surfaces includes vandalism; fading; weathering; mildew and moss; impact damage repair.		
Condition Analysis	Average condition overall.		
Life Cycle Analysis	Date of Acquisition: Normal Life Span: Effective Age: Remaining Life Span:	2011 15 4 11

Unit Quantity And Cost Estimates	Unit Quantity: Unit Cost Estimate: Current Repair or Replacement Estimate: Estimated Year of Major Repair or Replacement:	1 – allowance building repainting \$30,000.00 \$30,000.00 2026/ 2041	
Deficiency Analysis	Sealant and waterproofing is an ongoing maintenance item.

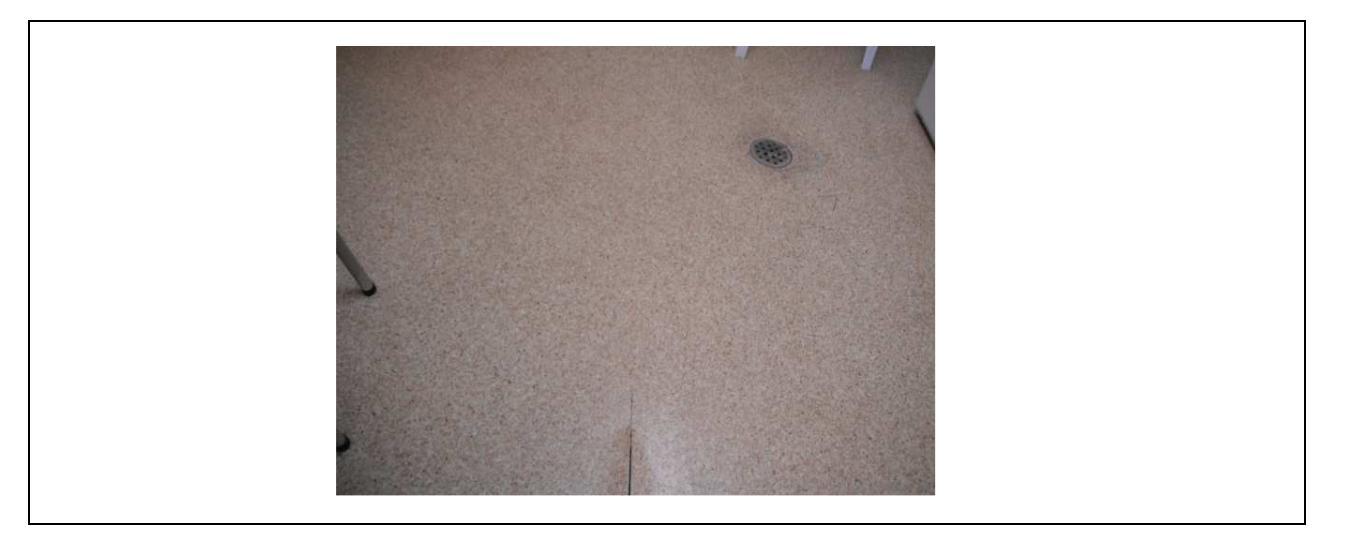
Reserve Component: (11)	Elevator Interior	
Physical Description:	The subject building has a single four stop hydraulic elevator. The elevator interior consists of paneled walls and ceilings and tile flooring. This reserve is for repair and replacement of wall, floor and ceiling finishing. This does not include safety features or mechanical or electrical components within the elevator enclosure.	
Financial Analysis	There are no expenditures in the minutes.	
Potential Deterioration	This includes potential problems such as general wear and tear to the wall, floor and ceiling finishes; impact damage and vandalism. Most cab interiors are constructed of materials to allow for a certain resistance to deterioration of this type.	
Condition Analysis	Overall observed condition was average however one of the floor tiles was noted as being cracked and should be replaced and the wall finishing is becoming dated. Elevator interiors typically have a durable interior and the impact, scratch resistant laminate and finishes

Life Cycle Analysis	Date of Acquisition: Normal Life Span: Effective Age: Remaining Life Span:	1973/unknown 25 years 15 years 10 years
Unit Quantity And Cost Estimates	Unit Quantity: Unit Cost Estimate: Current Repair or Replacement Estimate: Estimated Year of Major Repair or Replacement:	1 allowance \$10,500.00 \$10,500.00 2025
Deficiency Analysis	None noted. The cab of the elevator was in	average condition.

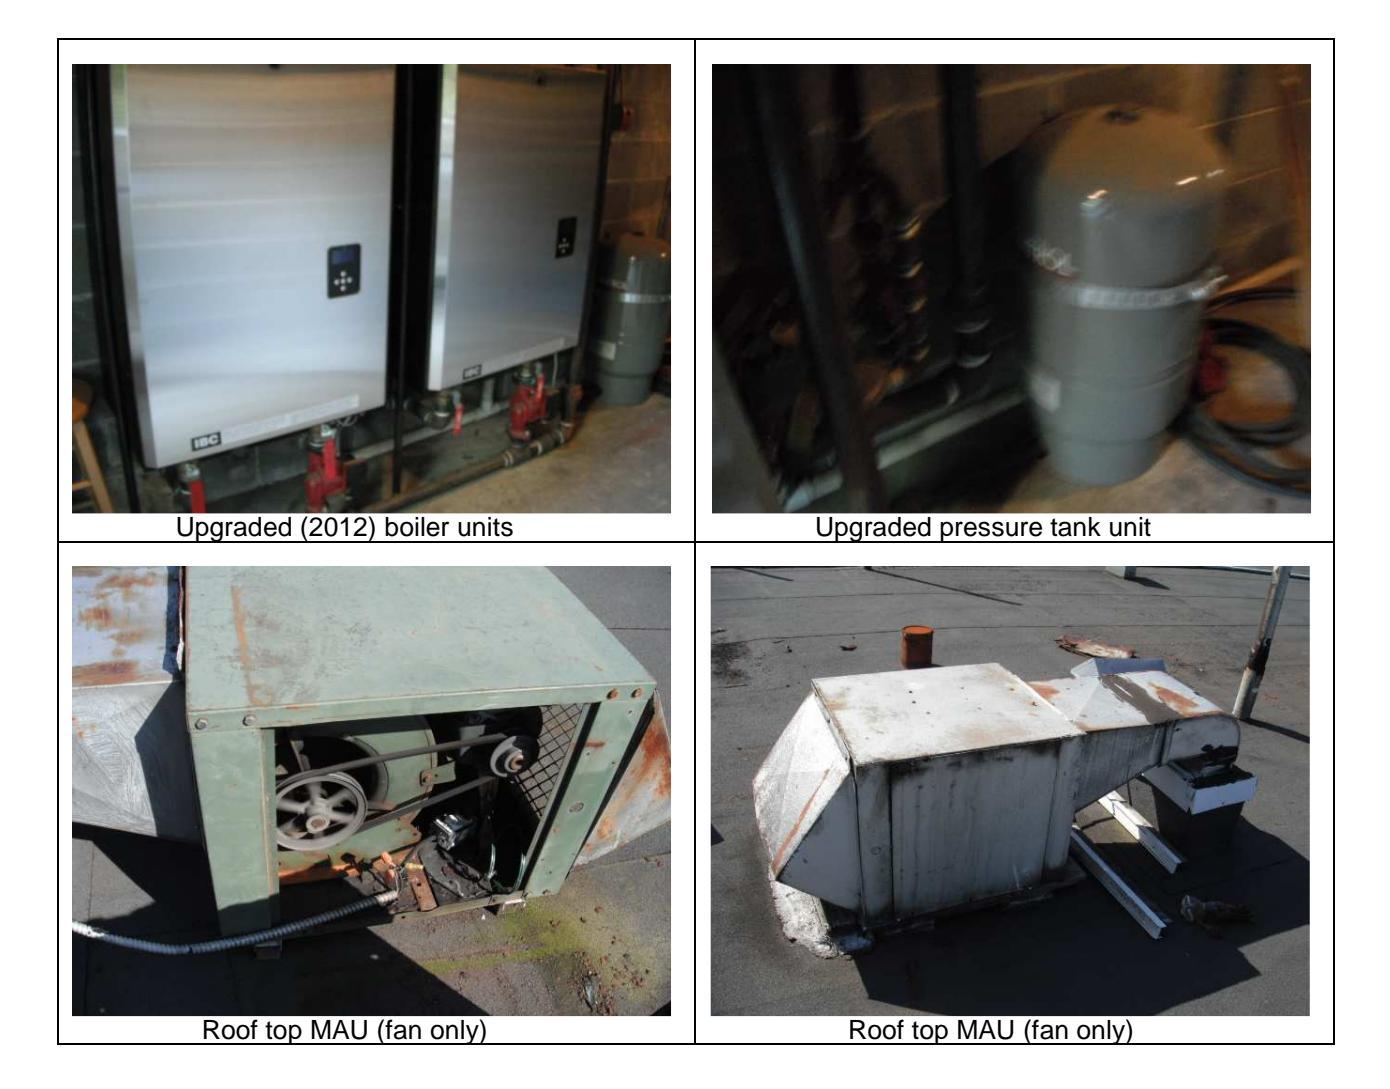
Reserve Component: (1-	4) Plumbing Systems		
Physical Description:	Primary components include water distribution piping, a natural draft, hot water boilers and storage tanks and a service sink in the laundry room. It also includes the hose connections, standpipe systems, etc. The boiler is a natural gas fired Saturn Super Hot Series unit with 2 x 284 litre storage tanks and expansion control tank. The age of the boiler unit is not		
Financial Analysis	The minutes indicate ongoing zone valves, etc. over the pas	The minutes indicate ongoing repairs and maintenance of the boiler, pumps, zone valves, etc. over the past few years.	
Potential Deterioration	Pitting corrosion is expected near the end of the copper pipe service life. Pressure reducing valves require maintenance and domestic water risers may require isolated replacement from time to time. Valves can leak and pipe work can become disconnected. Galvanized piping has an estimated lifespan in the 40 to 50 year range while

copper piping has a longer lifespan in the 50 to 60 year span. Re-piping is beginning to occur in older complexes in some communities in British Columbia as pipes reach the end of their useful economic lives.		
Condition Analysis	The inspection for Depreciation Report purposes is non-invasive in nature. The component appears to be in serviceable condition.		
	The building manager reports that water supply lines have deteriorated and significant repairs are required. A quotation has been received by the strata management which indicates a cost range from \$45,000 to \$55,000 for replacement of the lines in the main floor ceilings.		
Life Cycle Analysis	Date of Acquisition: Normal Life Span: Effective Age: Remaining Life Span:	1973 plus upgrades 50+ years 20 years 30 years	
Unit Quantity And Cost Estimates	Unit Quantity: Unit Cost Estimate: Current Repair or Replacement Estimate: Estimated Year of Major Repair or Replacement:	1 Allowance \$50,000.00 \$50,000.00 2017 repairs to lines 2028/2043 replacement of tanks. Allowance for periodic replacement of plumbing lines

Deficiency Analysis	None noted. The current plumbing systems are presumed to have met the requirements of the municipal authorities and the prevailing building codes when they were originally installed. Therefore, full replacement is not required. Nonetheless, these systems should be routinely maintained and inspected under a diligent maintenance program. Any leaking or replacement of copper pipes should be documented. As noted, the distribution line piping for the water lines has been showing increased leaking – predominantly on the ground floor hallway ceilings. A quotation for replacement of the piping has been received in the range of \$45,000 to \$55,000 excluding drywall repairs. A repair/upgrade cost of \$55,000.00 inclusive of drywall repairs has been made in year 2 for this upgrade with the 30 year reserve set at \$50,000.00.
