Remote Sensing Property Scan

March 29, 2018

Re: Remote Sensing Property Scan at 2761 Murray Drive, Victoria, BC

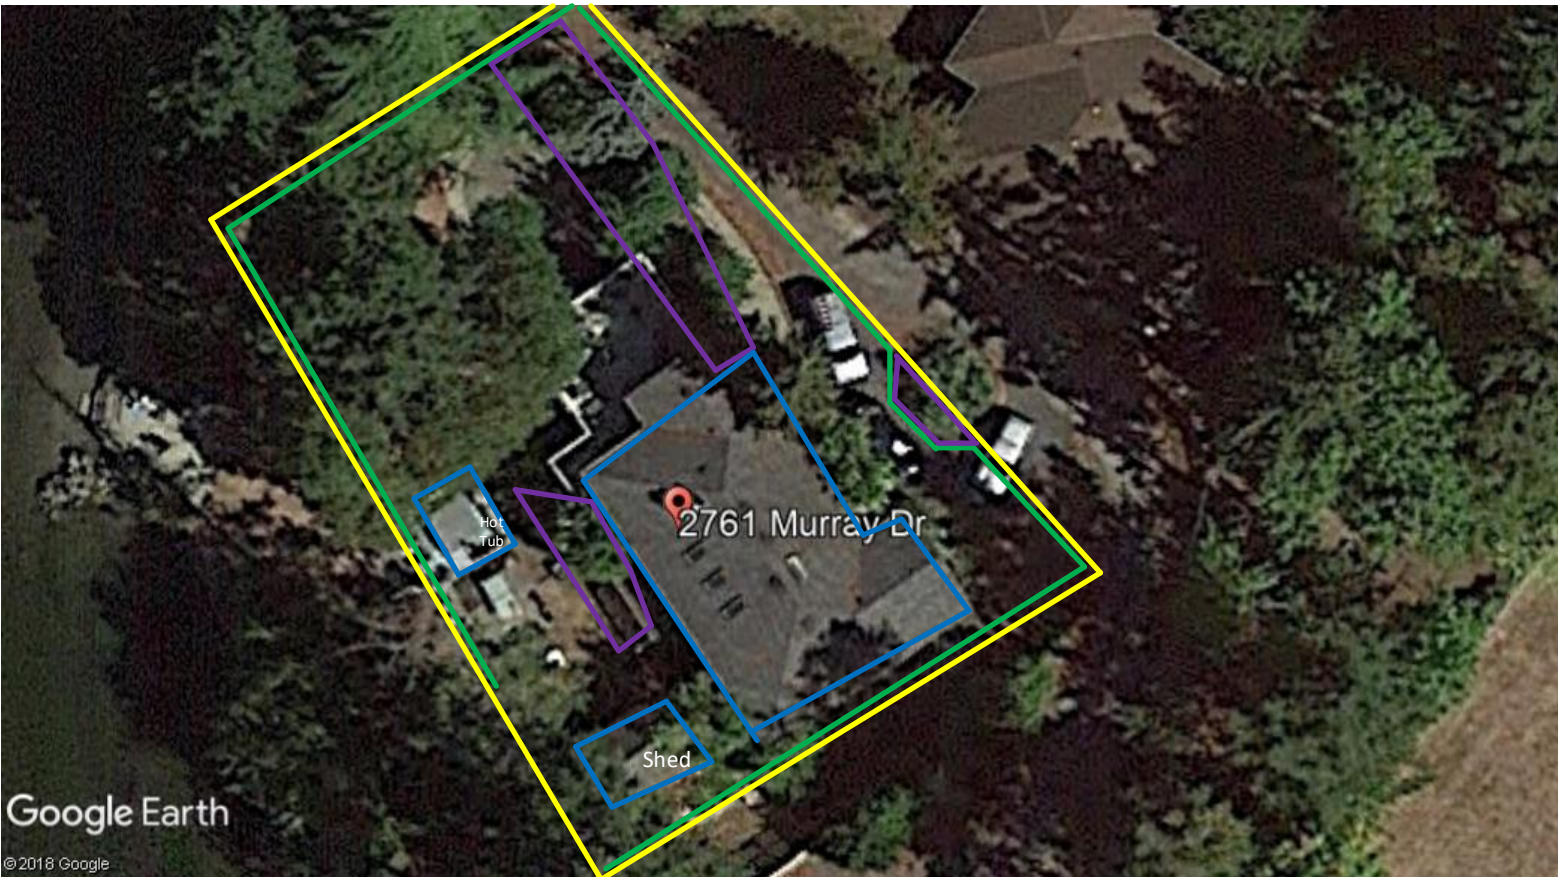
2761 Murray Drive, Victoria, BC
Ground Penetrating Radar Locate Map

Due to site specific limitations, such as a hot tub, a detached shed, landscaping, concrete walls, mature trees, shrubs, a pile of scrap lumber and garbage cans, some areas within the subject site boundaries were not accessible or feasible for GPR scanning. No other visual evidence of a UST was noted during the scan.

A GPR and Ferrous metal detect scan was completed with no evidence of a UST being found.

ScanPlus **did not locate visual evidence or remote scanned evidence**, of a UST on the above mentioned subject site.
