## **DEPRECIATION REPORT – SEAVIEW MANOR**

May 21, 2015

### Re: Depreciation Report Seaview Manor Apartments EPS401 218 Bayview Avenue, Ladysmith, BC

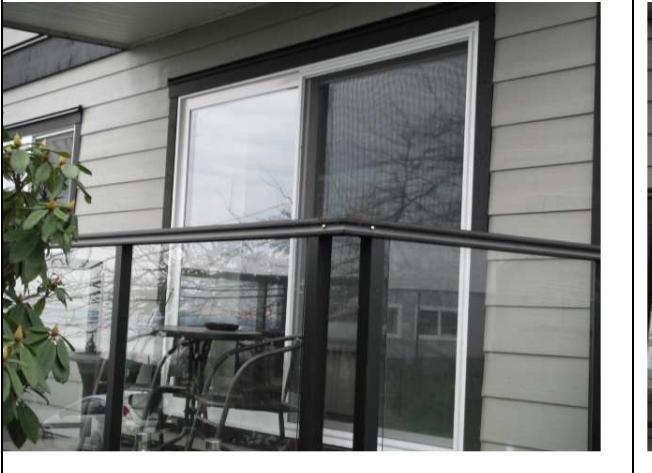
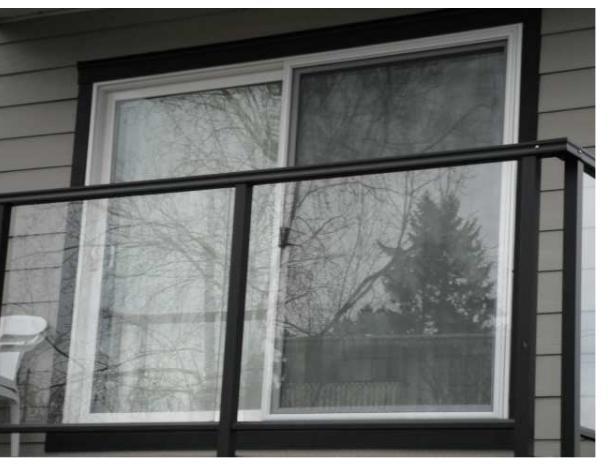
Reserve Component: (4) Balcony Doors				
Physical Description:	The balcony doors consist of 96" wide vinyl sliding doors.			
Financial Analysis	The balcony doors were replaced	in 2011 during the building upgrades.		
Potential Deterioration	Potential deterioration issues include the following: - Damage of framing due to impact - Brittleness of framing over time - Discolouration of frame over time - Seal of double-pane glazing			
Condition Analysis	The condition of the patio doors is commensurate with their age. As with windows and doors, balcony doors exposed to the prevailing weather will experience shorter lifespans than units on the protected side of the building. Balcony doors are generally replaced at the same time as a window replacement project due to cost efficiencies.			
Life Cycle Analysis	Date of Acquisition: Normal Life Span: Effective Age: Remaining Life Span:	2011 35 4 31		
Unit Quantity And Cost Estimates	Unit Quantity: Unit Cost Estimate: Current Repair or Replacement Estimate: Estimated Year of Major Repair or Replacement:	36 doors \$1,200.00/door \$43,200.00 2046

Deficiency Analysis	None noted. As with windows, slid track that should be kept clear.	ding doors typically have a drainage

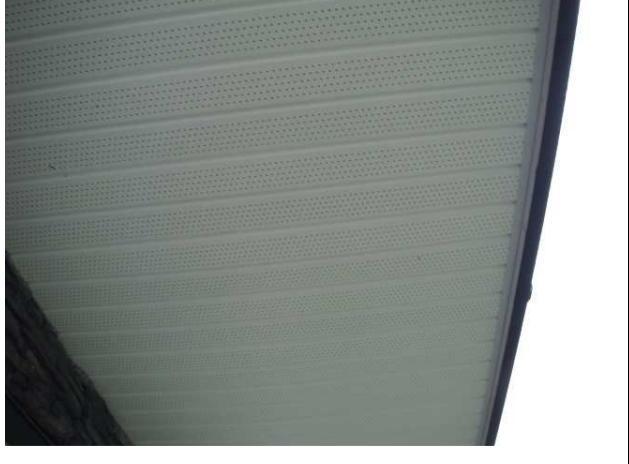
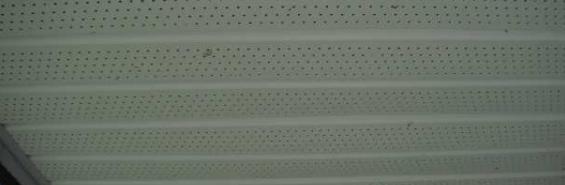
Reserve Component: (5) Soffits		
Physical Description:	This component includes all of the vinyl soffits surrounding the exterior of the building and below the decks/balconies.	
Financial Analysis	This is a reserve for replacement of the soffits. Typically, soffits are replaced at the time of replacement or major repair of the exterior siding. The component was installed at the time of the 2011 renovations. No expenditures for this component were noted in the minutes.	
Potential Deterioration	Deterioration over time as the soffits becomes brittle due to age. Wear and tear is not an issue due to the nature of the component. Animal/bird penetration can occur with loose panels or incorrect fitting panels.	
Condition Analysis	The soffits were observed to be in good condition relative to the age of the component.	
Life Cycle Analysis	Date of Acquisition: Normal Life Span: Effective Age: Remaining Life Span:	2011 40 years 4 years 36 years

Unit Quantity And Cost Estimates	Unit Quantity: Unit Cost Estimate: Current Repair or	2,560 square feet. \$6.25/sq.ft.
D.C.	Replacement Estimate: Estimated Year of Major Repair or Replacement:	\$16,000.00 2051
Analysis

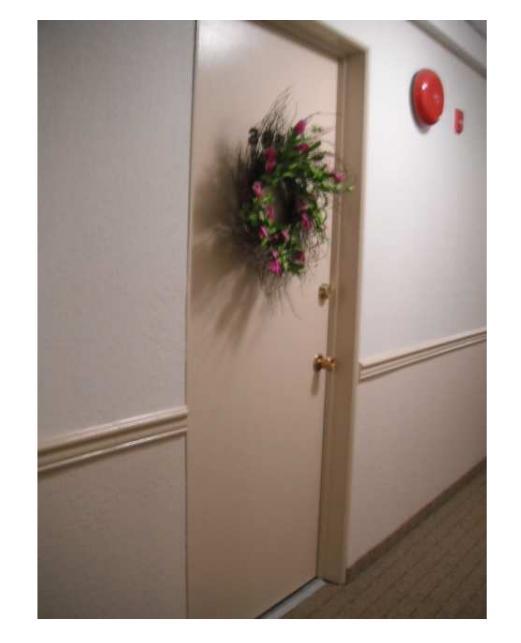
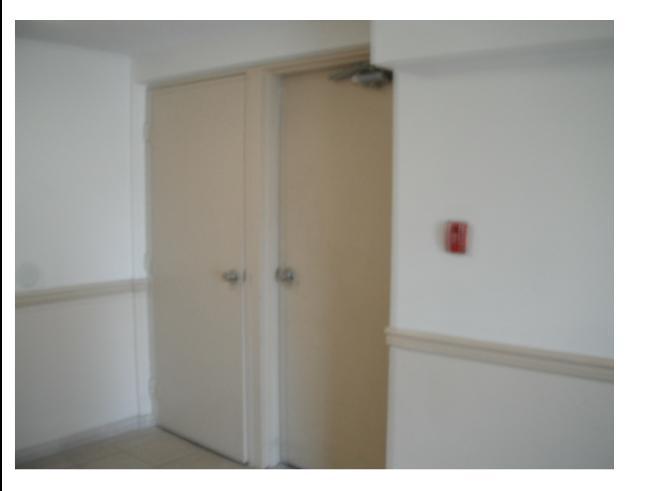
Reserve Component: (6) Doors		
Physical Description:	Suite doors consist of solid core wood doors with hardware and signage. Service doors are solid core metal and wood doors while the entry doors at the front entry are glazed aluminum frame units. Fire doors are solid core metal units.	
Financial Analysis	The minutes indicate that repairs to the entry doors were made in 2013, followed by replacement of the fire door closers in 2014 and replacement of the rear entry door in 2014.	
	An allowance for replacement of the year 20. Suite doors are unlikely to b or due to damage.	exterior service doors has been made at be replaced unless for aesthetic purposes
Potential Deterioration	Suite doors are more likely to be replaced for aesthetic purposes over time as opposed to deterioration.	
Condition Analysis	The doors were in average condition overall. Repainting of the interior suite doors for aesthetics is more likely than full replacement.

Life Cycle Analysis	Date of Acquisition: Normal Life Span: Effective Age: Remaining Life Span:	1973/Mixed 35 15 20
Unit Quantity And Cost Estimates	Unit Quantity: Unit Cost Estimate: Current Repair or Replacement Estimate: Estimated Year of Major Repair or Replacement:	1 allowance for partial replacement \$10,000.00 \$10,000.00 2035
Deficiency Analysis	Not applicable

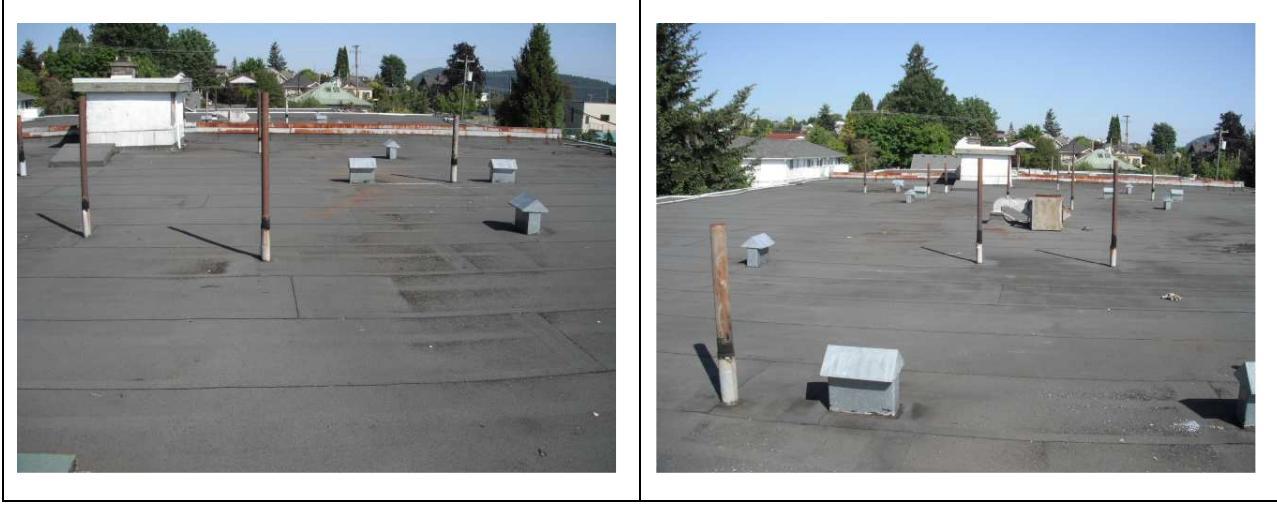
Reserve Component:	Reserve Component: (8) Torched Down Roof Surface and Drainage		
Physical Description:	The membrane roof consists of a flat design with a gentle slope towards the drains. The surface comprises a torch on membrane over on wood trusses. The roof replacement cost estimate covers the total roofing system, and includes the drainage and flashings.		
Financial Analysis	There are no notations in the minutes.		
Potential Deterioration	This includes such problems as: - Shrinkage at the sean appearing; - Shrinkage resulting in flashings; and - Damage to the roof du repair roof top equipme - Impact damage /wind d	ns, resulting in pulling apart and cracks a a break in the seal surrounding the ue to tradespersons crossing the roof to ent; Iriving moisture under loose seams.	
Condition Analysis	The roof surface is reported to have been replaced in 1998 which is commensurate with our observations of the surface. Roof drains should be periodically cleaned to ensure no blockages.

Life Cycle Analysis	Date of Acquisition: Normal Life Span: Effective Age: Remaining Life Span:	1998 25 years 17 years 8 years	
Unit Quantity And Cost Estimates	Unit Quantity: Unit Cost Estimate: Current Repair or Replacement Estimate: Estimated Year of Major Repair or Replacement:	±10,300 square feet 1 allowance including downspouts \$55,000.00 2023	
Deficiency Analysis	A professional should inspect flat roofs every year and all recommended maintenance should be carried out. All forms of roofing are intended to shed water and prevent its entry into the residence. Obstructions that prevent the free flow of water off of the roof surface or to a drain can cause leakage and/or premature failure of the roofing material. Roof cleaning is recommended on a semi-annual basis. Roof venting should also be checked and kept clear. All penetrations through the roof such as plumbing stacks, vents, etc., need to be checked annually and re-sealed as necessary.

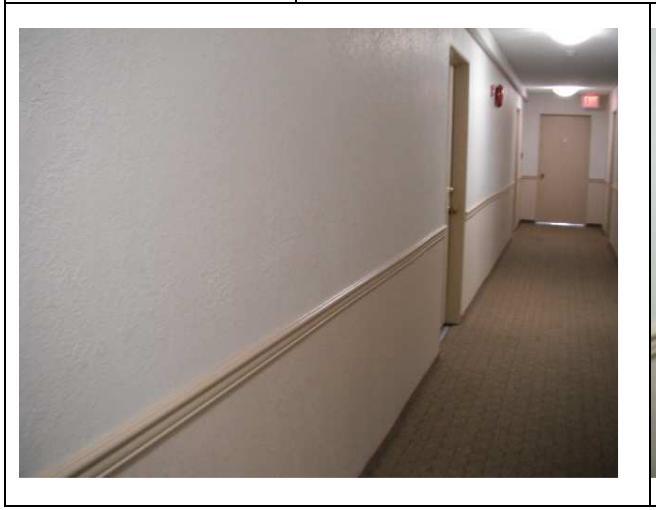
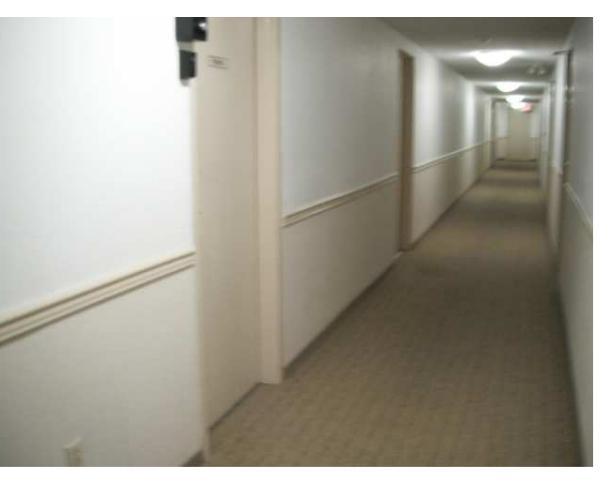
Reserve Component:	omponent: (9) Interior Painting and Decorating		
Physical Description:	The subject has painted and textured walls and ceilings through the hallways, stairwells and interior common areas. This reserve is for repairs and complete redecoration of all wall decoration as well as painting of the common areas. It covers wall coverings, ceilings and trims. Common area walls typically see a great deal of wear from objects being moved about, but it is possible that with care, the halls will not need to be repainted for much longer than the remaining economic life, whereas abuse will shorten the		
	Wall decoration is aesthetic in nature and is a discretionary expense based partially on decorating trends. Maintenance of the common areas is important to reflect pride of ownership, which will have a positive impact on visitors and potential buyers.		
Financial Analysis	Aside from repairs to the drywall ceilings on the ground floor resulting from water line leaks, there are no notations in the minutes. Touch up painting appears to have occurred over the past few years.

Potential Deterioration	Potential problems include general wear and tear along with changes in design styles over time, which result in re-decoration. Common area walls see a great deal of wear from objects being moved about.		
Condition Analysis	Overall observed condition was average to good. An allowance for repainting at 10 year intervals has been made commencing in year 6.		
Life Cycle Analysis	Date of Acquisition: Normal Life Span: Effective Age: Remaining Life Span:	Mixed 10 years 4 years 6 years	
Unit Quantity And Cost Estimates	Unit Quantity: Unit Cost Estimate: Current Repair or Replacement Estimate: Estimated Year of Major Repair or Replacement:	1 allowance \$20,000.00 \$20,000.00 2021/2031/2041	
Deficiency Analysis	None noted, the common areas were obs	served to be in average condition.

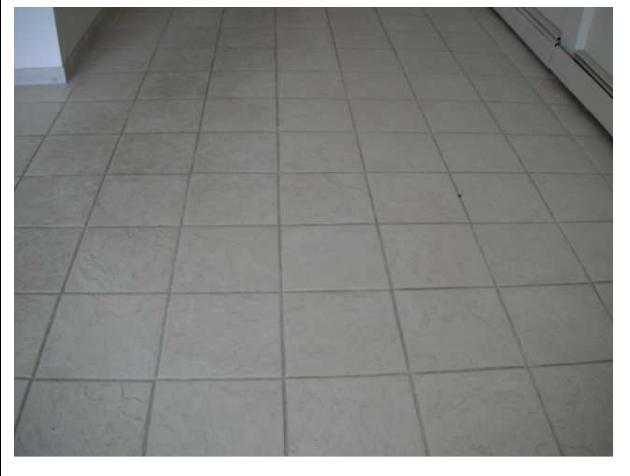
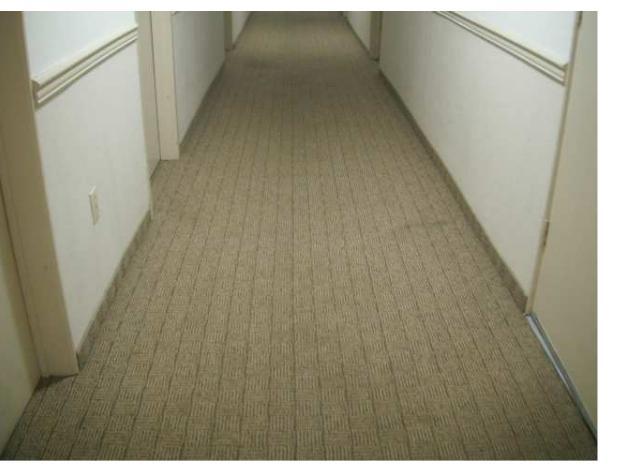
Reserve Component: (10)	Reserve Component: (10) Carpeting and Tile		
Physical Description:	The subject building flooring materia and ceramic tiles in the hallways flooring in the laundry room.	als consist of commercial grade carpet and lobby areas and a vinyl/linoleum	
	Common areas typically see a great interior lobbies.	deal of wear particularly at entries and	
	Decoration is aesthetic in nature and is a discretionary expense based partially on decorating trends. Maintenance of the common areas is important to reflect pride of ownership, which will have a positive impact on visitors and potential buyers.		
Financial Analysis	There are no notations on record aside from periodic cleaning. Portions of the interior flooring appear to have been replaced / upgraded as part of the building renovations in 2011.		
Potential Deterioration	Flooring wears out over time from traffic, spills and other soiling. Tiles can crack with impact damage and mortar can loosen over time and with heavy traffic. Ultimately, aesthetics are the key factor in the decision to change this component.

Condition Analysis	Overall observed condition was average with some minor stains and some seam separation noted. The component has an effective age of 8 years. An allowance for replacement at 20 year intervals has been made commencing in year 12. An allowance for repair/replacement of the laundry room floor has been made in year 2.		
Life Cycle Analysis	Date of Acquisition: Normal Life Span: Effective Age: Remaining Life Span:	Unknown 20 years ±8 years overall 12 years	
Unit Quantity And Cost Estimates	Unit Quantity: Unit Cost Estimate: Current Repair or Replacement Estimate: Estimated Voor of Major	1 allowance \$20,000.00 \$20,000.00	
	Repair or Replacement:	2027/ 2047	
Deficiency Analysis	it is important to maintain a go including vacuuming, steam extrac carpets in good condition.	od carpet maintenance program ction and pile lifting to maintain

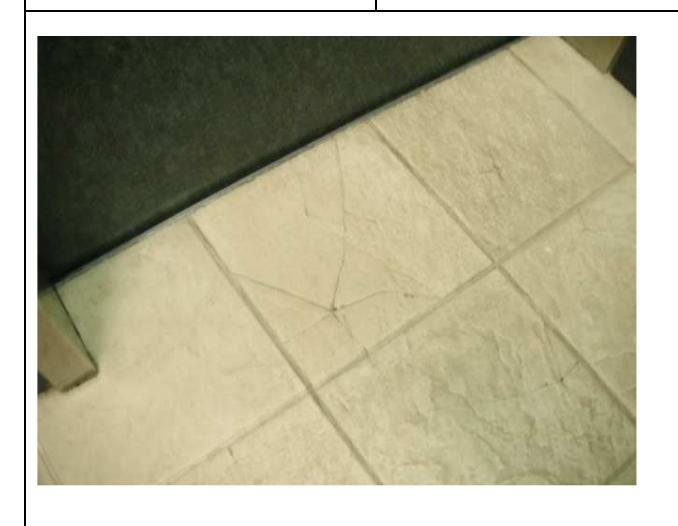
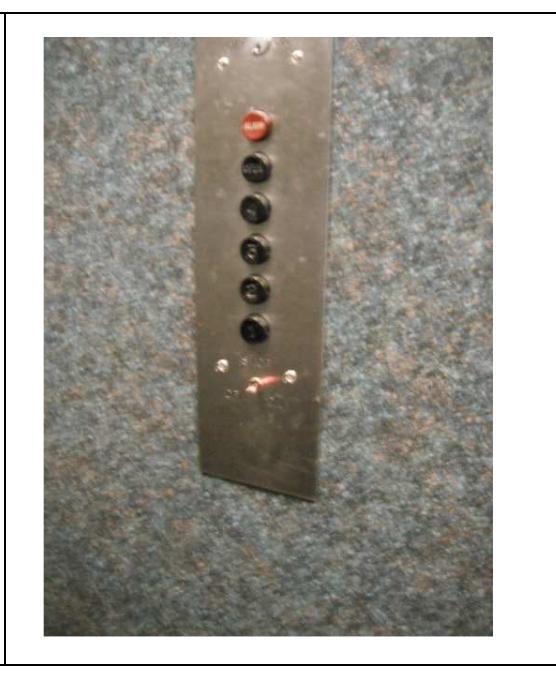
Reserve Component: (11)	Elevator Interior	
Physical Description:	The subject building has a single four stop hydraulic elevator. The elevator interior consists of paneled walls and ceilings and tile flooring. This reserve is for repair and replacement of wall, floor and ceiling finishing. This does not include safety features or mechanical or electrical components within the elevator enclosure.	
Financial Analysis	There are no expenditures in the minutes.	
Potential Deterioration	This includes potential problems such as general wear and tear to the wall, floor and ceiling finishes; impact damage and vandalism. Most cab interiors are constructed of materials to allow for a certain resistance to deterioration of this type.	
Condition Analysis	Overall observed condition was average however one of the floor tiles was noted as being cracked and should be replaced and the wall finishing is becoming dated. Elevator interiors typically have a durable interior and the impact, scratch resistant laminate and finishes

Life Cycle Analysis	Date of Acquisition: Normal Life Span: Effective Age: Remaining Life Span:	1973/unknown 25 years 15 years 10 years
Unit Quantity And Cost Estimates	Unit Quantity: Unit Cost Estimate: Current Repair or Replacement Estimate: Estimated Year of Major Repair or Replacement:	1 allowance \$10,500.00 \$10,500.00 2025
Deficiency Analysis	None noted. The cab of the elevator was in	average condition.

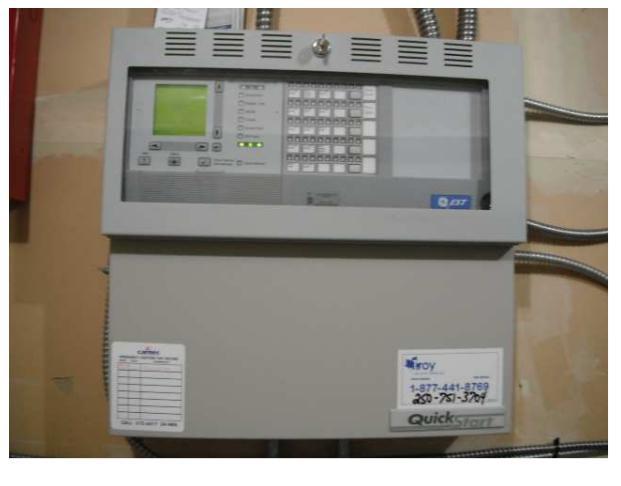
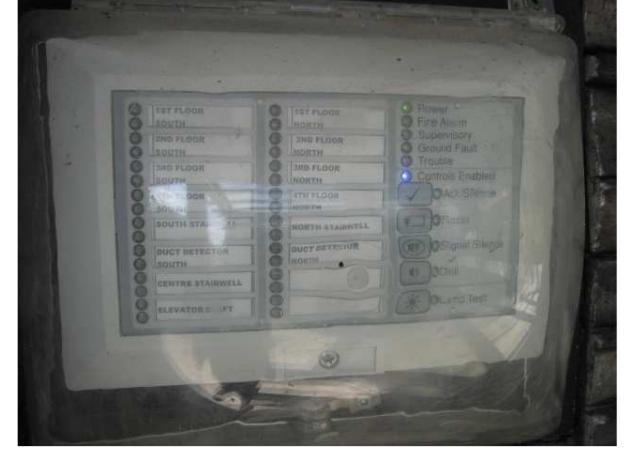
Reserve Component: (10	eserve Component: (16) Fire Panels and Emergency Lighting		
Physical Description:	The fire alarm system is controlled by a GE EST Quickstart Fire Alarm Control Panel, located in the electrical room and an annunciator panel at the front entry. The system also includes exit lighting above exit doors and emergency lighting and hose stations on each floor. The system is serviced under contract along by Island Fire Protection.		
Financial Analysis	The reserve is a contingency intended to cover any minor repairs or replacements of these systems including any upgrades, as required by future code amendments. It is not intended for complete replacement of the existing system. Information provided indicates that the fire panels and system were replaced in 2011 at the time of the building upgrades. The minutes indicate that the Alarm Panel Annunciator Card was replaced in 2013. It is assumed that periodic replacement of initiating devices (smoke/fire alarms, photoelectric sensors, hand pulls, etc.) and indicating appliances (horns, strobe lights, chimes, bells, etc.) would be completed during the regulated inspection process as part of the maintenance of the building. These items have not been accounted for in the reserve allowance. No expenditures for this item are noted in the strata minutes however financials indicate that periodic replacement has occurred in keeping with recommendations of the contracted maintenance company.

Potential Deterioration	Vandalism and functional obsolescence are the most likely problems. There are legislated requirements to insure equipment is operational.		
Condition Analysis	The fire alarm systems appear to be in good condition. They must be regularly inspected and tested to ensure their reliability of operation.		
Life Cycle Analysis	Date of Acquisition: Normal Life Span: Effective Age: Remaining Life Span:	2011 20 years 4 years 16 years	
Unit Quantity And Cost Estimates	Unit Quantity: Unit Cost Estimate: Current Repair or Replacement Estimate: Estimated Year of Major Repair or Replacement:	1 Allowance \$10,000.00 \$10,000.00 2031	
Deficiency Analysis	None noted. The component appears in average condition with no examples of deferred maintenance.		
		alle A

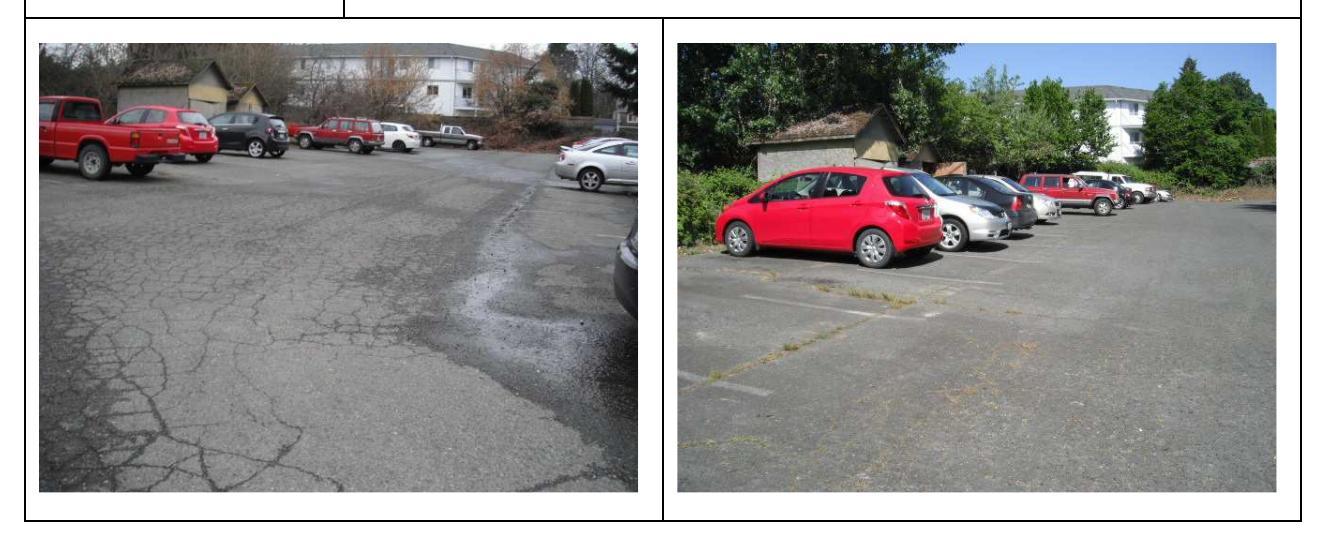
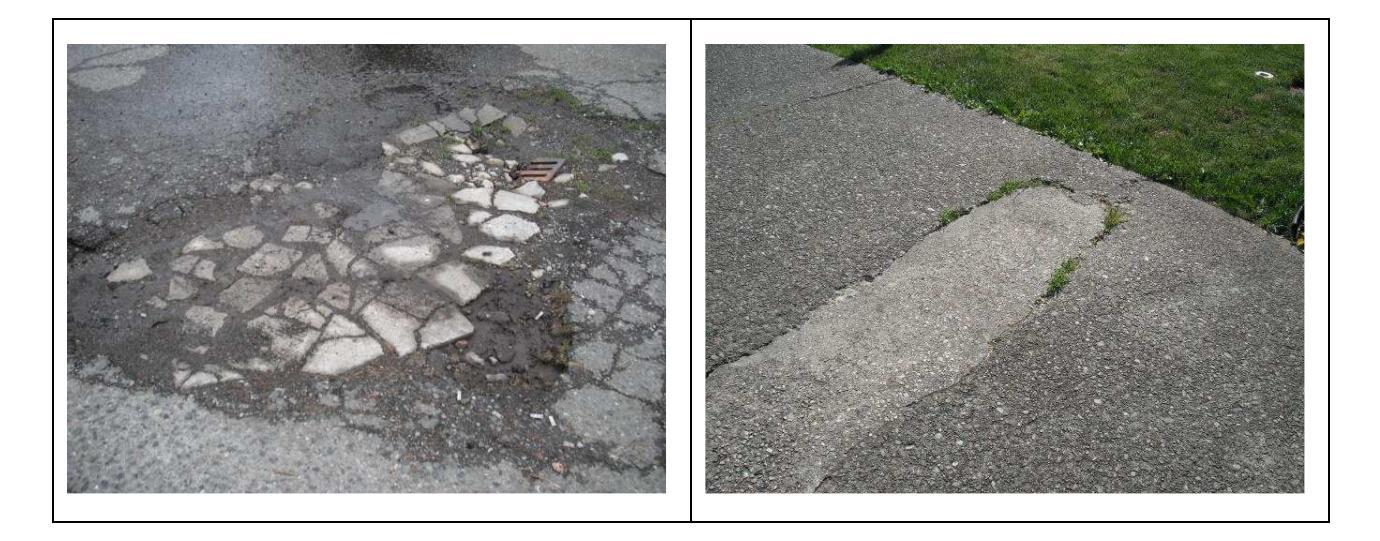
Reserve Component: (1	8) Walkways and Parking								
Physical Description:	This component includes all concrete walkways throughout the property along with the asphalt paved driveway and parking area.								
Financial Analysis	The parking lot lines appear to have been re-painted in the past few years. The reserve is a long-term reserve provision and consists of a contingency								
	for any repairs or partial replacements	ig areas which is deemed to be sufficient s.							
	Concrete is not usually replaced all a various rates whereby sections are re	at once since it usually wears and fails at paired on an 'as needed basis'.							
Potential Deterioration	Asphalt shifting and cracking over time. Damage may be accelerated by freeze-thaw cycle and tree/vegetation growth.								
Condition Analysis	Walkways are in average condition we lot areas to the side and front of the considerable alligator cracking was the concrete in places. Asphalt surfaces have an expected line case of the subject the rear parking economic life and as such will be due the 30 year study term.	with only minor wear noted. The parking building was in fair to poor condition and noted surrounding drains and shifting of fespan of approximately 50 years. In the g lot surface approaching the end of its e for resurfacing towards the initial part of

Life Cycle Analysis	Date of Acquisition: Normal Life Span: Effective Age: Remaining Life Span:	1973 50 years 45 years 5 years							
Unit Quantity And Cost	Unit Quantity:	1 allowance							
Estimates	Unit Cost Estimate: Current Repair or	\$65,000.00							
	Replacement Estimate:	\$65,000.00							
	Estimated Year of Major Repair or Replacement:	2020 resurfacing.							
Deficiency Analysis	Not applicable.

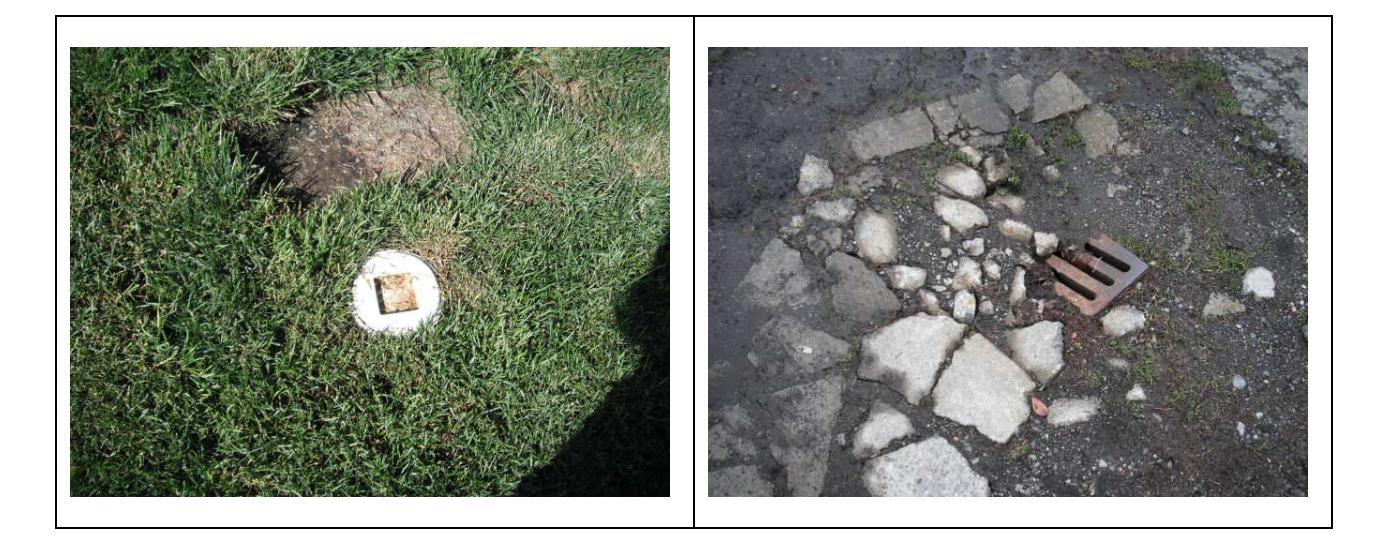
Reserve Component:	(19) Site Services						
Physical Description:	Site services include the water service pipe, sewer service piping, and storm water management which is inclusive of the property drainage and catch basins.						
Financial Analysis	No expenditures noted in the minutes aside from periodic cleaning and scoping of lines and flushing of the perimeter drains. It is generally expected that these systems will remain intact for the life of the property. However unexpected problems can occur. Unfortunately, there is generally no reliable way to predict whether or if such problems will arise. An allowance of approximately 25% of the estimated replacement cost of the component has been made.						
Potential Deterioration	Drains and catch basins must be cleared to prevent overflow. Over time, foliage and vegetation can interfere with utility lines. Perimeter drainage should be kept free of long rooted plants.

Condition Analysis	Items appear to be in serviceable condition. The inspection for depreciation report purposes is non invasive in nature.						
Life Cycle Analysis	Date of Acquisition:1973Normal Life Span:Complex lifeEffective Age:30 yearsRemaining Life Span:45 years						
Unit Quantity And Cost Estimates	Unit Quantity:1 AllowanceUnit Cost Estimate: Current Repair or Replacement Estimate: Estimated Year of Major Repair or Replacement:\$40,000.00 reserve allowance \$40,000.00 Allowance for repairs \$3,000.00 allowance for repairs at ye (2022) and in years 17 (2032) and 27 (2042).						
Deficiency Analysis	A physical inspection of these sys assumed that this item and its relate requirements of that era. Furthermore property, there was no evidence obse functioning as designed. Repairs and maintenance of these ensure the services are in good wo lines be scoped periodically to ensure Catch basins should be cleaned eve Drains should be kept clear of debris.	tems was not possible. Therefore, it is d components were built to prevailing code ore, having physically inspected the subject erved to suggest that these systems are not items are required on a regular basis to orking order. We recommend that service a no intrusion by foliage. ery year as part of a maintenance program.

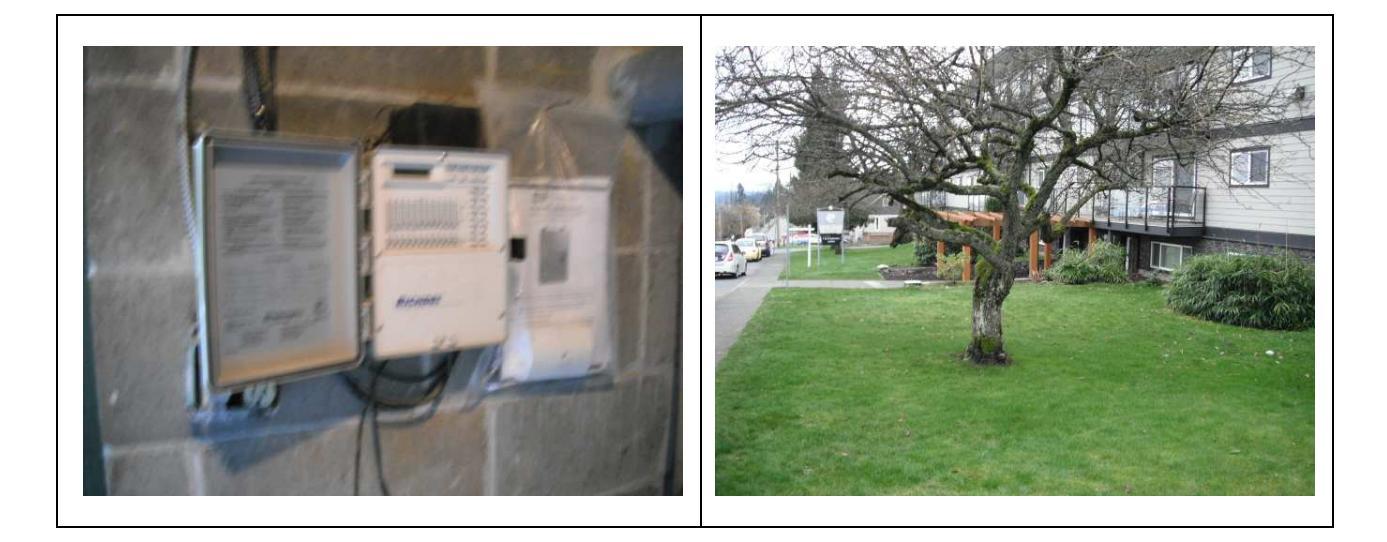
Reserve Component: (20) Landscaping and Miscellaneous Site Improvements								
Physical Description:	This component includes the soft landscaping, the gardens and the signage and the timber frame pergola at the front entry. Landscaping is comprised of a mixture of lawns, perimeter gardens, flower beds and shrubbery. Also included within this component is the irrigation system which is reported to be non functional.							
Financial Analysis	This reserves contingency intended to be used to offset the cost of replacing dead or declining landscaping when and if necessary and to upgrade the irrigation system at the end of its serviceable life. It is not intended to replace the landscaping in its entirety at one time and is not a substitute for regular maintenance expenses.							
Potential Deterioration	Vandalism, impact damage, general wear, weather and wind events.							
Condition Analysis	The components appear in serviceable	condition.

Life Cycle Analysis	Date of Acquisition: Normal Life Span: Effective Age: Remaining Life Span:	1973 plus upgrades 40 years 10 years 30 years						
Unit Quantity And Cost Estimates	Unit Quantity: Unit Cost Estimate: Current Repair or Replacement Estimate: Estimated Year of Major Repair or Replacement:	1 allowance \$20,000.00 \$20,000.00 Replacement of timber frame entry (2030)						
Deficiency Analysis	Long rooted plants should be kept back from the perimeter of the building to prevent interference with the perimeter drains. Trees and shrubs abutting any fencing or railings should be pruned to prevent interference and pressure.
