## **Parc Résidences** **Depreciation Report**

160 Wilson Street

September 11, 2013

RJC No.: VIC.106400.0001

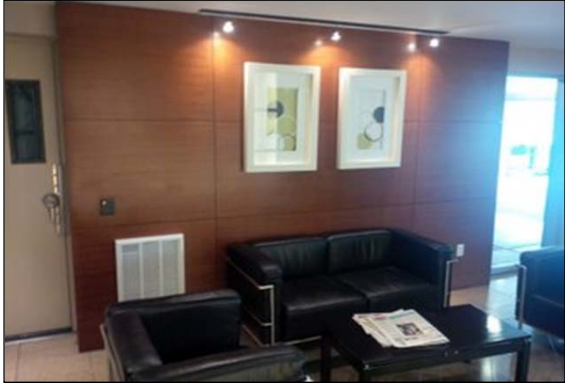
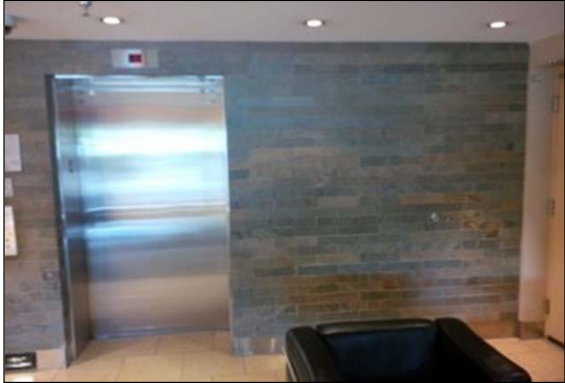
Item	Component	Description / Assessment / Priority						
<b>A1.0 Building Interior</b>								
1.01.a.1	Main Lobby - Walls/Ceiling - Renewal

<p><b>Description</b></p> <p>Main lobby wall finishes consist of wood panelling, glass, and tile veneer.</p> <p>Ceiling consists of painted drywall.</p> <p><b>Assessment</b></p> <p>The wall finishes appeared to be generally in good condition.</p> <p>Expected service life and present equivalent age shown below is for the paint finish.</p> <p>Renewals should not be required on the wood panelling, glass, and tile veneer within the time frame of this report.</p> <p>Strata records indicate that the walls were painted in 2010.</p> <p><b>Priority</b></p> <p>4 Building Functionality; cost effective and/or marketability upgrades.</p>

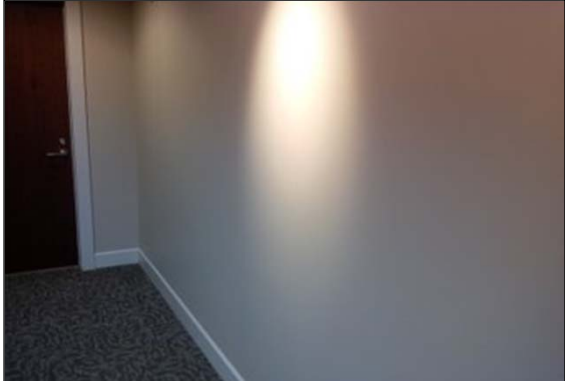
Item	Component	Description / Assessment / Priority
<b>A1.0 Building Interior</b>		
1.02.a.1	Hallway Finishes - Walls/Ceilings - Painted - Renewal

<p><b>Description</b></p> <p>The hallway wall finishes consist primarily of painted drywall with wood baseboards.</p> <p>The ceilings are textured.</p> <p><b>Assessment</b></p> <p>The paint finish appeared to be generally in good condition with some scuffing evident.</p> <p>The textured ceilings should not require refinishing within the time frame of this report.</p> <p>Strata records indicate that the hallways were painted in 2010.</p> <p>Strata records also indicate that high traffic areas in front of the elevators were repainted again in 2013.</p> <p><b>Priority</b></p> <p>4 Building Functionality; cost effective and/or marketability upgrades.</p>
	<p><b>Expected Service Life</b> 3 to 10 Years</p> <p><b>Present Equivalent Age</b> 0 to 3 Years</p> <p><b>Estimated Remaining Life</b> 3 to 7 Years</p>	<p><b>Note:</b></p> <p>Hallways - General; \$12,000; Every 10 years</p> <p>Hallways - High Traffic Areas; \$2,000; Every 3 years</p> <p style="text-align: right;"><b>Estimated Budget</b> See Above</p>

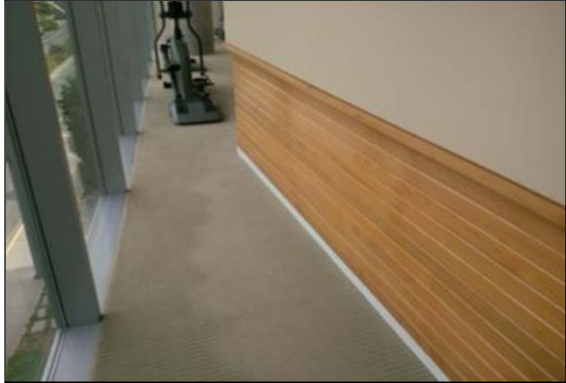
Item	Component	Description / Assessment / Priority
<b>A1.0 Building Interior</b>		
1.04.a.1	Gym Room Finishes - Walls - Renewal

<p><b>Description</b> Gym room wall finishes consist of painted drywall with stained wood wainscoting.</p> <p><b>Assessment</b> The wall finishes appeared to be generally in good condition.</p> <p><b>Priority</b> 4 Building Functionality; cost effective and/or marketability upgrades.</p>
	<p><b>Expected Service Life</b> 10 Years</p> <p><b>Present Equivalent Age</b> 5 Years</p> <p><b>Estimated Remaining Life</b> 5 Years</p>	<p><b>Note:</b></p> <p style="text-align: right;"><b>Estimated Budget \$ 1,500</b></p>

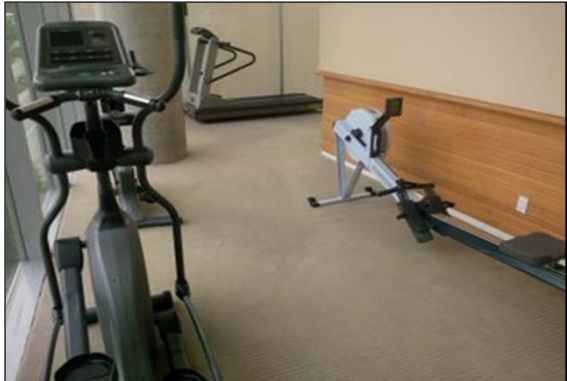
Item	Component	Description / Assessment / Priority
<b>A1.0 Building Interior</b>		
1.04.b.1	Gym Room Finishes - Flooring - Replacement

<p><b>Description</b> Gym room floor finishes consist of solid colour carpet.</p> <p><b>Assessment</b> The carpet appeared to be generally in good condition.</p> <p><b>Priority</b> 4 Building Functionality; cost effective and/or marketability upgrades.</p>
	<p><b>Expected Service Life</b> 25 Years</p> <p><b>Present Equivalent Age</b> 7 Years</p> <p><b>Estimated Remaining Life</b> 18 Years</p>	<p><b>Note:</b></p> <p style="text-align: right;"><b>Estimated Budget \$ 2,500</b></p>

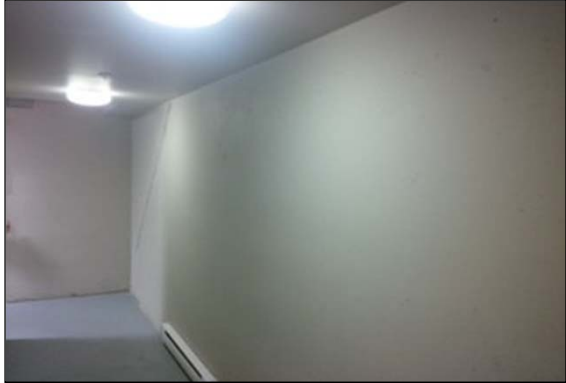
Item	Component	Description / Assessment / Priority
<b>A1.0 Building Interior</b>		
1.05.a.1	Parkade Corridor Finishes - Walls - Renewal

<p><b>Description</b> Parkade corridor wall finishes consist of painted concrete or painted drywall.</p> <p><b>Assessment</b> The finishes appeared to be generally in good condition.</p> <p><b>Priority</b> 4 Building Functionality; cost effective and/or marketability upgrades.</p>
	<p><b>Expected Service Life</b> 10 Years</p> <p><b>Present Equivalent Age</b> 3 Years</p> <p><b>Estimated Remaining Life</b> 7 Years</p>	<p><b>Note:</b> The Estimated Budget for painting is included in Item 1.02.a.1.</p> <p style="text-align: right;"><b>Estimated Budget</b>      <b>NA</b></p>

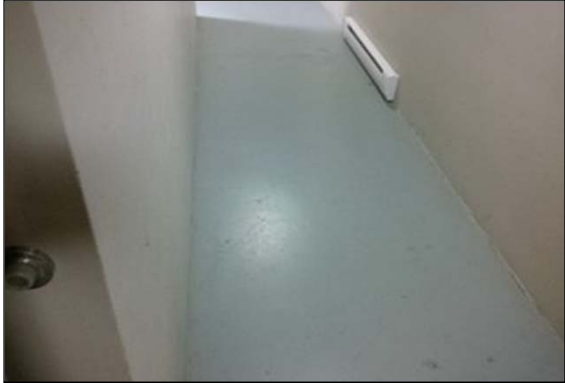
Item	Component	Description / Assessment / Priority
<b>A1.0 Building Interior</b>		
1.05.b.1	Parkade Corridor Finishes - Flooring - Renewal/Replacement

<p><b>Description</b></p> <p>Parkade corridor floor finishes consists of a painted concrete floor.</p> <p>Elevator lobby areas within the parkade consist of a ceramic tile.</p> <p><b>Assessment</b></p> <p>The floor finishes appeared to be generally in good condition.</p> <p>Expected service life of paint on a concrete floor is approximately 7 years compared to 30 years for the ceramic tile.</p> <p><b>Priority</b></p> <p>4 Building Functionality; cost effective and/or marketability upgrades.</p>
	<p><b>Expected Service Life</b> 7 to 30 Years</p> <p><b>Present Equivalent Age</b> 3 to 7 Years</p> <p><b>Estimated Remaining Life</b> 4 to 23 Years</p>	<p><b>Note:</b></p> <p>Painted finish: \$2,000</p> <p>Ceramic tile: \$1,500</p> <p style="text-align: right;"><b>Estimated Budget</b>    <b>See Above</b></p>

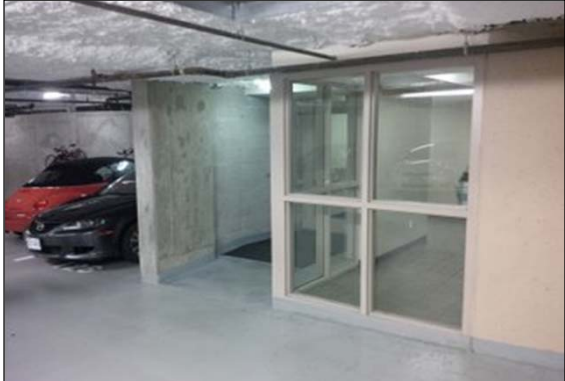
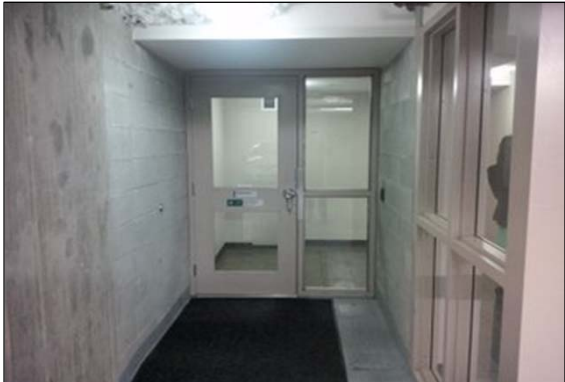
Item	Component	Description / Assessment / Priority
<b>A1.0 Building Interior</b>		
1.09.a.1	Common Area Doors - Elevator Lobbies - Replacement

<p><b>Description</b> Metal door with glass infill and windows located at entrances to parkade and elevator lobbies.</p> <p><b>Assessment</b> The door and window assemblies appeared to be generally in good condition.</p> <p><b>Priority</b> 4 Building Functionality; cost effective and/or marketability upgrades.</p>
	<p><b>Expected Service Life</b> 55 Years</p> <p><b>Present Equivalent Age</b> 7 Years</p> <p><b>Estimated Remaining Life</b> 48 Years</p>	<p><b>Note:</b></p> <p style="text-align: right;"><b>Estimated Budget</b> NA</p>

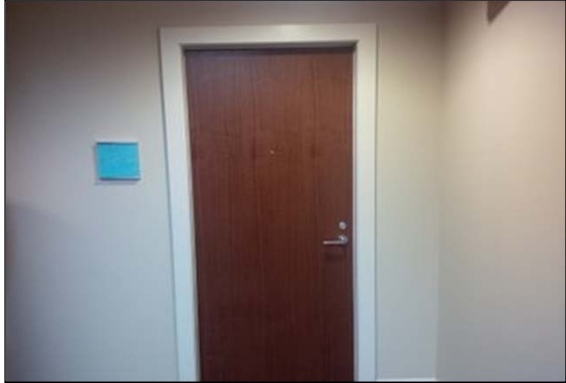
Item	Component	Description / Assessment / Priority
<b>A1.0 Building Interior</b>		
1.09.b.1	Common Area Doors - Suite - Replacement

<p><b>Description</b> Suite entry doors consist of solid core veneer door with metal hardware.</p> <p><b>Assessment</b> The doors appeared to be generally in good condition.</p> <p><b>Priority</b> 4 Building Functionality; cost effective and/or marketability upgrades.</p>
	<p><b>Expected Service Life</b> 55 Years  <b>Present Equivalent Age</b> 7 Years  <b>Estimated Remaining Life</b> 48 Years</p>	<p><b>Note:</b></p> <p style="text-align: right;"><b>Estimated Budget</b>      <b>NA</b></p>

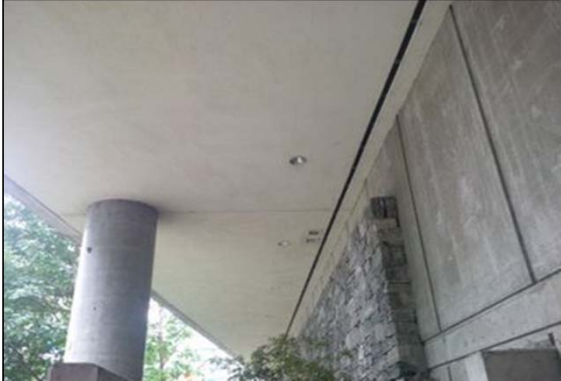
Item	Component	Description / Assessment / Priority
<b>A2.0 Building Exterior</b>		
2.01.d.1	Soffit Assemblies - Stucco - Renewal

<p><b>Description</b>                      Stucco soffits are located in areas below living space such as under the gym area on the east side of the building.</p> <p><b>Assessment</b>                      The stucco soffits appeared to be generally in good condition.                       Renewals of the stucco, other than surface cleaning as necessary, should not be required.</p> <p><b>Priority</b>                      4 Building Functionality; cost effective and/or marketability upgrades.</p>
	<p>Expected Service Life NA</p> <p>Present Equivalent Age NA</p> <p>Estimated Remaining Life NA</p>	<p><b>Note:</b></p> <p style="text-align: right;"><b>Estimated Budget NA</b></p>

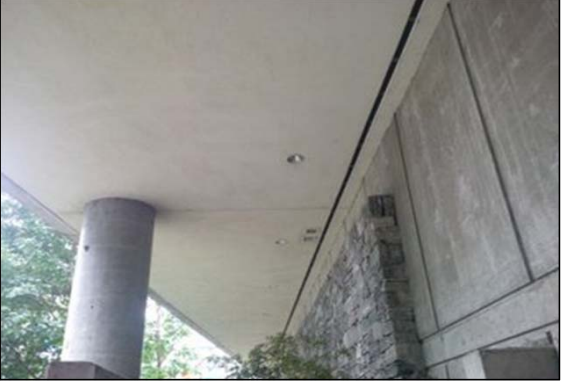
Item	Component	Description / Assessment / Priority
<b>A2.0 Building Exterior</b>		
2.01.d.2	Soffit Assemblies - Stucco - Replacement

<p><b>Description</b>                      Stucco soffits are located in areas below living space such as under the gym area on the east side of the building.</p> <p><b>Assessment</b>                      The stucco soffits appeared to be generally in good condition.                       Stucco is a durable cladding material with a long expected service life.</p> <p><b>Priority</b>                      4 Building Functionality; cost effective and/or marketability upgrades.</p>
	<p><b>Expected Service Life</b> 75 Years  <b>Present Equivalent Age</b> 7 Years  <b>Estimated Remaining Life</b> 68 Years</p>	<p><b>Note:</b></p> <p style="text-align: right;"><b>Estimated Budget</b> NA</p>

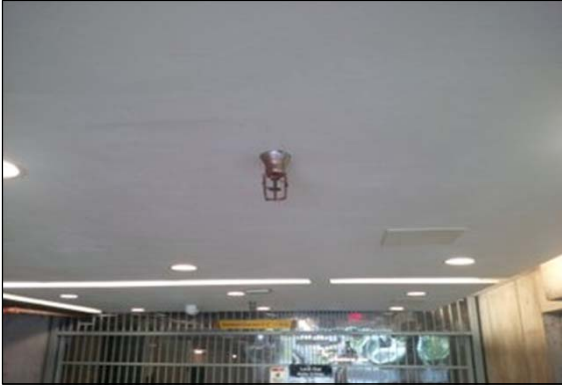
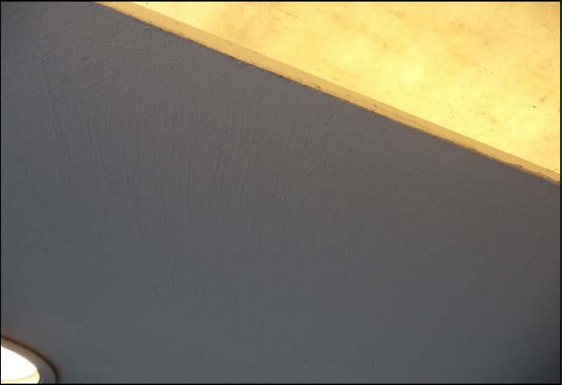
Item	Component	Description / Assessment / Priority
<b>A2.0 Building Exterior</b>		
2.01.e.2	Soffit Assemblies - Wood - Replacement

<p><b>Description</b> Wood drop soffit panels are located at the main entrance.</p> <p><b>Assessment</b> The soffits appeared to be generally in good condition.</p> <p><b>Priority</b> 4 Building Functionality; cost effective and/or marketability upgrades.</p>
	<p><b>Expected Service Life</b> 50 Years</p> <p><b>Present Equivalent Age</b> 7 Years</p> <p><b>Estimated Remaining Life</b> 43 Years</p>	<p><b>Note:</b></p> <p style="text-align: right;"><b>Estimated Budget</b> NA</p>

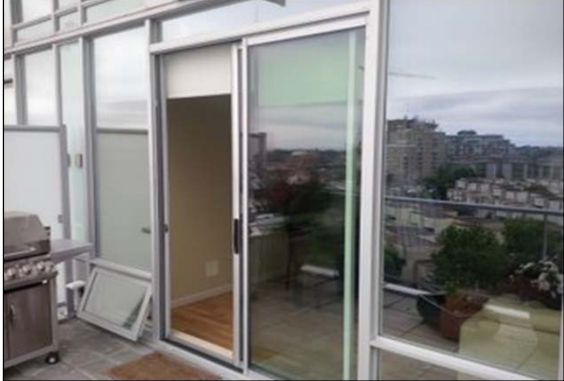
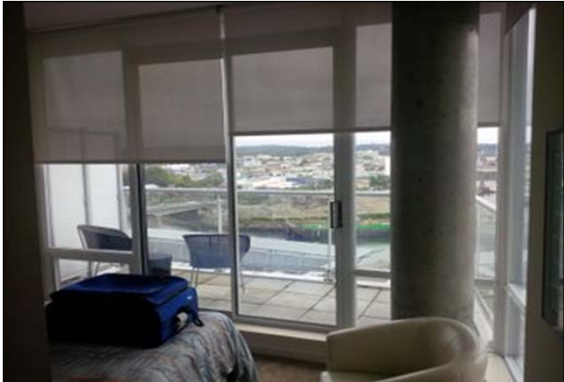
Item	Component	Description / Assessment / Priority
<b>A2.0 Building Exterior</b>		
2.03.a.1	Doors - Aluminum - Renewal

<p><b>Description</b>                      Balcony, deck, and patio doors consist of thermally-broken, aluminum framed sliding doors with double-glazed Insulated Glazing Units (IGUs).</p> <p><b>Assessment</b>                      The door assemblies appeared to be generally in good condition.</p> <p>Similar to the windows, the IGU seals can be expected to fail at random after 10 to 15 years and should be replaced on an as-required basis.</p> <p>It is recommended that an allowance of \$3,000 be set aside every 3 years for the replacement of failed sealed units.</p> <p><b>Priority</b>                      4 Building Functionality; cost effective and/or marketability upgrades.</p>
	<p><b>Expected Service Life</b> 10 to 5 Years  <b>Present Equivalent Age</b> Varies  <b>Estimated Remaining Life</b> Varies</p>	<p><b>Note:</b>                      The Expected Service life on the Item Schedule has been set at 3 years to represent a 3 year renewal schedule.</p> <p style="text-align: right;"><b>Estimated Budget \$ 3,000</b></p>

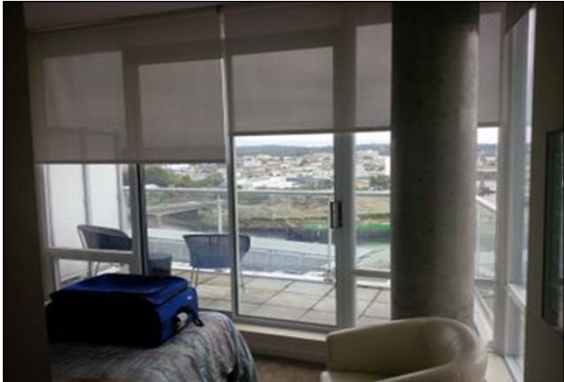
Item	Component	Description / Assessment / Priority
<b>A2.0 Building Exterior</b>		
2.03.a.2	Doors - Aluminum - Replacement

<p><b>Description</b>                      Balcony, deck, and patio doors consist of thermally-broken, aluminum framed sliding doors with double-glazed Insulated Glazing Units (IGUs).</p> <p><b>Assessment</b>                      The door assemblies appeared to be generally in good condition.                       Aluminum frames can last 40 to 50 years or longer.                       Replacement of the frames is not expected to be required within the next 30 years.</p> <p><b>Priority</b>                      4 Building Functionality; cost effective and/or marketability upgrades.</p>
	<p><b>Expected Service Life</b> 50 Years  <b>Present Equivalent Age</b> 7 Years  <b>Estimated Remaining Life</b> 43 Years</p>	<p><b>Note:</b></p> <p style="text-align: right;"><b>Estimated Budget</b> NA</p>

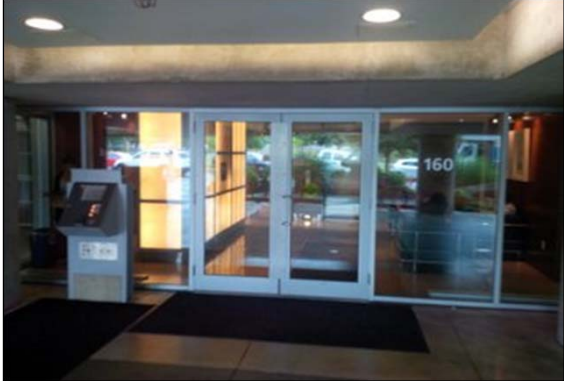
Item	Component	Description / Assessment / Priority
<b>A2.0 Building Exterior</b>		
2.03.c.1	Doors - Main Entrance - Renewal

<p><b>Description</b>                      Main entrance consists of an aluminum storefront system with double-glazed Insulated Glazing Units (IGUs), and an aluminum framed glazed infill double-door.</p> <p><b>Assessment</b>                      The door assembly appeared to be generally in good condition.                       Similar to the windows, the IGU seals can be expected to fail at random after 10 to 15 years and should be replaced on an as-required basis.</p> <p><b>Priority</b>                      4 Building Functionality; cost effective and/or marketability upgrades.</p>
	<p><b>Expected Service Life</b> 10 to 15 Years  <b>Present Equivalent Age</b> Varies  <b>Estimated Remaining Life</b> Varies</p>	<p><b>Note:</b>                      The Expected Service life on the Item Schedule has been set at 3 years to represent a 3 year renewal schedule.                       The renewals budget is included in Section 2.03.a.1.</p> <p style="text-align: right;"><b>Estimated Budget</b>      <b>NA</b></p>

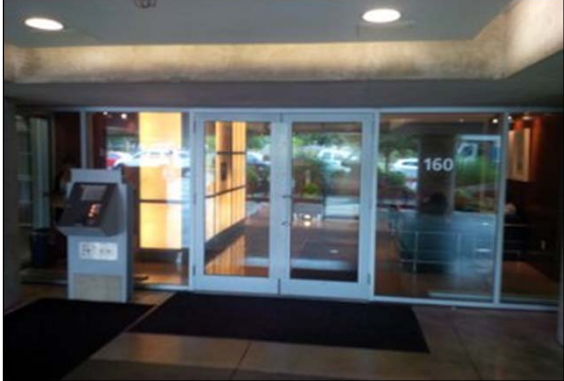
Item	Component	Description / Assessment / Priority
<b>A2.0 Building Exterior</b>		
2.03.c.2	Doors - Main Entrance - Replacement

<p><b>Description</b>                      Main entrance consists of an aluminum storefront system with double-glazed Insulated Glazing Units (IGUs), and an aluminum framed glazed infill double-door.</p> <p><b>Assessment</b>                      The door assembly appeared to be generally in good condition.                       Replacement of the frames is not expected to be required within the next 30 years.</p> <p><b>Priority</b>                      4 Building Functionality; cost effective and/or marketability upgrades.</p>
	<p><b>Expected Service Life</b> 50 Years  <b>Present Equivalent Age</b> 7 Years  <b>Estimated Remaining Life</b> 43 Years</p>	<p><b>Note:</b></p> <p style="text-align: right;"><b>Estimated Budget</b> NA</p>

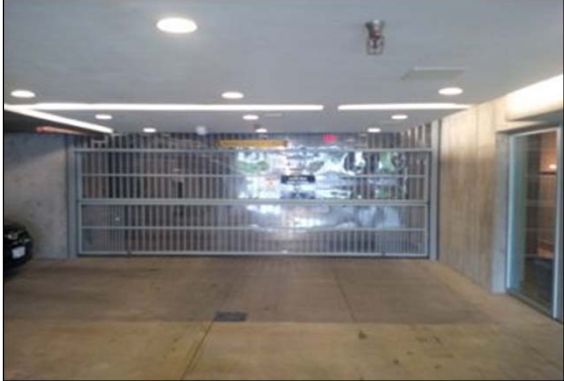
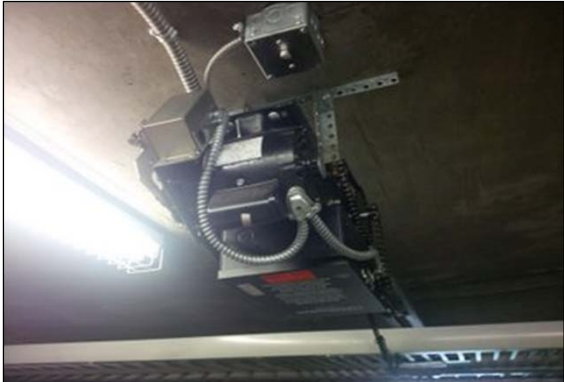
Item	Component	Description / Assessment / Priority						
<b>A2.0 Building Exterior</b>								
2.03.d.1	Doors - Parkade Gate - Replacement

<p><b>Description</b>                      Two metal frame and picket gates are present within the parkade. Gate has been covered with acrylic panels. Gate is powered by an electric motor and chain drive.</p> <p><b>Assessment</b>                      The door and operator assemblies appeared to be generally in good condition.                       Replacement of the doors should not be required within the next 30 years.                       The drive assembly however should be budgeted for replacement within the next 8 years due to the high usage.</p> <p><b>Priority</b>                      4 Building Functionality; cost effective and/or marketability upgrades.</p>

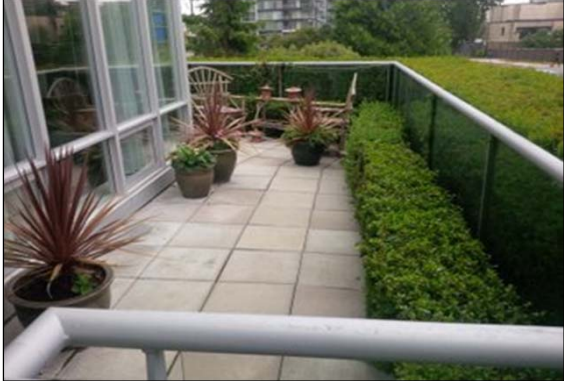
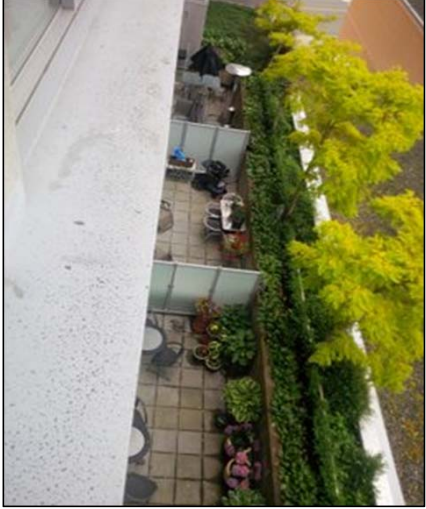
Item	Component	Description / Assessment / Priority
<b>A2.0 Building Exterior</b>		
2.04	Patio Assemblies - Replacement

<p><b>Description</b>                      Patio assemblies on the north elevation consist of concrete paving stones atop of a modified bitumen membrane.                       The patios on the west/south elevation are at grade.</p> <p><b>Assessment</b>                      The concrete pavers appeared to be generally in good condition.                       Good quality concrete pavers should last 35 to 40 years before requiring replacement.</p> <p><b>Priority</b>                      4 Building Functionality; cost effective and/or marketability upgrades.</p>
	<p><b>Expected Service Life</b> 40 Years  <b>Present Equivalent Age</b> 7 Years  <b>Estimated Remaining Life</b> 33 Years</p>	<p><b>Note:</b></p> <p style="text-align: right;"><b>Estimated Budget</b> NA</p>

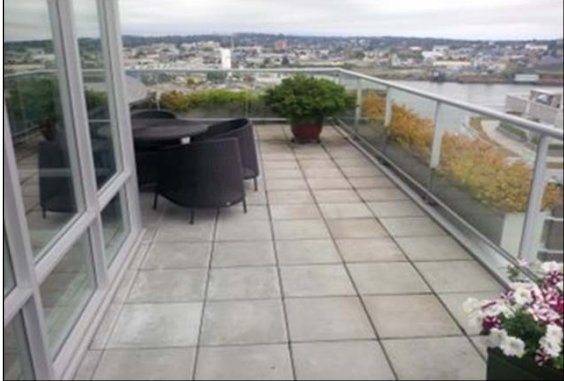
Item	Component	Description / Assessment / Priority
<b>A2.0 Building Exterior</b>		
2.05.a.1	Balcony Assemblies - Modified Bitumen/Pavers - Replacement

<p><b>Description</b>                      Decks consist of concrete paving stones atop of filter cloth, rigid insulation and a modified bitumen membrane on the concrete substrate.</p> <p><b>Assessment</b>                      The assemblies appeared to be generally in good condition.                      No leaks or other problems were reported by the Strata.                      This type of protected waterproofing assembly would be expected to last 35 to 40 years before requiring replacement.                      The pavers would be expected to last the life of the membrane.</p> <p><b>Priority</b>                      4 Building Functionality; cost effective and/or marketability upgrades.</p>
	<p><b>Expected Service Life</b> 40 Years  <b>Present Equivalent Age</b> 7 Years  <b>Estimated Remaining Life</b> 33 Years</p>	<p><b>Note:</b></p> <p style="text-align: right;"><b>Estimated Budget</b> NA</p>

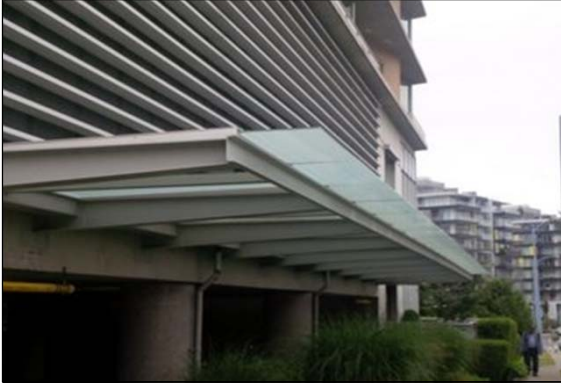
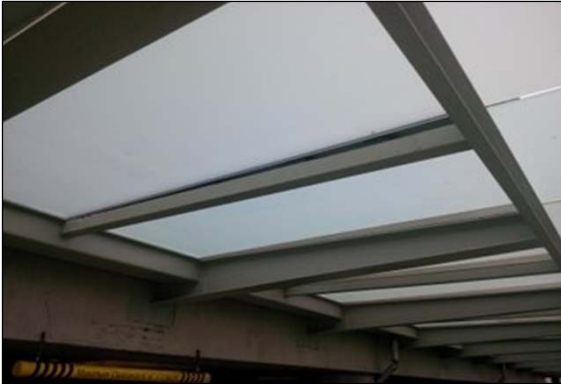
Item	Component	Description / Assessment / Priority
<b>A3.0 Roofing Systems</b>		
3.04.a.1	Awnings - Glazed - Renewal

<p><b>Description</b>                      Glazed awning is located along the west side of the building at the main entrance. Glazing is supported by a cantilevered steel frame. Glazing is frosted laminated glass.</p> <p><b>Assessment</b>                      The glazing appeared to be generally in good condition however there was minor corrosion on the steel frame.                       Renewals would include repainting the steel frame.</p> <p><b>Priority</b>                      4 Building Functionality; cost effective and/or marketability upgrades.</p>
	<p><b>Expected Service Life</b> 7 Years  <b>Present Equivalent Age</b> 4 Years  <b>Estimated Remaining Life</b> 3 Years</p>	<p><b>Note:</b></p> <p style="text-align: right;"><b>Estimated Budget \$ 2,000</b></p>

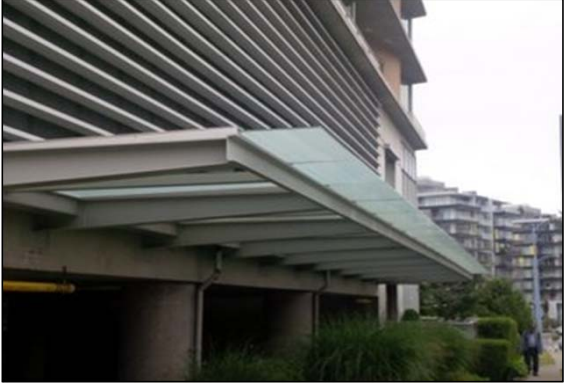
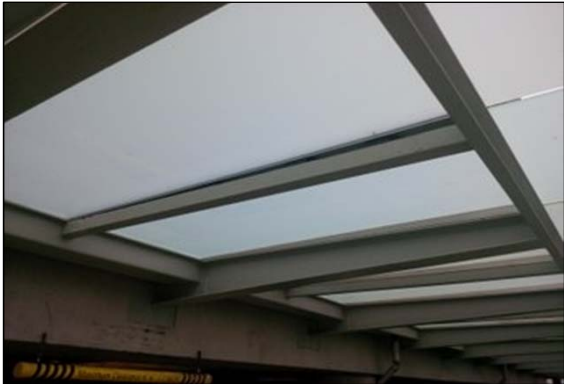
Item	Component	Description / Assessment / Priority
<b>A3.0 Roofing Systems</b>		
<b>3.04.a.2</b>	<b>Awnings - Glazed - Replacement</b>

<p><b>Description</b>                      Glazed awning is located along the west side of the building at the main entrance. Glazing is supported by a cantilevered steel frame. Glazing is frosted laminated glass.</p> <p><b>Assessment</b>                      The glazing appeared to be generally in good condition however there was minor corrosion on the steel frame.</p> <p>Replacement of the entire assembly should not be required within the next 30 years.</p> <p><b>Priority</b>                      2 Structural Integrity</p>
	<p><b>Expected Service Life</b> 40 Years</p> <p><b>Present Equivalent Age</b> 7 Years</p> <p><b>Estimated Remaining Life</b> 33 Years</p>	<p><b>Note:</b></p> <p style="text-align: right;"><b>Estimated Budget</b> NA</p>

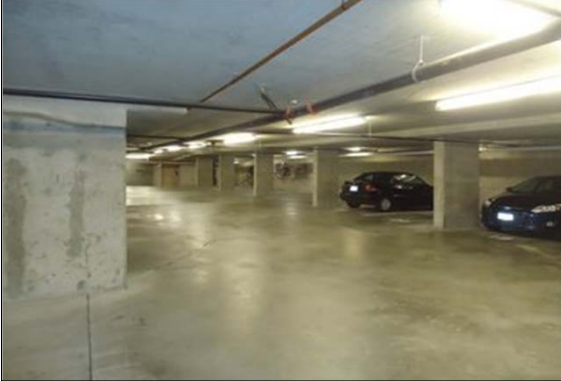
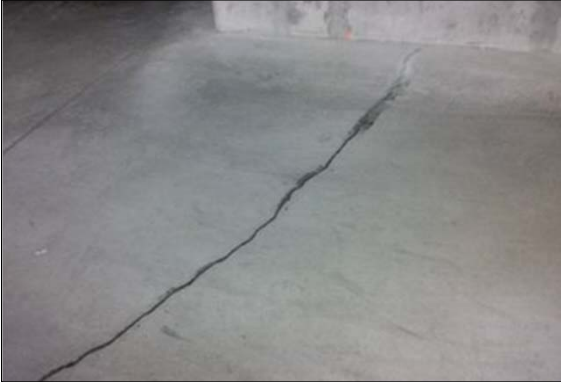
Item	Component	Description / Assessment / Priority
<b>A4.0 Building Structure</b>		
4.02.a.1	Underground Parkade - Slab - P1 - Renewal

<p><b>Description</b>                      Level P1 of the parkade consists of an exposed concrete slab-on-grade with a polished finish.</p> <p><b>Assessment</b>                      The concrete slab appeared to be generally in good condition although there were a number of cracks noted.</p> <p>A budget of \$5,000 is suggested for partial repairs every 10 years.</p> <p><b>Priority</b>                      2 Structural Integrity</p>
	<p><b>Expected Service Life</b> 10 Years  <b>Present Equivalent Age</b> 7 Years  <b>Estimated Remaining Life</b> 3 Years</p>	<p><b>Note:</b></p> <p style="text-align: right;"><b>Estimated Budget \$ 5,000</b></p>

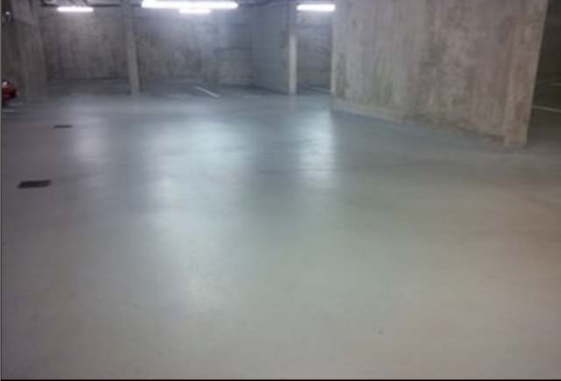
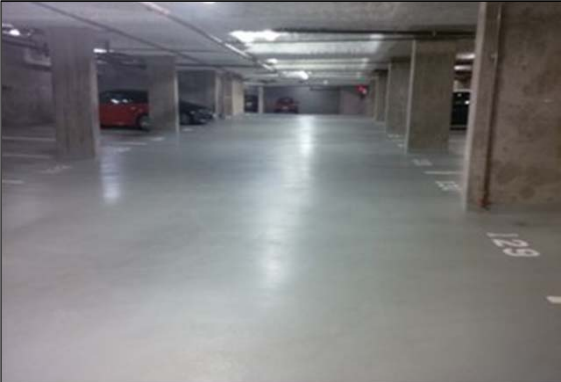
Item	Component	Description / Assessment / Priority
<b>A4.0 Building Structure</b>		
4.02.a.2	Underground Parkade - Slab - P2, P3, P4 - Renewal

<p><b>Description</b> Levels P2, P3, and P4 of the parkade consists of concrete slab with a liquid applied waterproofing membrane.</p> <p><b>Assessment</b> The liquid applied membrane appeared to be generally in good condition.  Because of the higher wear on this traffic membrane compared to the balconies, renewal should be budgeted every 10 years.  The membrane could be renewed in a phased approach with 1/3 being done each year.</p> <p><b>Priority</b> 2 Structural Integrity</p>
	<p><b>Expected Service Life</b> 10 Years</p> <p><b>Present Equivalent Age</b> 5 Years</p> <p><b>Estimated Remaining Life</b> 5 Years</p>	<p><b>Note:</b> The Estimated Budget is for each of the 3 Phases</p> <p style="text-align: right;"><b>Estimated Budget \$ 165,000</b></p>

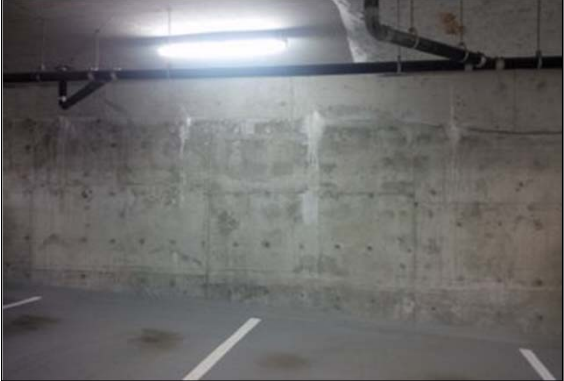
Item	Component	Description / Assessment / Priority
<b>A4.0 Building Structure</b>		
4.02.b.1	Underground Parkade - Walls - Renewal

<p><b>Description</b>                      Parkade walls consist of unfinished concrete.</p> <p><b>Assessment</b>                      The walls appeared to be generally in good condition and renewals would not be expected within the next 30 years.</p> <p><b>Priority</b>                      2 Structural Integrity</p>
	<p><b>Expected Service Life</b> 75 Years  <b>Present Equivalent Age</b> 7 Years  <b>Estimated Remaining Life</b> 68 Years</p>	<p><b>Note:</b></p> <p style="text-align: right;"><b>Estimated Budget</b> NA</p>

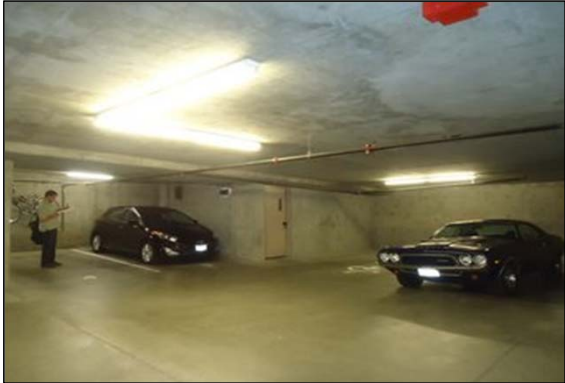
Item	Component	Description / Assessment / Priority
<b>A4.0 Building Structure</b>		
4.02.c.1	Underground Parkade - Soffit - Renewal

<p><b>Description</b>                      Spray applied, non-combustible fiberglass insulation applied on soffit directly under living space. Soffit is unfinished elsewhere.</p> <p><b>Assessment</b>                      The soffits and floor slabs appeared to be generally in good condition.                       No renewals of the soffit would be expected over the next 30 years.</p> <p><b>Priority</b>                      2 Structural Integrity</p>
	<p><b>Expected Service Life</b> 40 Years  <b>Present Equivalent Age</b> 7 Years  <b>Estimated Remaining Life</b> 33 Years</p>	<p><b>Note:</b>                      The Expected Service Life shown is for the spray applied insulation.</p> <p style="text-align: right;"><b>Estimated Budget</b> NA</p>

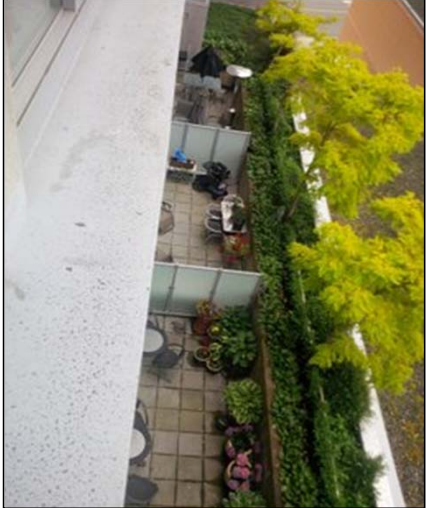
Item	Component	Description / Assessment / Priority
<b>A4.0 Building Structure</b>		
<b>4.03</b>	Plaza Waterproofing - Replacement

<p><b>Description</b> Plaza waterproofing is present under the patios located on the north side of the building. Membrane consists of a modified bitumen membrane atop the concrete suspended slab.</p> <p><b>Assessment</b> This type of protected membrane is expected to last approximately 40 years. The membrane was not visible; no leaks were evident or reported by the Strata.</p> <p><b>Priority</b> 2 Structural Integrity</p>
	<p><b>Expected Service Life</b> 40 Years  <b>Present Equivalent Age</b> 7 Years  <b>Estimated Remaining Life</b> 33 Years</p>	<p><b>Note:</b></p> <p style="text-align: right;"><b>Estimated Budget</b> NA</p>

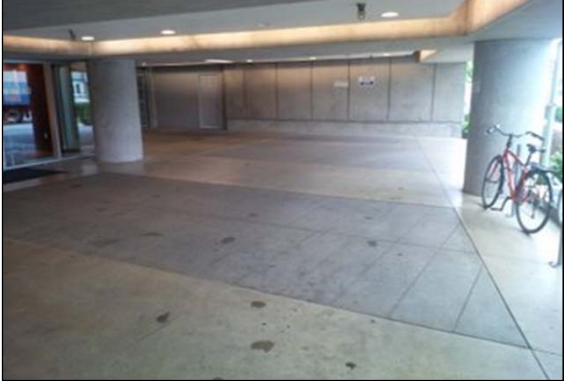
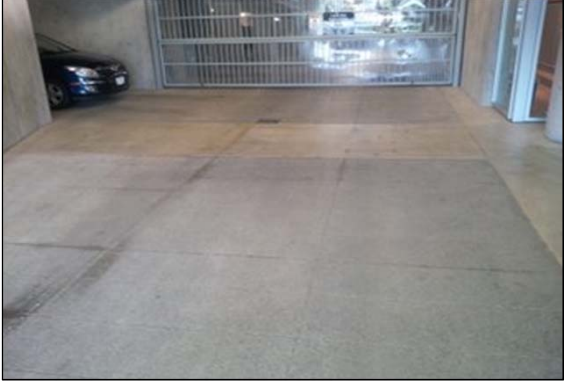
Item	Component	Description / Assessment / Priority
<b>A5.0 Exterior Landscaping and Miscellaneous</b>		
5.01	Entrance Driveway and Ramp - Renewal

<p><b>Description</b> The entrance driveway and ramp consist of a cast-in-place concrete with various finishes.</p> <p><b>Assessment</b> The concrete appeared to be generally in good condition with minor cracking.</p> <p><b>Priority</b> 2 Structural Integrity</p>
	<p><b>Expected Service Life</b> 40 Years</p> <p><b>Present Equivalent Age</b> 7 Years</p> <p><b>Estimated Remaining Life</b> 33 Years</p>	<p><b>Note:</b> A repair budget of \$2,500 is suggested in 3 years.</p> <p style="text-align: right;"><b>Estimated Budget \$ 2,500</b></p>

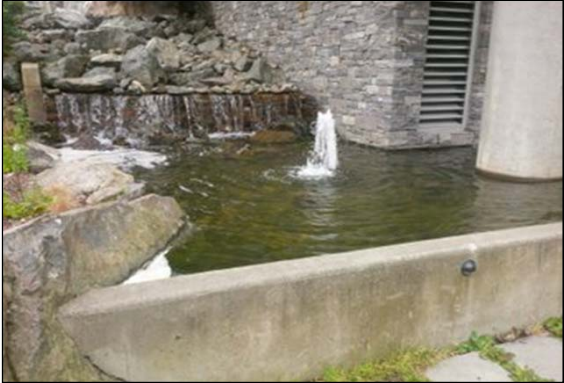
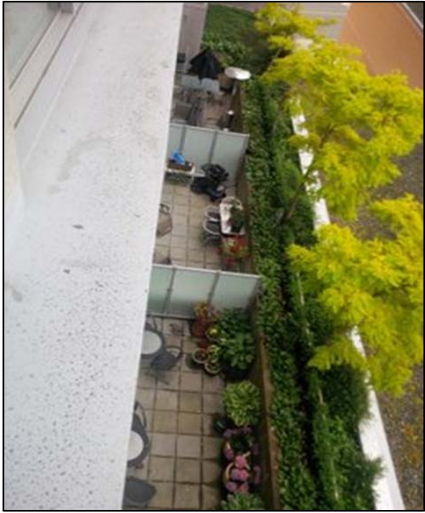
Item	Component	Description / Assessment / Priority
<b>A5.0 Exterior Landscaping and Miscellaneous</b>		
5.03	Retaining Wall - Concrete - Renewal

<p><b>Description</b> Concrete retaining walls are located at the pond at the east side of the building, along the patio at the south-west corner of the building, and along the patios at the north side of the building.</p> <p><b>Assessment</b> The concrete retaining walls appeared to be generally in good condition and should not require renewals within the next 30 years.</p> <p><b>Priority</b> 2 Structural Integrity</p>
	<p><b>Expected Service Life</b> 50+ Years  <b>Present Equivalent Age</b> 7 Years  <b>Estimated Remaining Life</b> 43 Years</p>	<p><b>Note:</b></p> <p style="text-align: right;"><b>Estimated Budget</b> NA</p>

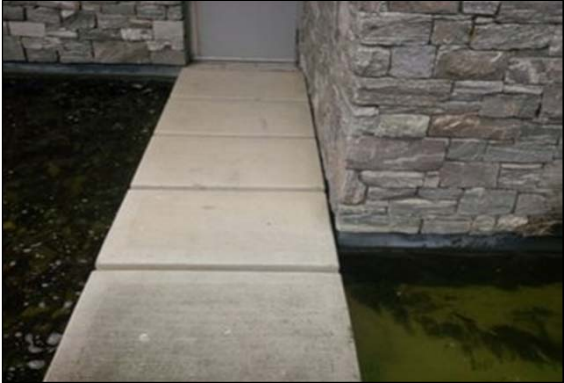
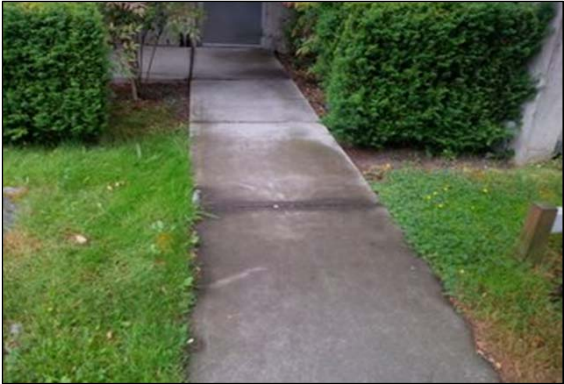
Item	Component	Description / Assessment / Priority
<b>A5.0 Exterior Landscaping and Miscellaneous</b>		
5.04	Concrete Walkways - Renewal

<p><b>Description</b> Concrete walkways at various locations.</p> <p><b>Assessment</b> The concrete walkways appeared to be generally in good condition and renewals would not be expected within the next 30 years.</p> <p><b>Priority</b> 2 Structural Integrity</p>
	<p><b>Expected Service Life</b> 40 Years</p> <p><b>Present Equivalent Age</b> 7 Years</p> <p><b>Estimated Remaining Life</b> 33 Years</p>	<p><b>Note:</b></p> <p style="text-align: right;"><b>Estimated Budget</b> NA</p>

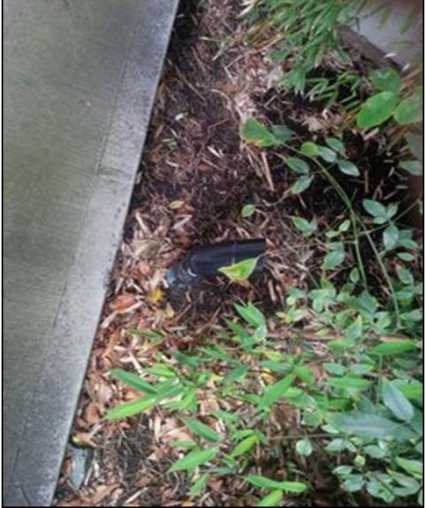
Item	Component	Description / Assessment / Priority
<b>A5.0 Exterior Landscaping and Miscellaneous</b>		
5.06	Landscape Irrigation - Replacement

<p><b>Description</b> Landscape irrigation is present along planters and garden beds.</p> <p><b>Assessment</b> The system was not accessible for a visual review however the Strata did not indicate any issues with the system.</p> <p><b>Priority</b> 4 Building Functionality; cost effective and/or marketability upgrades.</p>
	<p><b>Expected Service Life</b> 25 Years  <b>Present Equivalent Age</b> 7 Years  <b>Estimated Remaining Life</b> 18 Years</p>	<p><b>Note:</b></p> <p style="text-align: right;"><b>Estimated Budget \$ 7,500</b></p>

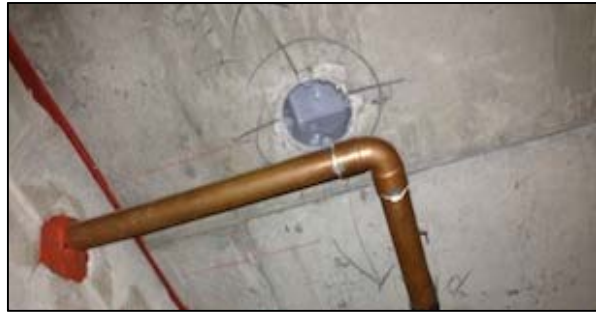
Item	Component	Description / Assessment / Priority
<b>M2.0 Plumbing Systems</b>		
2.04	Domestic Water Distribution System - Replacement

<p><b>Description</b> Cold, hot and recirculation mains distribute water to/from suites. Piping in common areas and risers are ductile iron and copper. Within suites, in-slab PEX piping delivers hot and cold water to plumbing fixtures.</p> <p><b>Assessment</b> Good condition.</p> <p>A water leak that occurred previously on level 5 is believed to be the result of stress on the copper pipe due to thermal expansion / contraction. Should this continue to be an issue, the recommendation is to install an expansion loop about half-way along the length of the pipe that runs down the hallway.</p> <p>In order to reduce the risk caused by water leaks, the Strata and owners are encourage to review the measures for washer hoses, washer valves and dishwashers included in the attached PLUMBING RISK MANAGEMENT document.</p> <p><b>Priority</b> 4 Building Functionality; cost effective and/or marketability upgrades.</p>

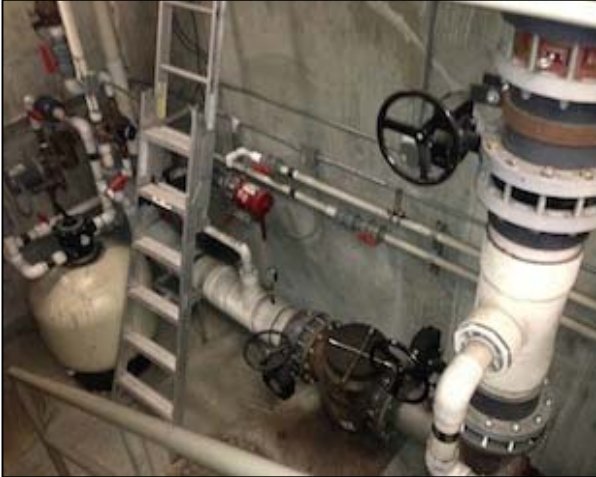
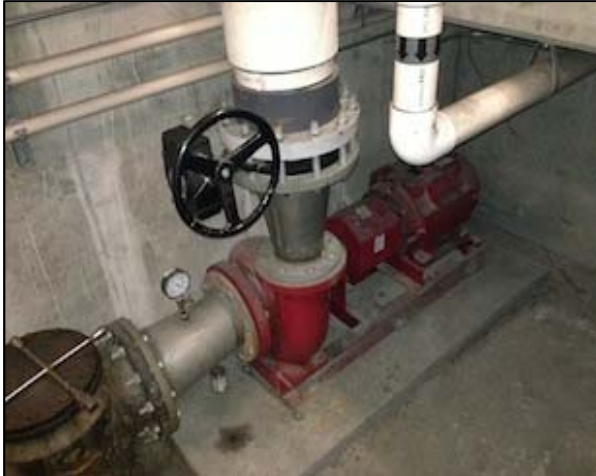
Item	Component	Description / Assessment / Priority
<b>M2.0 Plumbing Systems</b>		
2.09	Waterfall System - Replacement

<p><b>Description</b> The waterfall and fountains have a circulation, filtration and ozone system located in the P1 mechanical room. The piping and components are a combination of plastic, stainless steel, and enameled steel.</p> <p><b>Assessment</b> The piping and circulation system appears to be in fair condition.</p> <p>The Strata reports that there is significant water loss due to evaporation on warm days, which becomes a concern when the CRD starts implementing water restrictions.</p> <p><b>Priority</b> 4 Building Functionality; cost effective and/or marketability upgrades.</p>
	<p><b>Expected Service Life</b> 25 Years</p> <p><b>Present Equivalent Age</b> 8 Years</p> <p><b>Estimated Remaining Life</b> 17 Years</p>	<p><b>Note:</b> The estimated budget for replacement is for the water circulation equipment only and excludes structural, waterproofing and aesthetic components such as the interior surge tank, exterior water pools, faux rocks.</p> <p style="text-align: right;"><b>Estimated Budget \$ 90,000</b></p>

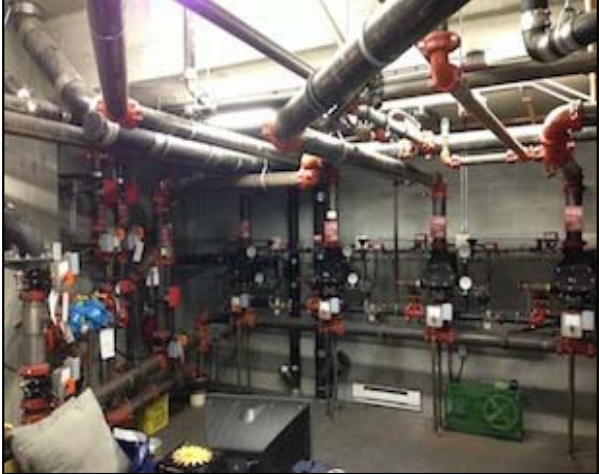
Item	Component	Description / Assessment / Priority
<b>M3.0 Fire Suppression Systems</b>		
3.01A	Fire Water Entry / Sprinkler Tree - Replacement

<p><b>Description</b> The sprinkler tree is supplied by an underground fire main off Wilson St. Components include pipe, fittings, shut-off valves, and flow sensors. The fire department connection located near the main entrance connects to the sprinkler tree.</p> <p><b>Assessment</b> Good condition.</p> <p><b>Priority</b> 4 Building Functionality; cost effective and/or marketability upgrades.</p>
<p><b>Expected Service Life</b> 50 Years  <b>Present Equivalent Age</b> 8 Years  <b>Estimated Remaining Life</b> 42 Years</p>		<p><b>Note:</b> Estimate includes replacement of the underground main, cutting and patching, plus piping in the mechanical room.</p> <p style="text-align: right;"><b>Estimated Budget \$ 5,000</b></p>

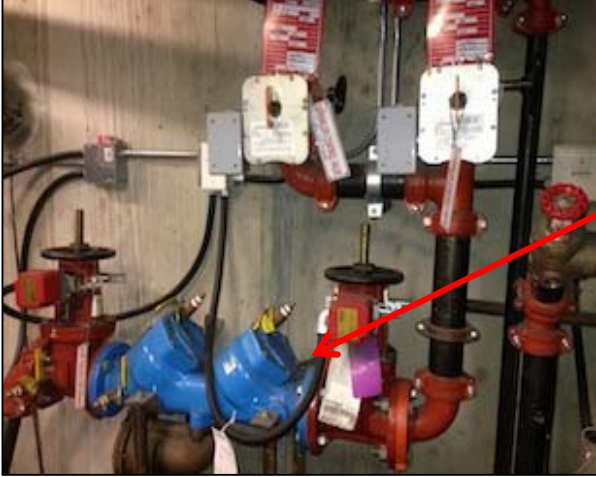
Item	Component	Description / Assessment / Priority
<b>M3.0 Fire Suppression Systems</b>		
<b>3.01B</b>	Fire Water Backflow Preventers - Replacement

<p><b>Description</b> Backflow devices protect the municipal water supply from possible contamination by the building. There is a device on the primary fire water supply, and the antifreeze system line.</p> <p><b>Assessment</b> Devices are in good condition. They are tagged and receive regular testing.</p> <p><b>Priority</b> 4 Building Functionality; cost effective and/or marketability upgrades.</p>
	<p><b>Expected Service Life</b> 30 Years  <b>Present Equivalent Age</b> 8 Years  <b>Estimated Remaining Life</b> 22 Years</p>	<p><b>Note:</b> Estimated budget is \$3,000 each.</p> <p style="text-align: right;"><b>Estimated Budget \$ 6,000</b></p>

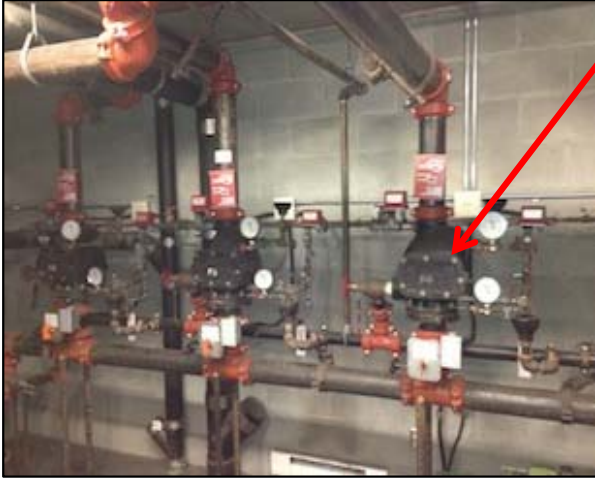
Item	Component	Description / Assessment / Priority
<b>M3.0 Fire Suppression Systems</b>		
3.02A	Dry Sprinkler System - Valve Replacement

<p><b>Description</b> The dry sprinkler system protecting the parkade has valves that automatically release water into the system if a sprinkler head is triggered.</p> <p><b>Assessment</b> Good condition.</p> <p><b>Priority</b> 4 Building Functionality; cost effective and/or marketability upgrades.</p>
	<p><b>Expected Service Life</b> 25 Years  <b>Present Equivalent Age</b> 8 Years  <b>Estimated Remaining Life</b> 17 Years</p>	<p><b>Note:</b> Valves can often be rebuilt / refurbished in order to postpone replacement. Estimated budget is \$5,000 each for replacement.</p> <p style="text-align: right;"><b>Estimated Budget \$ 20,000</b></p>

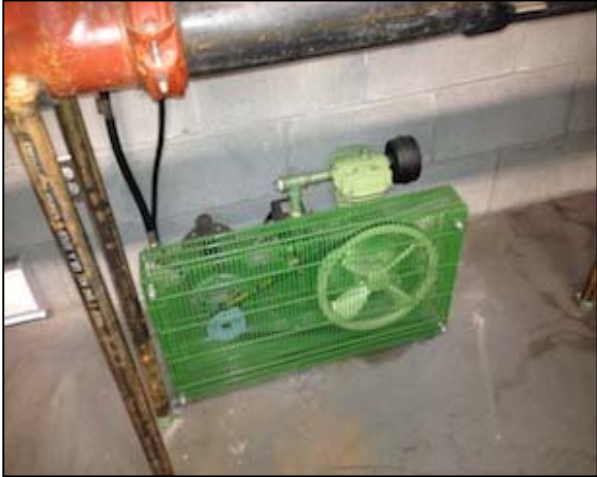
Item	Component	Description / Assessment / Priority
<b>M3.0 Fire Suppression Systems</b>		
<b>3.02B</b>	Dry Sprinkler System - Compressor Replacement

<p><b>Description</b> The dry sprinkler system that protects the parkade has a compressor to keep the piping filled with pressurized air. In the event of a fire, sprinkler head(s) will release this air from the system and then water will flow from the dry valve.</p> <p><b>Assessment</b> Good condition.</p> <p>Ensure that compressor is serviced regularly and that air filter is changed.</p> <p><b>Priority</b> 4 Building Functionality; cost effective and/or marketability upgrades.</p>
	<p><b>Expected Service Life</b> 20 Years  <b>Present Equivalent Age</b> 7 Years  <b>Estimated Remaining Life</b> 13 Years</p>	<p><b>Note:</b></p> <p style="text-align: right;"><b>Estimated Budget \$ 2,500</b></p>

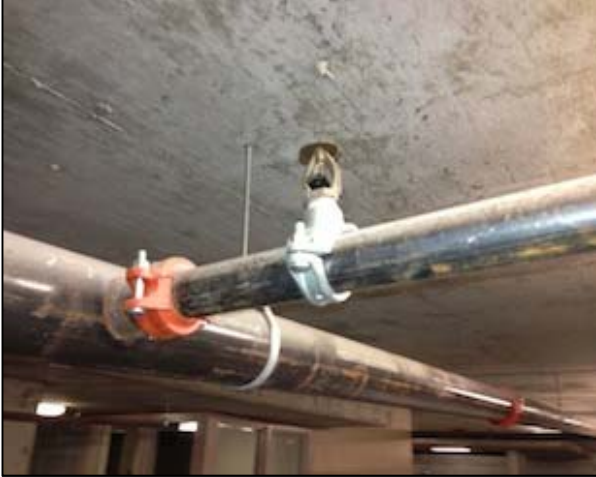
Item	Component	Description / Assessment / Priority								
<b>M3.0 Fire Suppression Systems</b>										
<b>3.02C</b>	Dry Sprinkler Systems - Head Replacement

<p><b>Description</b> Sprinkler heads are installed on wet and dry systems located throughout the building.</p> <p><b>Assessment</b> Good condition.  Heads cannot be painted.</p> <p><b>Priority</b> 4 Building Functionality; cost effective and/or marketability upgrades.</p>

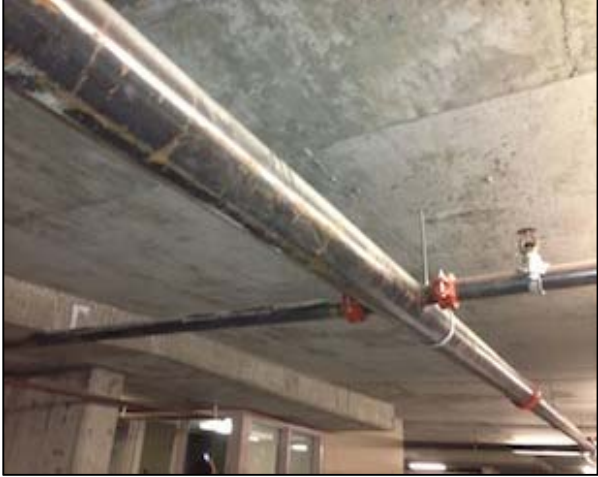
Item	Component	Description / Assessment / Priority								
<b>M3.0 Fire Suppression Systems</b>										
<b>3.02D</b>	Dry Sprinkler Systems - Piping Replacement

<p><b>Description</b> Dry sprinkler systems are installed in parkades. Piping is steel.</p> <p><b>Assessment</b> Good condition.  Pipe painting is recommended in order to extend service life.</p> <p><b>Priority</b> 4 Building Functionality; cost effective and/or marketability upgrades.</p>

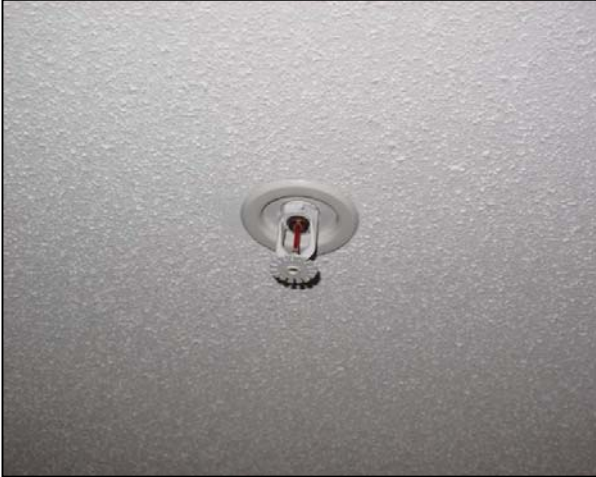
Item	Component	Description / Assessment / Priority
<b>M3.0 Fire Suppression Systems</b>		
3.03A	Combined Wet Sprinkler & Standpipe Systems - Head Replacement

<p><b>Description</b> Sprinkler heads are installed on wet and dry systems located throughout the building.</p> <p><b>Assessment</b> Good condition.  Heads cannot be painted.</p> <p><b>Priority</b> 4 Building Functionality; cost effective and/or marketability upgrades.</p>
	<p><b>Expected Service Life</b> 25 Years  <b>Present Equivalent Age</b> 5 Years  <b>Estimated Remaining Life</b> 20 Years   <b>Estimated quantity</b> 1,230 Heads</p>	<p><b>Note:</b> Estimate is based on 10 heads per suite x 123 suites x \$50 per head.</p> <p style="text-align: right;"><b>Estimated Budget \$ 61,500</b></p>

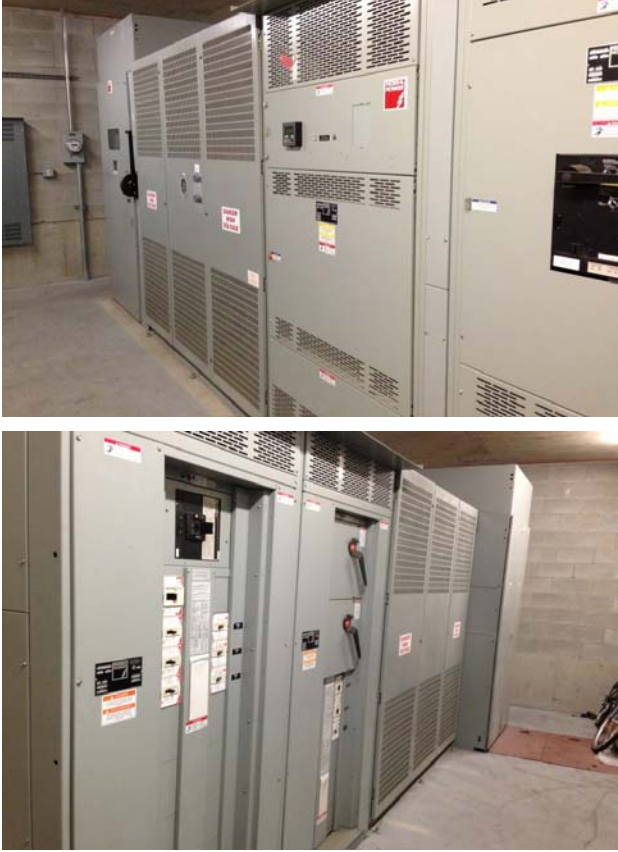
Item	Component	Description / Assessment / Priority
<b>E1.0 Electrical Systems</b>		
1.01	Incoming Service & Main Distribution Assembly

<p><b>Description</b></p> <p>The main service assembly is comprised of several components, including incoming wireway sections, transformer sections, and disconnect switch &amp; breaker sections. This multi section assembly steps down the 15/25KV incoming voltage to two different voltages used within the building: 120/208V and 347/600V.</p> <p>Distribution board is manufactured by Federal Pioneer and is will be adequate into distant future provided the systems are regularly maintained.</p> <p>The room is adequately vented and has significant air flow to keep equipment cool.</p> <p><b>Assessment</b></p> <p>Distribution assembly appears in great condition and should last many years. It is recommended that thermal imaging be conducted at regular (2-3 years) intervals to provide early detection of potential issues (hot spots). All electrical connections should be checked and tightened to the appropriate levels.</p> <p><b>Priority</b> NA</p>

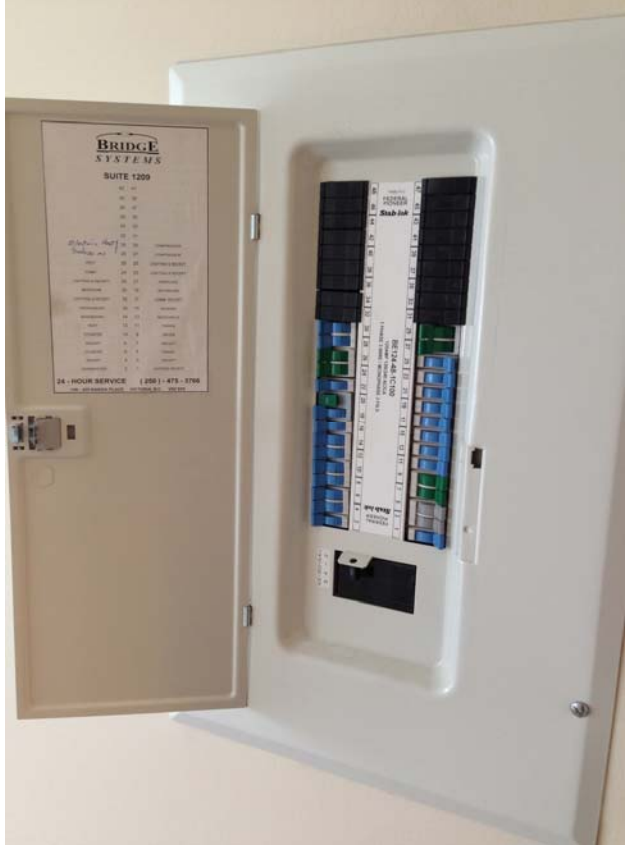
Item	Component	Description / Assessment / Priority
<b>E2.0 Unit Systems</b>		
2.01	Dwelling Units

<p><b>Description</b></p> <p>Suite panels are manufactured by Federal Pioneer, and are 208V single phase, rated at 100A. Panels are fitted with local main service disconnects, as well as GFI and arc-fault breakers as required by Code.</p> <p>Fire alarm devices were present and adequate.</p> <p><b>Assessment</b></p> <p>No changes required.</p> <p><b>Priority</b></p>
<p><b>Expected Service Life</b> 45 Years</p> <p><b>Present Equivalent Age</b> 8 Years</p> <p><b>Estimated Remaining Life</b> 37 Years</p>		<p><b>Note:</b></p> <p>This is an individual owner responsibility and is shown for information only.</p>
		<p style="text-align: right;"><b>Estimated Budget</b> NA</p>
