## **Parc Résidences** **Depreciation Report**

160 Wilson Street

September 11, 2013

RJC No.: VIC.106400.0001

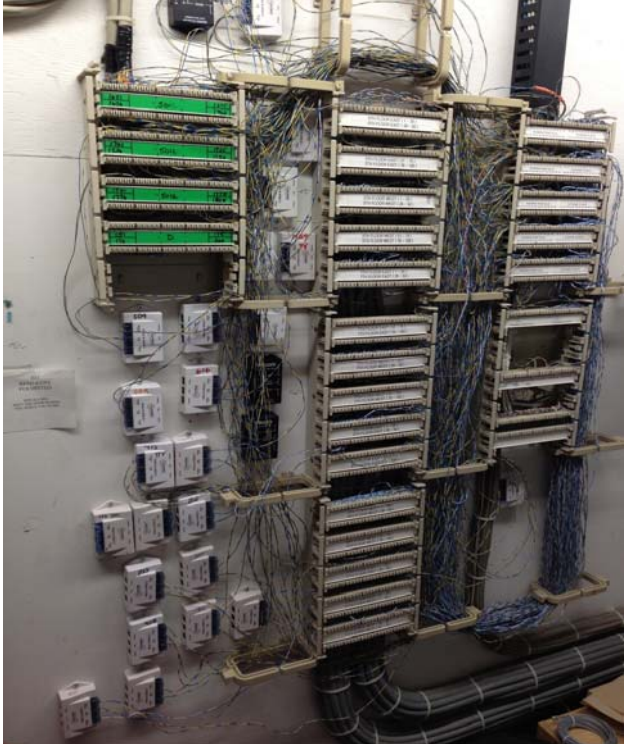
Item	Component	Description / Assessment / Priority
<b>E3.0 Communication System</b>		
3.01	CTV & Telephone System

<p><b>Description</b></p> <p>The primary communication demarcation point is located adjacent to the main electrical room in the communications room. Additional equipment is located on the residential floors within the closets. The telephone equipment is modern and in good condition.</p> <p><b>Assessment</b></p> <p>It is generally the responsibility of the utility to upgrade existing infrastructure to offer new services to customers. They will generally perform these upgrades at little to no cost to the building. The utility can be contacted to inquire as to what service upgrades might be required to enable the provision of new services to occupants.</p> <p><b>Priority</b></p>
<p><b>Expected Service Life</b> 50 Years</p> <p><b>Present Equivalent Age</b> 7 Years</p> <p><b>Estimated Remaining Life</b> 43 Years</p>		<p><b>Note:</b></p> <p style="text-align: right;"><b>Estimated Budget</b> NA</p>

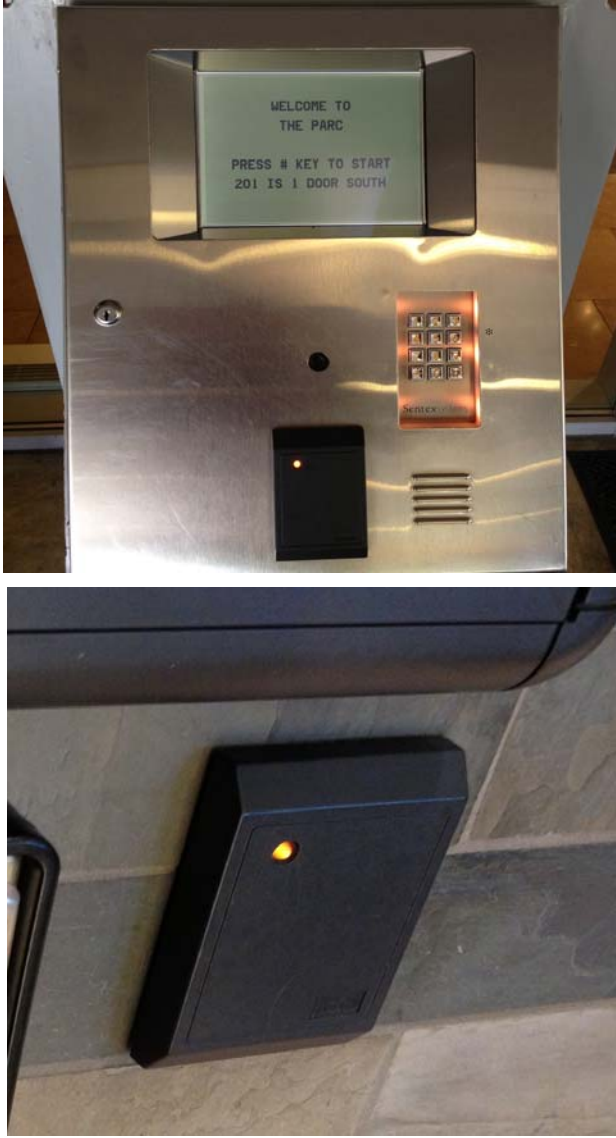
Item	Component	Description / Assessment / Priority
<b>E3.0 Communication System</b>		
3.02	Access Control System

<p><b>Description</b></p> <p>The access control system is located at the main building entry. The panel is manufactured by Sentex and appears recently installed.</p> <p>Entry control points are as shown in the lower image, and are located at a number of locations throughout the building. The system is controlled via a central PC station in the communications room.</p> <p><b>Assessment</b></p> <p>Systems appear modern and up to date. Systems as installed should continue to operate properly for the medium to long term.</p> <p><b>Priority</b></p> <p>4 Building Functionality; cost effective and/or marketability upgrades.</p>
<p><b>Expected Service Life</b> 35 Years</p>		<p><b>Note:</b> To replace existing enter phone and all access controls</p>
<p><b>Present Equivalent Age</b> 7 Years</p>

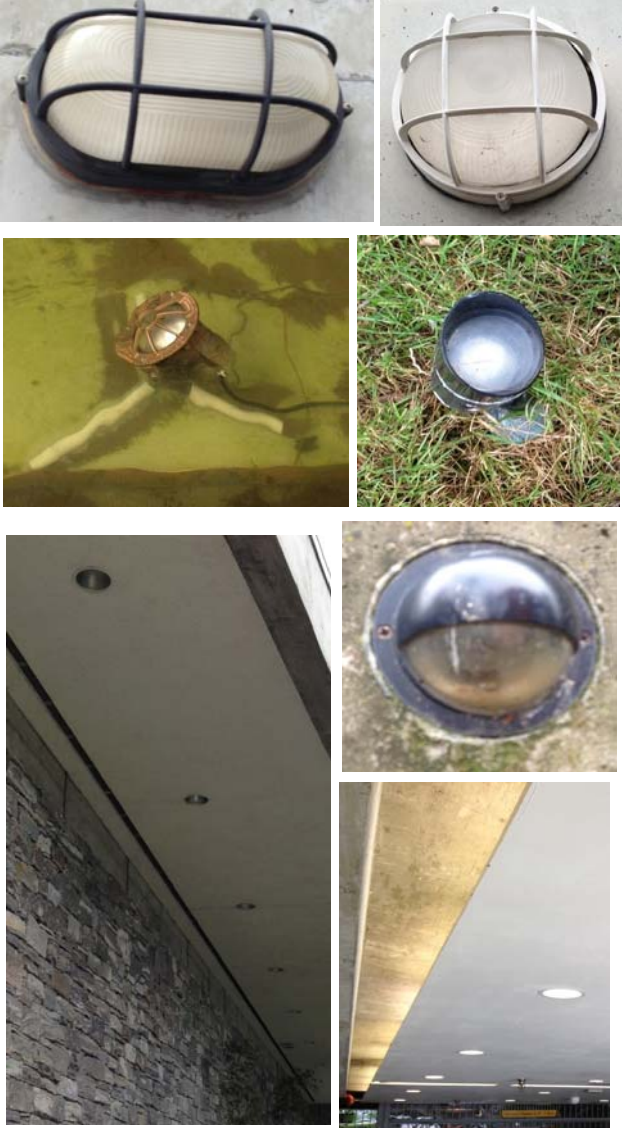
Item	Component	Description / Assessment / Priority
<b>E4.0 Lighting Systems</b>		
4.02	Exterior Lighting

<p><b>Description</b> Exterior fixtures were generally in good condition, but signs of wear are beginning to appear - particularly those near the water feature. Lamp sources are generally fluorescent or HPS and are adequate for the purpose.</p> <p><b>Assessment</b> Fixtures are adequate for the medium to long term.</p> <p><b>Priority</b> 4 Building Functionality; cost effective and/or marketability upgrades.</p>
	<p><b>Expected Service Life</b> 35 Years  <b>Present Equivalent Age</b> 7 Years  <b>Estimated Remaining Life</b> 28 Years</p>	<p><b>Note:</b> For replacement of all exterior fixtures</p> <p style="text-align: right;"><b>Estimated Budget \$ 25,000</b></p>

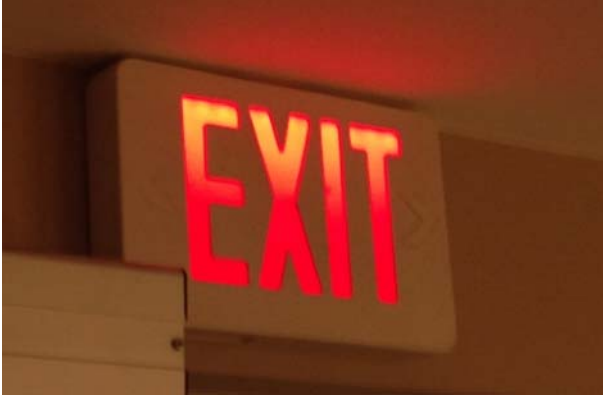
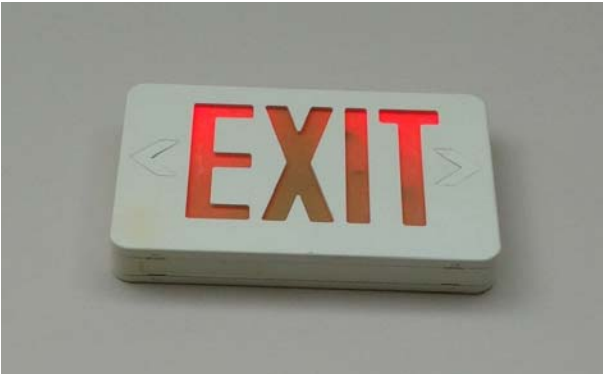
Item	Component	Description / Assessment / Priority
<b>E5.0 Exit and Emergency Systems</b>		
5.01	Exit and Emergency Lighting

<p><b>Description</b> Exit lighting was found to be adequate throughout the building. Exit signage are all LED based units, and are recent.</p> <p>Emergency lighting is provided by a generator unit located on the ground level. The generator provides emergency power to select light fixtures along building egress paths. The coverage or adequacy of emergency lighting was not obvious walking through the building, so no comments are made with respect to coverage and light levels.</p> <p>See the generator section of this report for more information.</p> <p><b>Assessment</b> Annual maintenance should be conducted on exit signage and emergency lighting to ensure continued operation.</p> <p><b>Priority</b> 2 Health and Safety</p>
	<p><b>Expected Service Life</b> 45 Years <b>Present Equivalent Age</b> 7 Years <b>Estimated Remaining Life</b> 38 Years</p>	<p><b>Note:</b></p> <p style="text-align: right;"><b>Estimated Budget</b> NA</p>

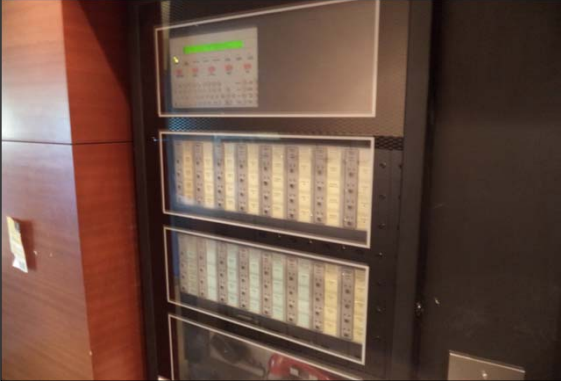
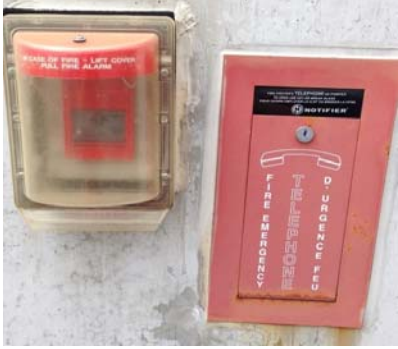
Item	Component	Description / Assessment / Priority
<b>E6.0 Fire Alarm System</b>		
6.01	Fire Alarm Panel & Annunciator

<p><b>Description</b></p> <p>The existing fire alarm system is manufactured by Notifier, and consists of two components - the main FACP (Fire Alarm Control Panel) at the building entry lobby, and a second set of panels in the electrical room to monitor device zones within the parkade. The zones monitored by the parkade panels are supervised by and report to the FACP at the entry lobby. This addressable panel is current, and still supported by the manufacturer. The panel uses speakers capable of voice announcements to building occupants, and provides voice communication to firefighters handsets throughout the building, as required by Code as a 'high building'.</p> <p><b>Assessment</b></p> <p>Records on site indicate fire alarm system maintenance has been occurring on an annual basis, with the last review occurring in July 2012. This maintenance schedule should continue to ensure maximum reliability of the system.</p> <p><b>Priority</b></p> <p>2 Health and Safety</p>

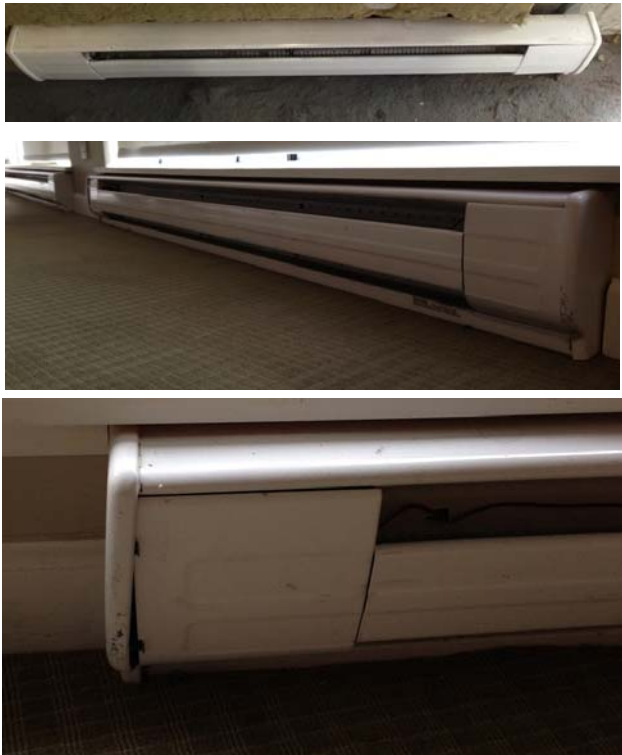
Item	Component	Description / Assessment / Priority
<b>E8.0 Electric Heat</b>		
<b>8.01</b>	<b>Baseboard Heaters</b>

<p><b>Description</b> Electric baseboard heaters are installed in various common spaces throughout the building.</p> <p><b>Assessment</b> Units are in good to fair condition, with some wear showing in some higher traffic areas.</p> <p><b>Priority</b> 4</p>
	<p><b>Expected Service Life</b> 40 Years <b>Present Equivalent Age</b> 7 Years <b>Estimated Remaining Life</b> 33 Years</p>	<p><b>Note:</b></p> <p style="text-align: right;"><b>Estimated Budget</b> NA</p>

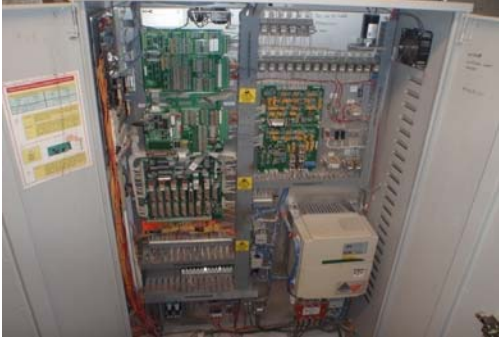
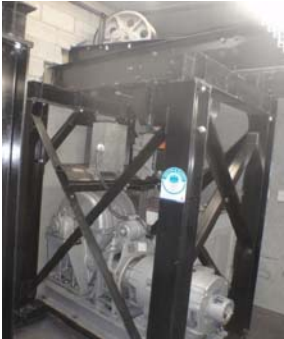
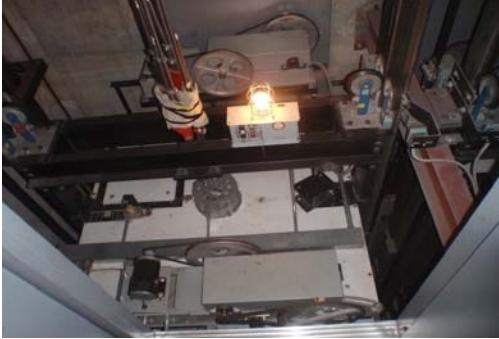
Item	Component	Description / Assessment / Priority
<b>C1.0 Conveying Systems</b>		
<b>1.01</b>	Passenger Elevators, Machine Room & Hoistway Equipment	
	<p>Controller/Drive</p>

<p><b>Description</b></p> <p>Geared overhead traction passenger elevators installed by General Elevator (Now ThyssenKrupp) circa 2004; Elev. 1: 2100 lbs, Elev. 2 3000 lbs capacity; 350 fpm contract speed. MCE VFMC 1000 microprocessor control, with Torqmax AC drive and Imperial AC motor; Hollister Whitney traction machines in a overhead side mount arrangement, instead of a typical overhead arrangement where the machine room is directly above the hoistway. ECI 1000 door operator with infrared light curtain.</p> <p><b>Assessment</b></p> <p>The control equipment uses a microprocessor based system. These controllers have since been replaced with a new model, but are supported by the OEM. The geared machines are of a good design and are in adequate condition, with no leaking noted. The elevators appeared to be in good operation, and the levelling was good. The door operators are of an outdated design and do not have closed feedback control. The elevators are equipped with infrared door detectors which reopen the elevator doors without physical contact. If problems with the door operator equipment become apparent, they should be upgraded (within the next 10 years, cost \$30,000.00 per elevator) prior to completing a modernization as noted below.</p> <p><b>Priority</b></p> <p>4 Building Functionality; cost effective and/or marketability upgrades.</p>

<p><b>Expected Service Life</b> 30 Years</p> <p><b>Present Equivalent Age</b> 8 Years</p> <p><b>Estimated Remaining Life</b> 22 Years</p>	<p><b>Note:</b></p> <p>The Budget does not include for the required fire alarm modifications that are associated with a modernization.</p> <p>Phase 1: \$60,000 door operators (10 years)</p> <p>Phase 2: \$350,000 complete modernization (22 years)</p> <p style="text-align: right;"><b>Estimated Budget</b> See Above</p>

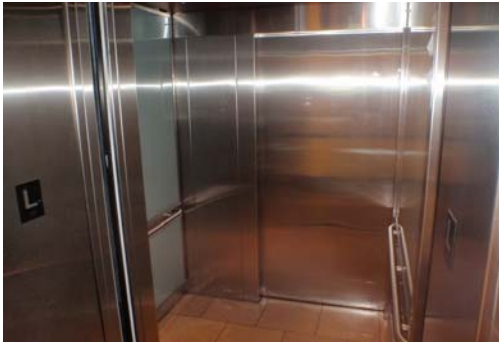
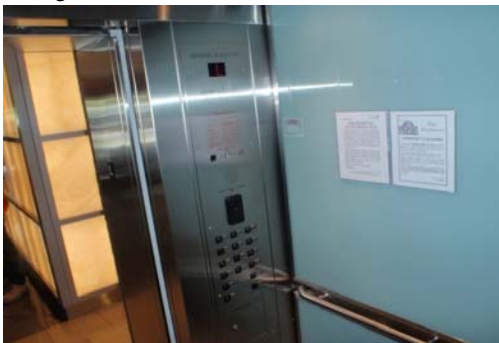
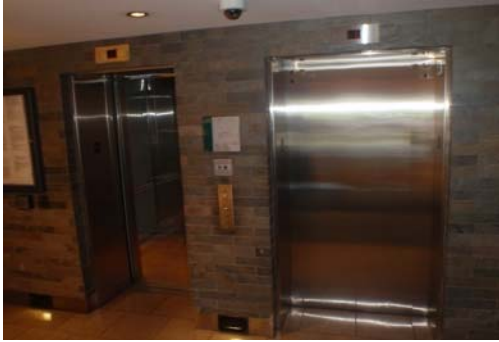
<b>1.02</b>	Passenger Elevators, Cab Interior and Operating Fixtures	
	<p>Cab Interior</p>

<p><b>Description</b></p> <p>Cab finishes are original: Raised back painted glass on side walls with stainless steel reveals; Stainless steel car doors, jambs, returns and headers on front and rear entrances; Wood ceiling; Tile floor.</p> <p>Original fixtures: Dupar US 89 stainless steel push buttons with LED illumination, LED dot matrix position indicator in car and level 1, car lanterns, no audible indicators. There are hands free emergency communications in the elevator cabs.</p> <p><b>Assessment</b></p> <p>Cab finishes are in good shape but operating fixtures do not meet all requirements for persons with physical disabilities. The mandatory requirement for emergency communications is in place.</p> <p><b>Priority</b></p> <p>4 Building Functionality; cost effective and/or marketability upgrades.</p> <p><b>Note:</b></p> <p>Modernization of operating fixtures and emergency communication is included under section C1.1 budget. Budget is only for replacement of cab interior finishes and is at the Owners discretion.</p> <p style="text-align: right;"><b>Estimated Budget \$ 40,000</b></p>
